FLOOD RISK ASSESSMENT

**Land at
Cellars Clough,
Nr Marsden,
Huddersfield,
West Yorkshire
HD7 6NB**

E15/6518/FRA001C

**April 2016
REVISED September 2017
Revised June 2018**

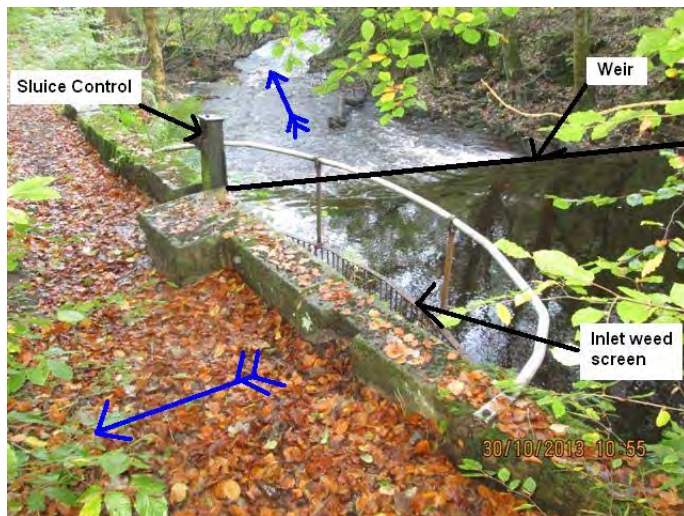
1. Weir and sluice inlet

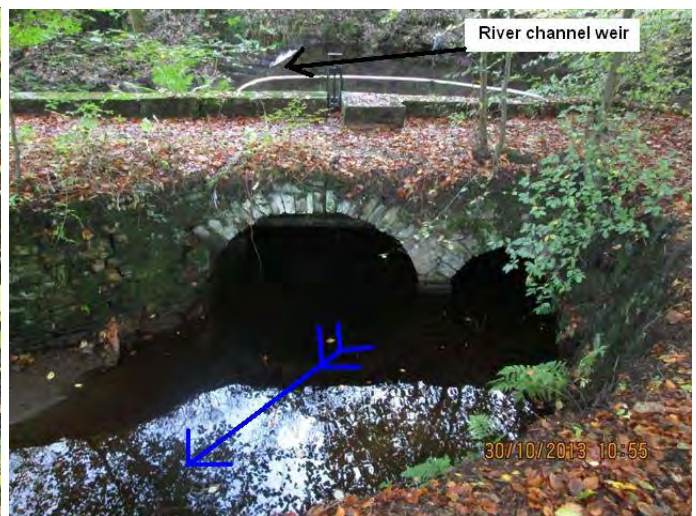
2. Masonry arch inlet culvert

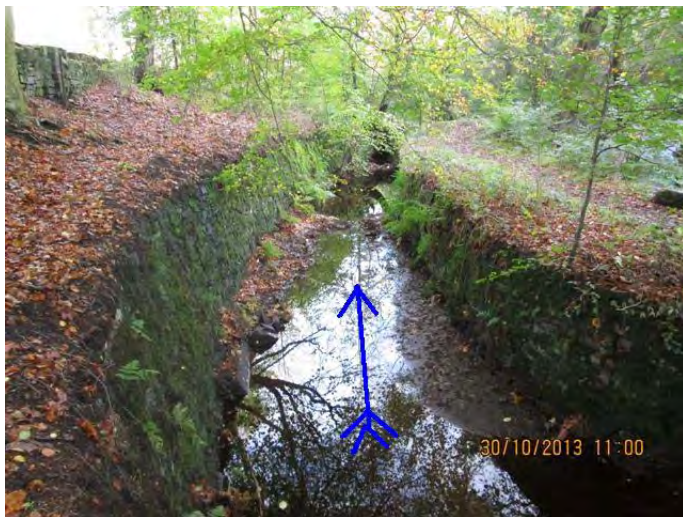
3. Masonry lined inlet channel

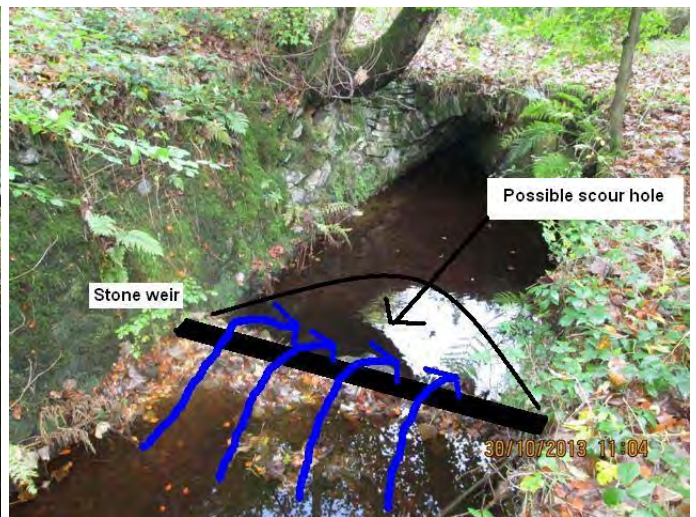
4. Stone weir in inlet channel

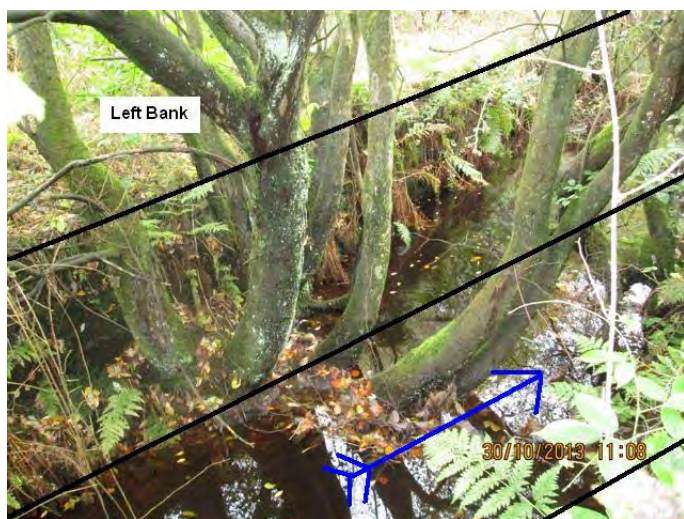
5. Tree in inlet channel reducing capacity

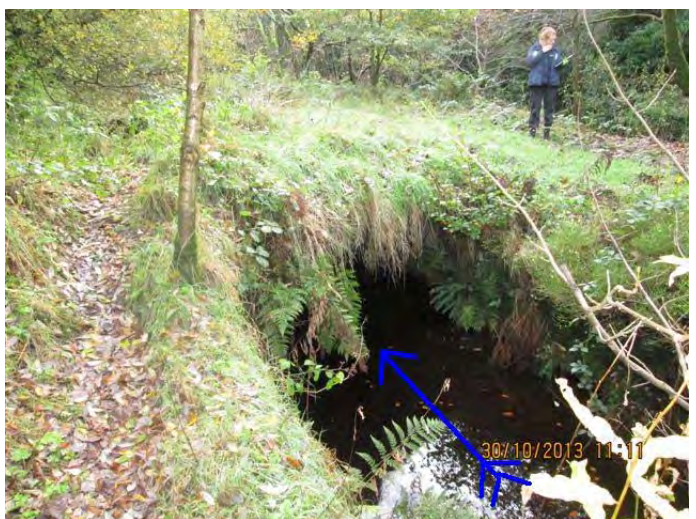
6. Bridge over inlet channel

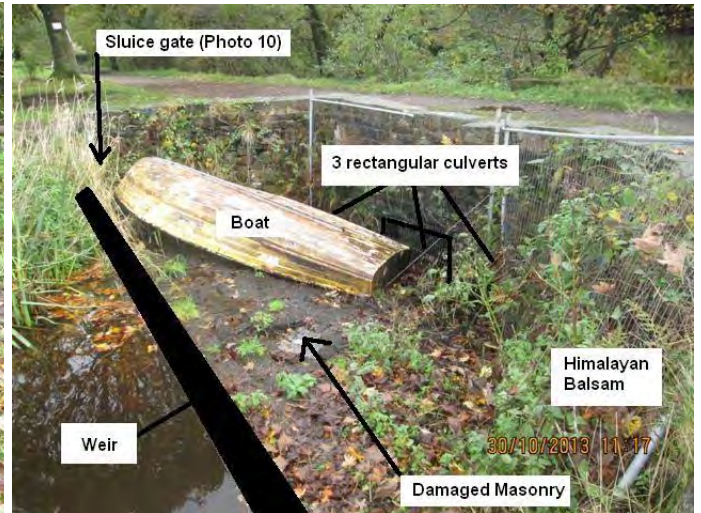
8. Overflow

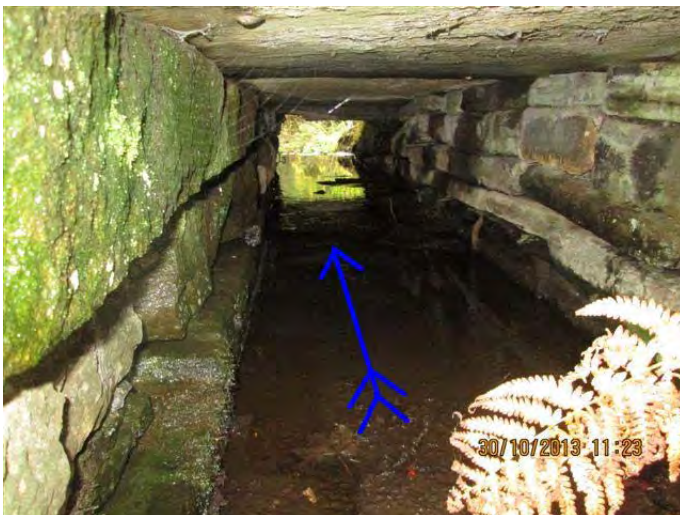
9. Rectangular culvert from overflow

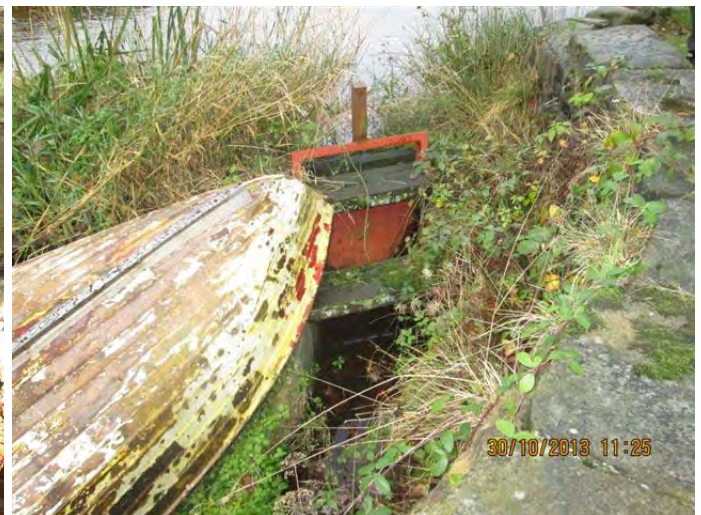
10. Sluice control on left side of overflow

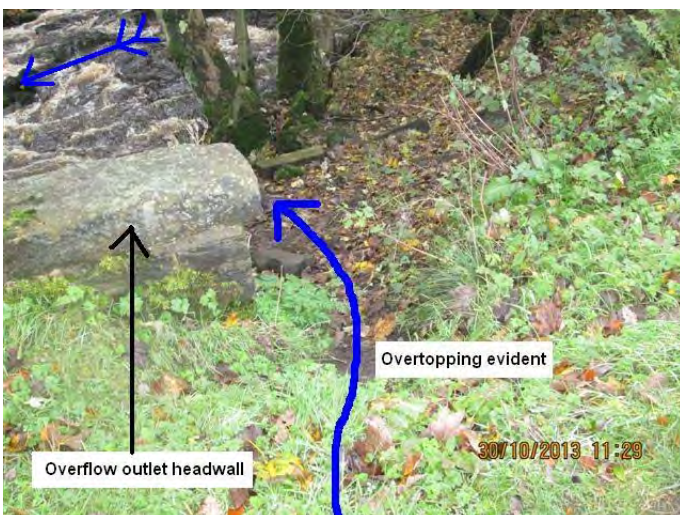
11. Possible overtopping flow path

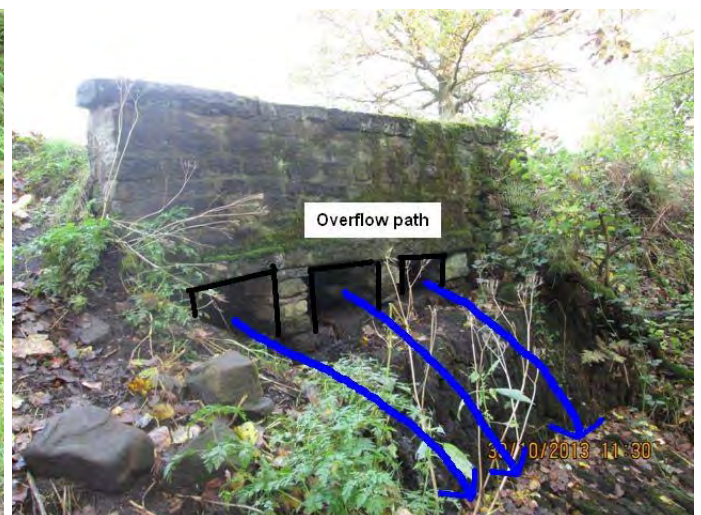
12. Culverts from overflow into watercourse

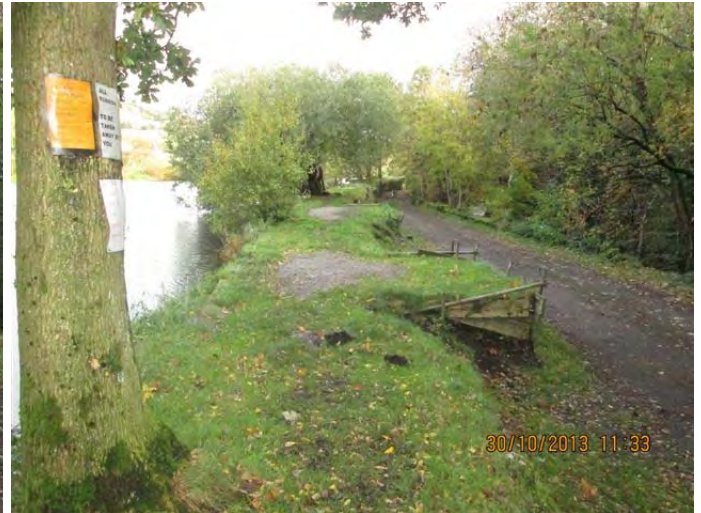
14. View looking north east across crest

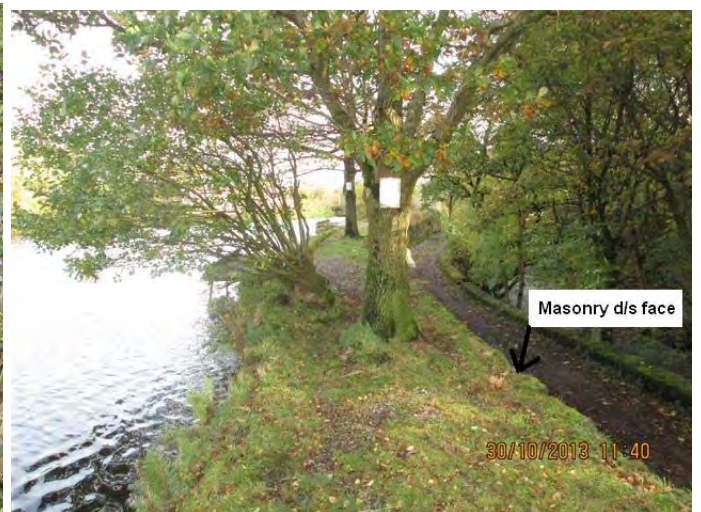
16. View looking north east across crest

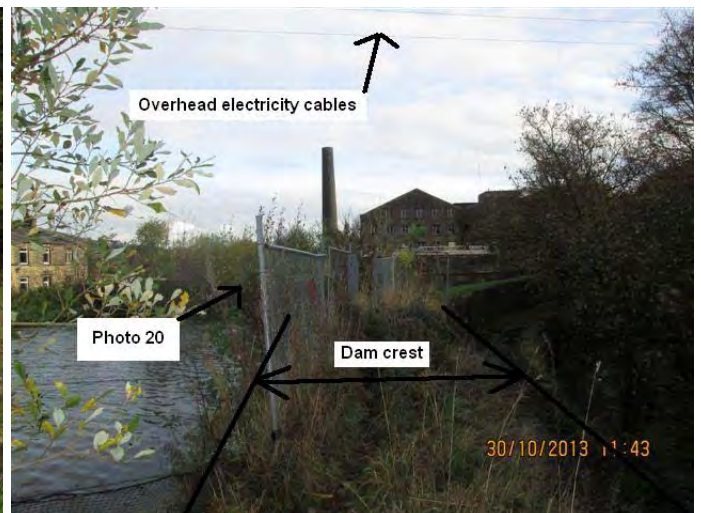
18. View looking east across crest

- Remedial works to stop the leakage from the northern dam along with repairs undertaken to Canal towpath (picture 28)
- Removal of the submerged boat within the reservoir.
- Maintenance of overflow spillway to reinstate missing masonry.
- Management and maintenance of trees within the inlet channel, on the upstream face and dam crest. (picture 5)
- Consideration given to the removal of the fencing panel on the overflow arrangement to reduce blockage risk. (picture 18)

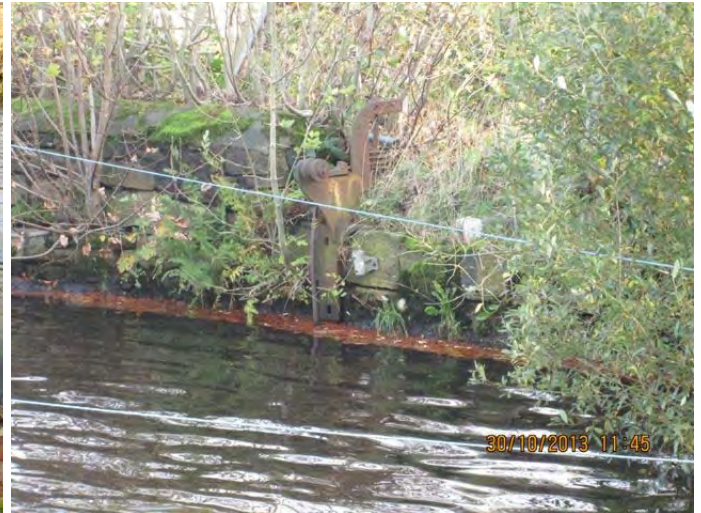
20. Sluice control in intermediate dam.

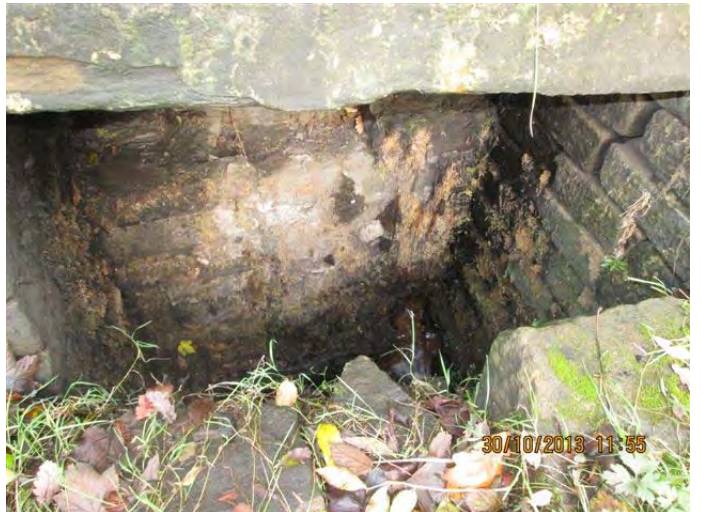
22. Chamber in masonry retaining wall

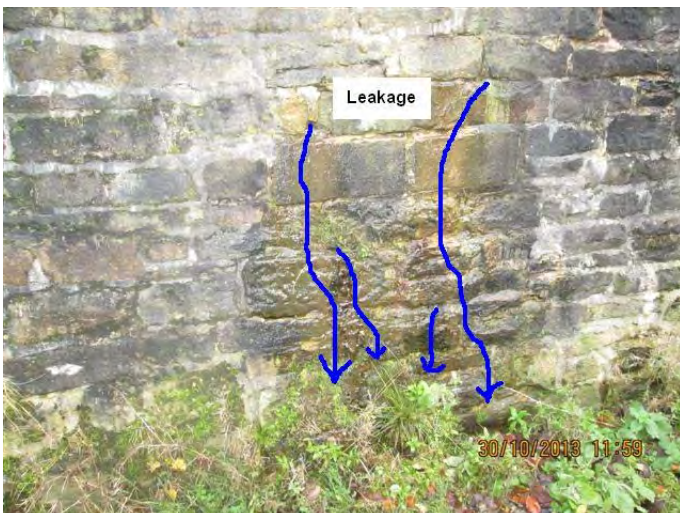
23. Leakage through masonry wall

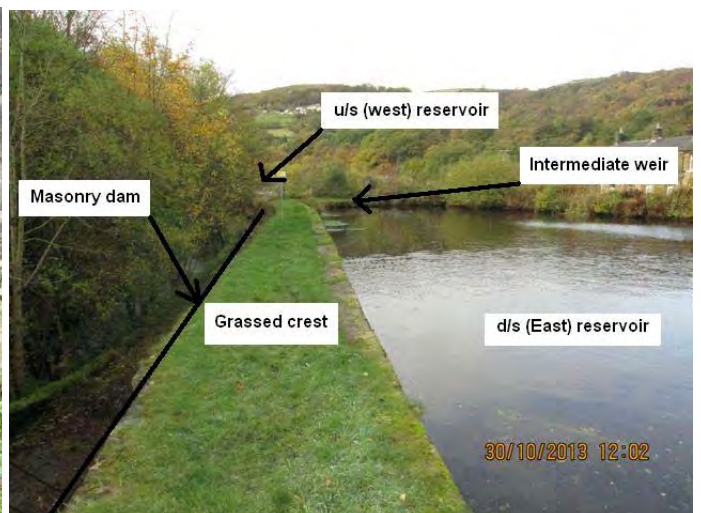
24. View looking west across crest

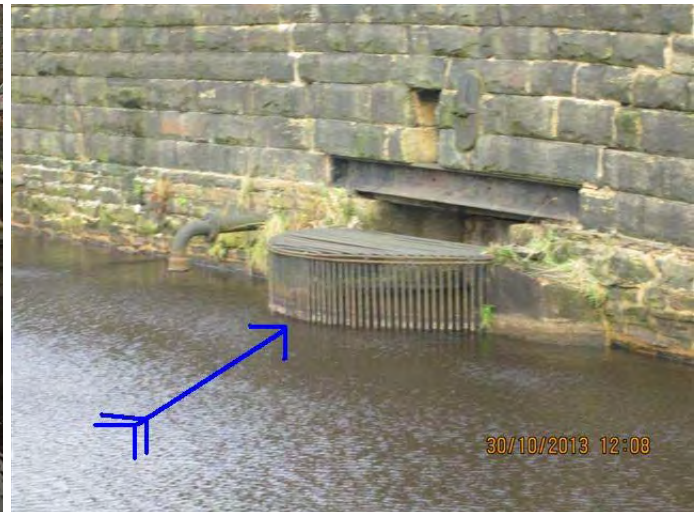
26. Outlet into mill building

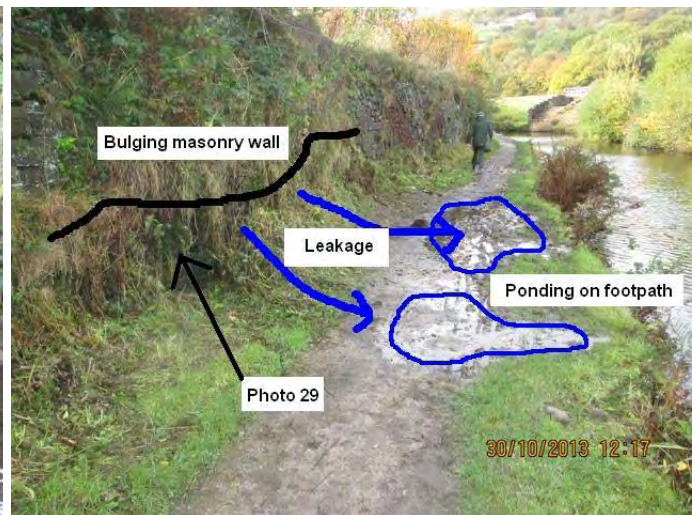
28. Leakage and bulging masonry

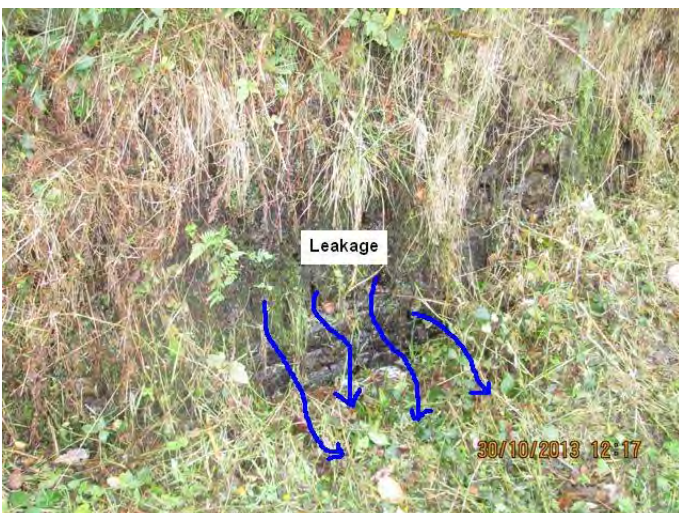
29. Leakage flow

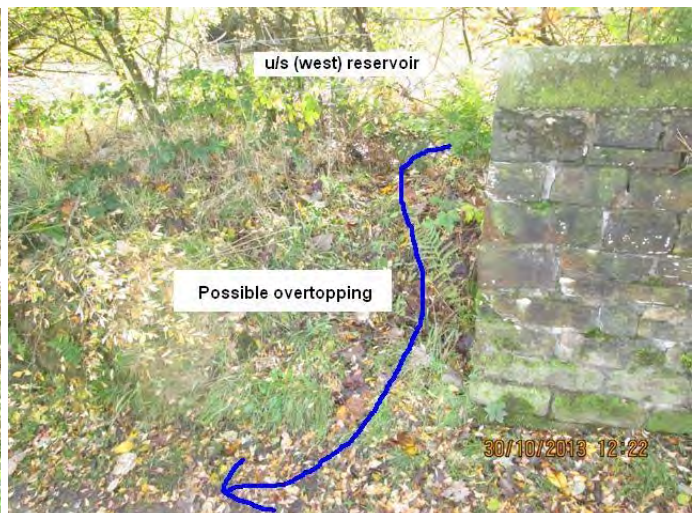
Retaining Structure (Northern Bank)	Construction	Masonry dam and earth crest.		
		Freeboard	<ul style="list-style-type: none">Freeboard estimated to be 500mm.		
		Upstream Face	Not visible during site inspection.		
		Crest	Not visible during site inspection.		
		Downstream Face	<ul style="list-style-type: none">Masonry retaining wall with leakage identified in 3nr locations resulting in ponding and erosion of canal towpath (Photo 28 & 29).Bulging identified in a number of locations along its length (Photo 28).Possible overtopping flow path identified opposite Sparth reservoir discharge point (Photo 30).

30. Possible Overtopping
