CONTAMINATED LAND RISK ASSESSMENT
PHASE 1 DESK TOP STUDY AND SITE WALKOVER SURVEY

Blackmores Ltd

**Lock Street
Dewsbury**

Date: 3rd September 2012

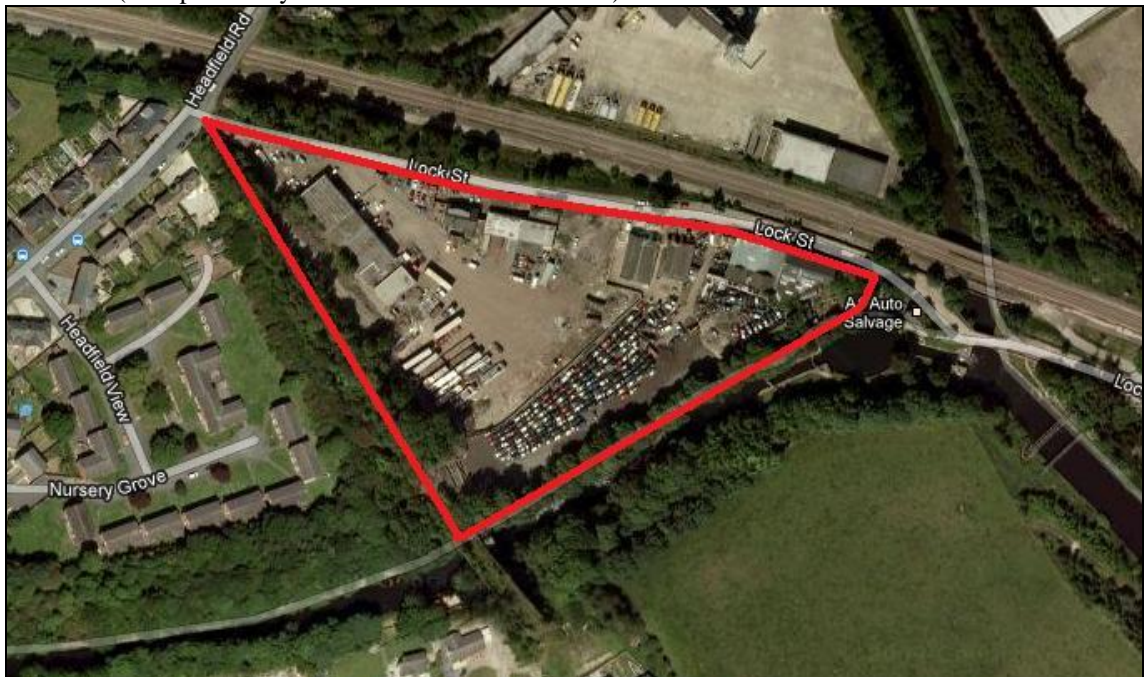
Photo 1. (This photo may be several months out of date)

The site assessed for this investigation currently comprises approximately 2.51 ha of land located off Lock Street, Dewsbury. A road bounds the site to the north, with canals to the east and south, and residential properties to the west (Photo 1).

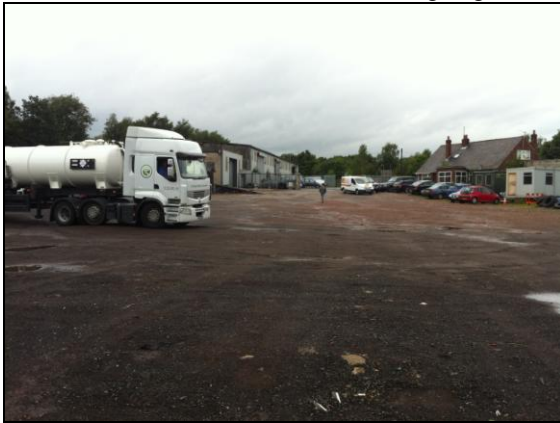
Photo 2.(View E to W towards MOT garages.)

The site is currently occupied by a scrap yard (Photos 2 and 3), with a car service garage to north-west (Photos 4 & 5), wrought iron and gate paint works to the north (Photos 6 and 7), and a car breakers yard on the east (Photo 9). The dismantled railway located running along the western boundary of the site (from the north-west to the south) is at a higher elevation than the rest of the site (Photo 11). The site surface is covered with crushed rock and gravel.

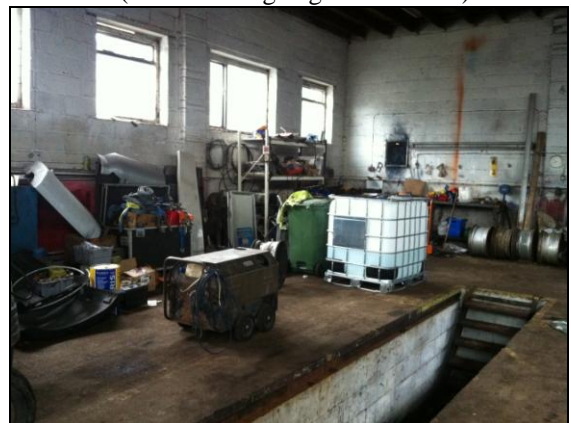
Photo 5 (View inside garages to the NW)

Tyres, detergents, oils, paints, machinery and tools were located in the service garages on the north-west of the site (Photo 5).

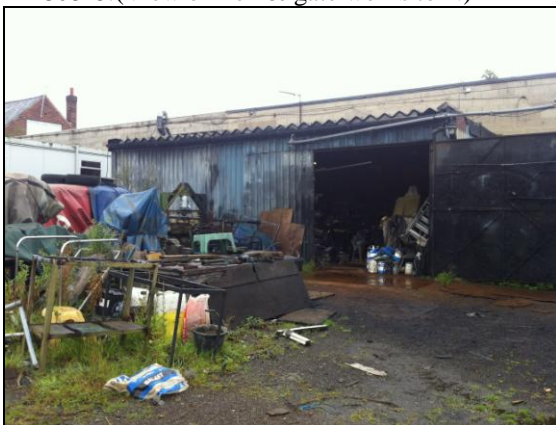
Photo 6.(View of iron & gate works to N)

Paints, tools and machinery were situated in the wrought iron and gate works on the centre-north of the site (Photos 6 and 7).

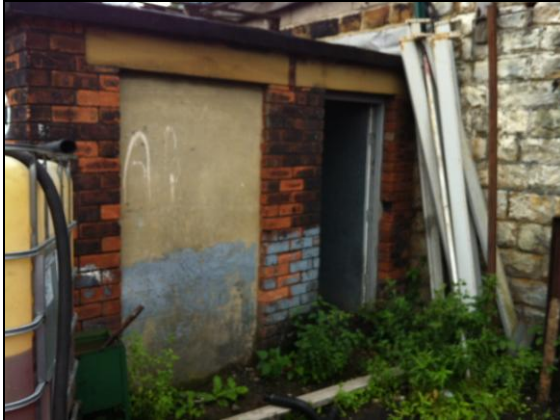
Photo 8 (Electric sub station located NE of site)

An electricity substation was noted on the north-east of the site (Photo 8). Minor spillages of oils were evident on the ground in the car-breakers area (Photo 9).

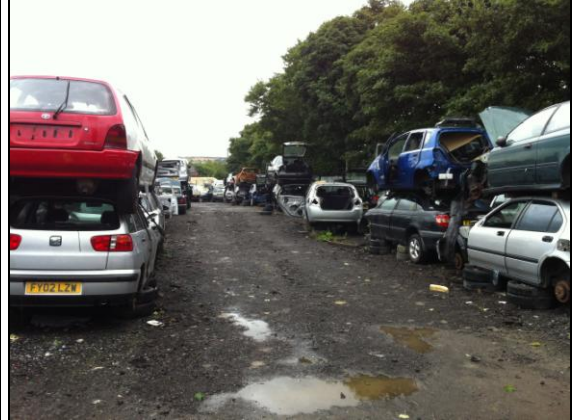
Photo 9 (View NE to SW- car breakers)

- 1 Leaks and spillages from the use of hydrocarbons, solvents and paints on the site.
- 2 Leaks and spillages of hydrocarbons from car-breaking activities
- 3 Metals and metal compounds from workshop repair activities.

The Phase 2 intrusive investigation should include eight boreholes to assess the ground for PAHs, aliphatic and aromatic compounds, metals, and VOC's. Ground water wells should be inserted to assess water quality.

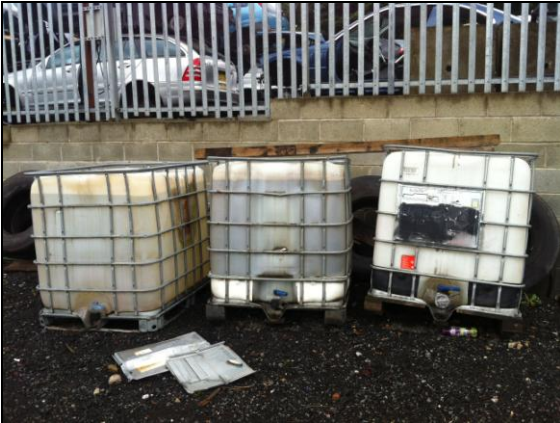
Photo 10 (Waste oil located to centre east)

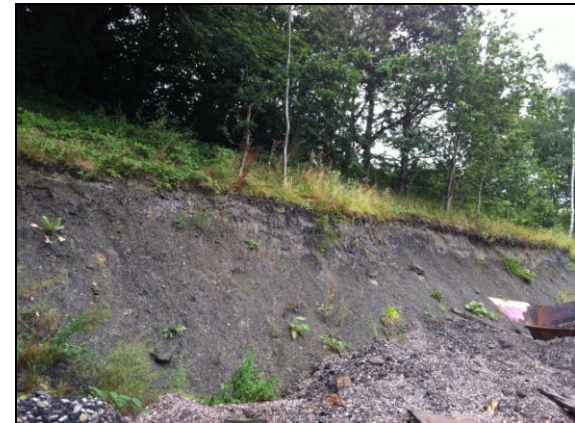
Photo 11 (View centre W to E up to dismantled rail)

The railway embankment on the site consisted of clay and shale (Photo 11).
