Title: Initial Phase 1 Desk Top Study:
Hoyle Ing Dyeworks
Hoyle Ing
Linthwaite
Huddersfield
HD7 5QS

For: James Dyson Directors' Pension Scheme

Date: 30th March 2011

Ref: NG7621/HOY/st

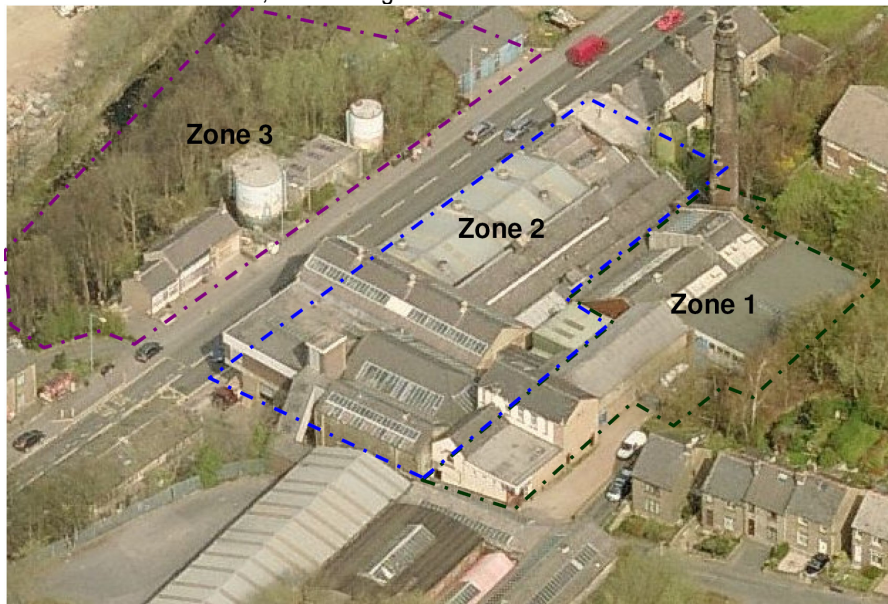
Figure 1: Birds eye view of site showing zones

Southern section of site: The site is fully occupied by the vacant dyeworks buildings, a collection of single and two storey masonry buildings housing redundant machinery. The site slopes significantly from the south eastern boundary of the site down to Manchester Road. Due to the topography of the surrounding area, the south eastern third of the site (zone 1) is elevated from the section of site that borders Manchester Road (zone 2). The south eastern wall of zone 2 is a masonry retaining wall and vegetation was seen growing on the wall. Zone 1 was used for drying wool/fibres in dryer machines and an engineers' workshop. Zone 2 was used for the wet processes associated with the colouration and chemical finishing of the loose fibres. A 4"-6" borehole (now capped off) is also located in zone 2, used to extract water from the ground water below and used in the wet processes of dyeing. A boiler is located in the building in the northern corner of zone 2. Offices are located on the first floor of the two storey buildings in zone 2.

Northern section of site (zone 3): This area contains a dental practice, a vacant brick building and the former water treatment and effluent balancing tanks associated with the dyehouse, fronts onto Manchester Road. The treatment/balancing tanks are above ground structures. The ground slopes significantly from Manchester Road, down to the River Colne. Large trees are located to the rear of the structures, on the embankment.
