## **SPRINGHEAD FARM SCHOLES MOOR ROAD SCHOLES HOLMFIRTH HD9 1RU**

### **1.0 Introduction**

- 1.1 We are instructed by Mr & Mrs P Crompton care of Townsend Planning Consultants, 10 Rishworth Street, Wakefield, WF1 3BY to undertake a survey of the farm buildings within the yard of the subject property, Springhead Farm, Scholes Moor Road, Scholes.

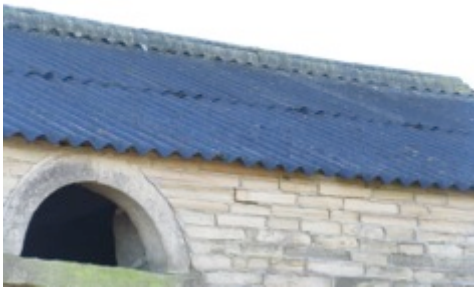
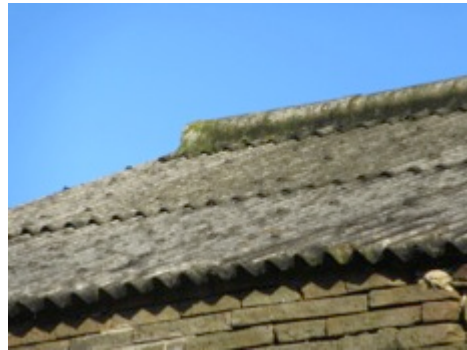
- 3.1.1 The roof was inspected from ground level, with the aid of binoculars. The roof is of traditional appearance being pitched with a covering of asbestos cement sheeting. Overall the covering is weather proof with no evidence of water ingress. Asbestos cement sheet covered roofs are not suitable for habitable buildings and will require removing as a matter of course.

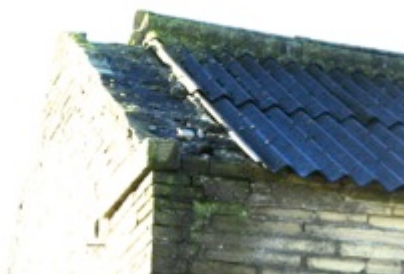
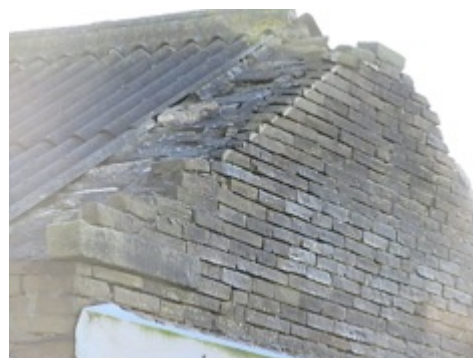
- 3.1.2 There has been considerable publicity and concern in recent years regarding the health hazards associated with asbestos. The material is however generally only hazardous when in dust form and it is therefore only when it is being worked, moved or has been damaged, that it represents a risk. Provided that the surface is unbroken and preferably kept sealed, perhaps by painting where appropriate (though obviously not sanding prior to this), then no hazard should arise. It is understood that small-boarded materials can be carefully sealed in a plastic bag and taken for special disposal to the Local Authority refuse disposal point.
- 3.1.3 Over the masonry walls at the gables, there are no stone copings. The stone at the top of the wall is now exposed and saturated. As an interim measure the open masonry should be protected from the weather.

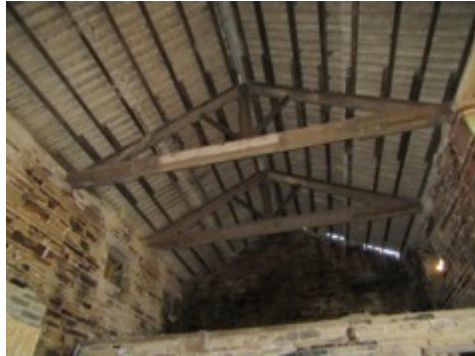
- 3.1.5 The supporting structure is traditional, with a timber framework, supported on the main walls of the building. This takes the form of eight purlins (the horizontal beams) to each roof slope with three timber King Post trusses spanning front to rear. The purlins sit on the top cord of each truss. No significant deflections were noted in the timber frame.

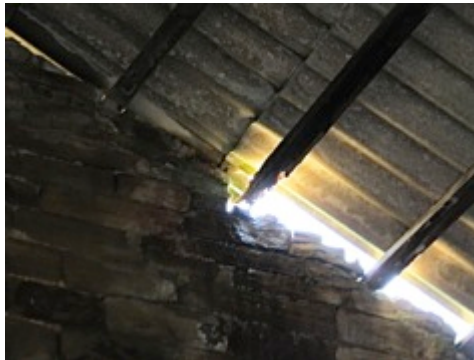
- 3.1.6 At the junction with the gable walls, several purlins have decayed where they are now exposed to the elements. Replacement of the defective sections of timber is required.

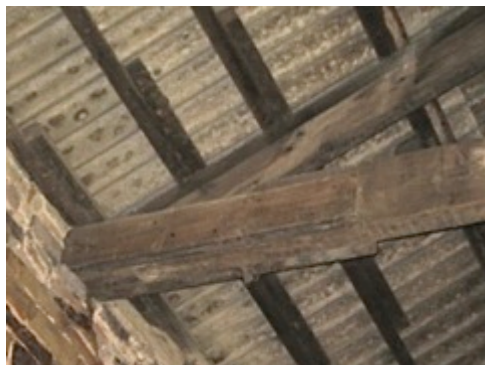
- 3.1.7 Spliced timber repairs have been carried out to the bottom members of the trusses, where previously damaged timber has been removed. The members appear serviceable in their present condition.

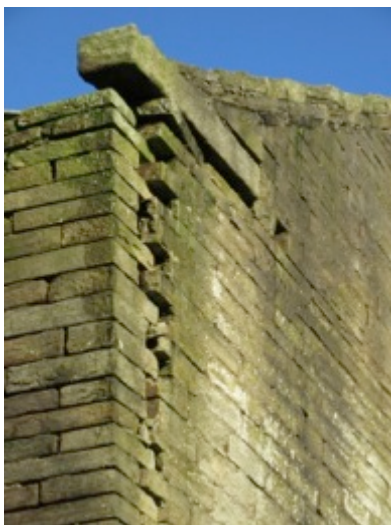
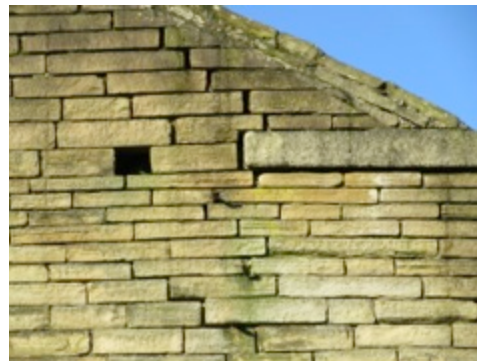
- 3.2.5 The masonry of the left hand side gable wall is displaced above the eaves and gable cut up. In this area, where the wall is damaged, there is a requirement to cut out and re-bond the affected area.

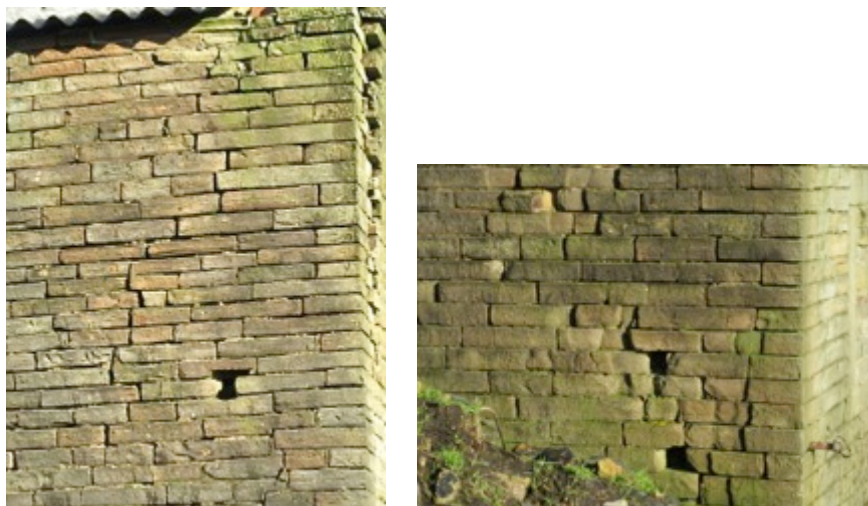
- 3.2.6 Along the rear elevation, towards the left hand corner, opening of the masonry joints has occurred. Localised repair of the wall in the affected area is required. The repair work is no more than an item of routine maintenance. The incorporation of stainless steel “heli-bar” will reinforce the repair across the open joints.

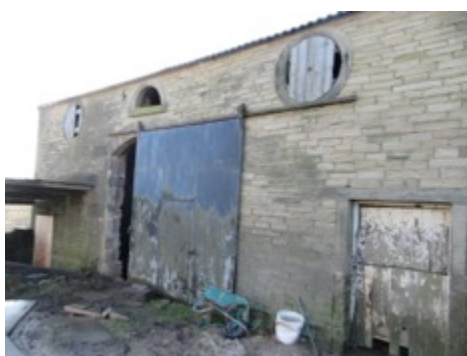
- 3.2.7 The front elevation masonry is in serviceable condition requiring no more than repointing as part of a routine maintenance programme.

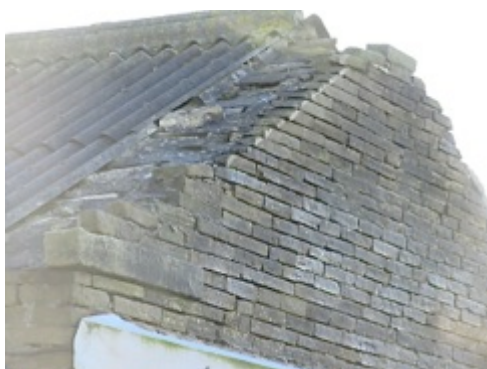
- 3.2.8 The pointing to the upper section of the right hand side gable wall requires repointing. Lack of regular maintenance is the primary reason for the need to undertake the repair.

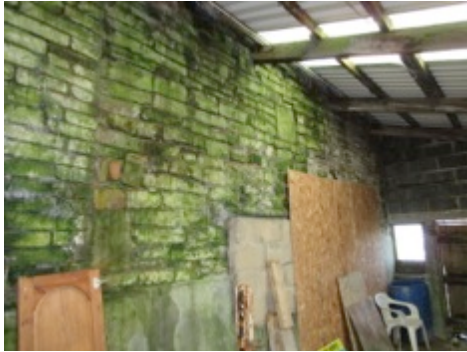
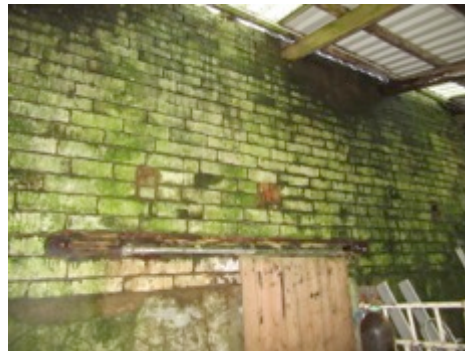
- 3.2.9 The lower and/or missing section of the wall inside the milking parlour is damp affected, as a result of a defective flashing between the side lean-to roof covering and masonry. The wall will readily dry out after the roof junction is sealed.

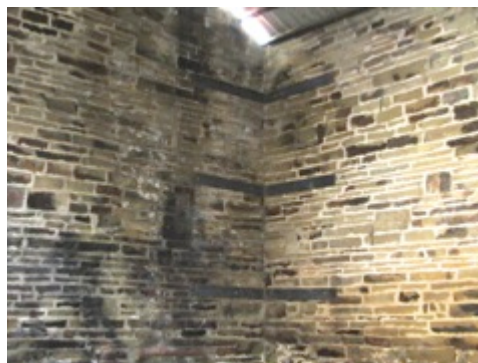
- 3.2.11 Steel straps have been installed across the internal angles of the left hand side gable wall. The steel is a relatively light section and is bolted to the stonework. The metal bracing does not appear to be offering a great deal of restraint to the masonry. No sign of recent movement was apparent.

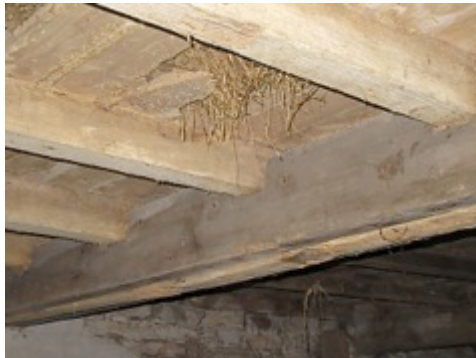
- 3.3.2 There is insect attack and considerable decay in the structural members and floorboards of the suspended timber first floor. As part of any work at all on the building there is a need to take out and replace the affected timbers.

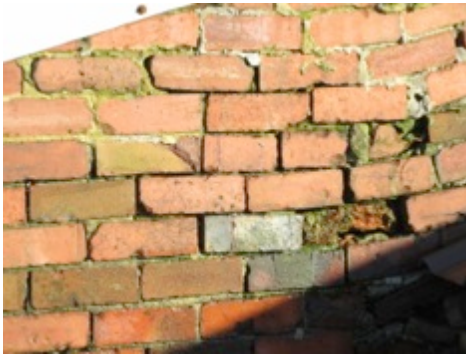
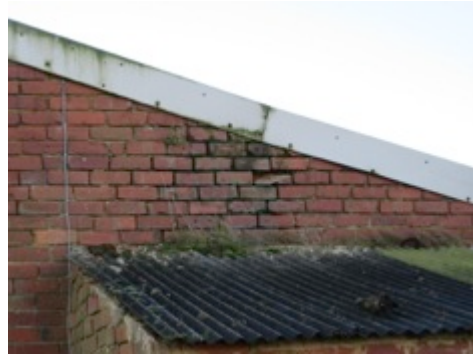
- 4.3.3 Areas of brickwork are open jointed externally and require pointing. Work of this nature is no more than routine maintenance.

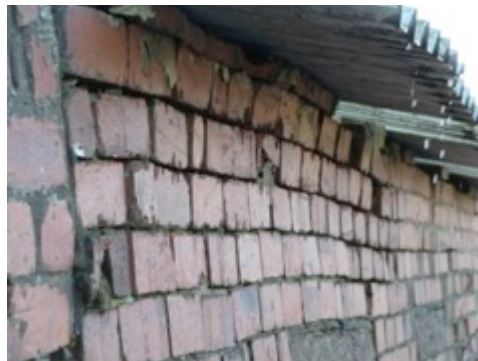
- 4.3.4 Immediately below the steel sheets, at the eaves along the right hand side elevation, the brickwork is loosening. The defect appears to be simply attributable to lack of regular routine maintenance.

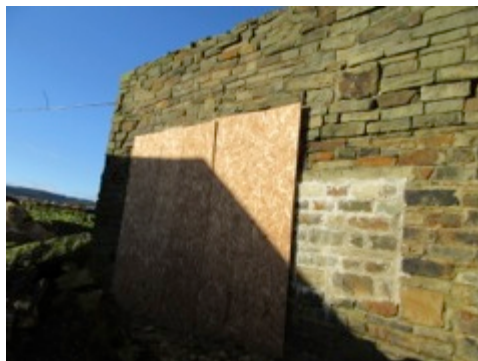
- 4.3.5 The rear section of the left hand side wall of the milking parlour, extending beyond the rear of the barn, is stone. The masonry is in satisfactory condition.

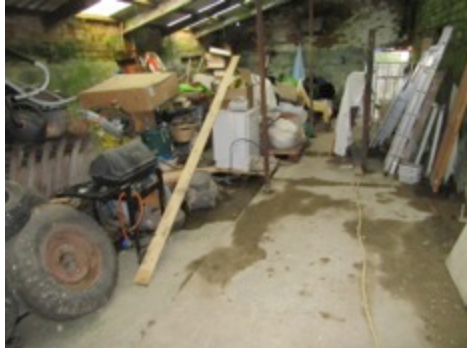
- 4.4.1 The ground floor is concrete. The floor is satisfactory for the buildings current use. For use as a dwelling and to comply with Building Regulations, a new floor will have to be laid.

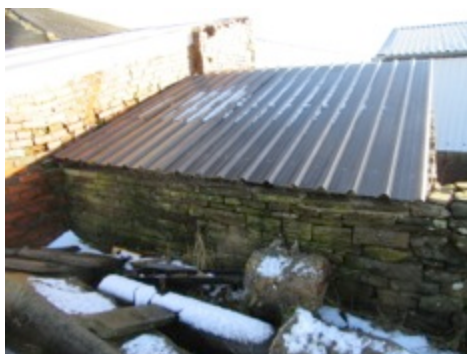
- 4.5.1 The roof is a mono-pitched construction with a covering of profiled metal sheets supported on a timber frame. The covering and structure are in serviceable condition.

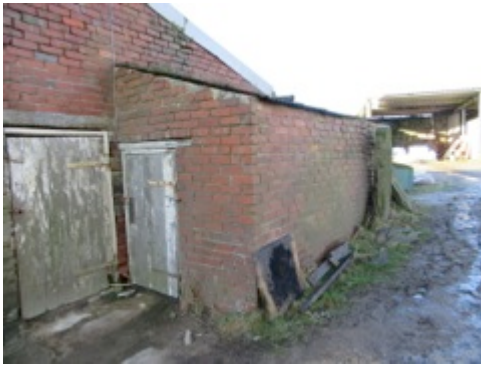
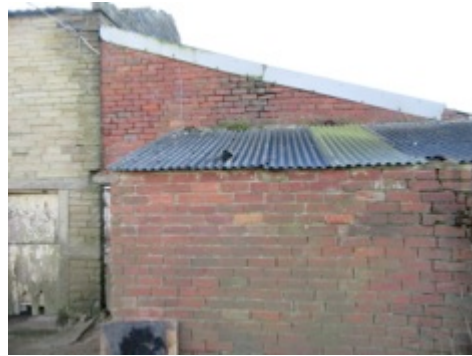
- 4.6.1 The lean-to roof is covered with asbestos cement sheets. As a matter of course, the covering should be stripped off and disposed of safely notwithstanding any other proposed use of the building.
- 4.6.2 Externally a timber lintel above the right hand side window head has decayed allowing settlement of the brickwork above. Replacement of the support and rebuilding the damaged brickwork is required.

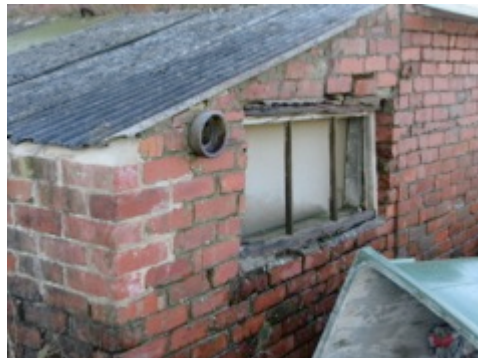
- 4.6.3 Internally there are no significant structural defects in the walls or floor.
