ARBORICULTURAL REPORT
to BS 5837:2012
at
Flockton Green Working Mens Club
Barnsley Road
Flockton
West Yorkshire
WF4 4AA

Client:
Barratt David Wilson Yorkshire West

JCA Ref:
12734/ChC

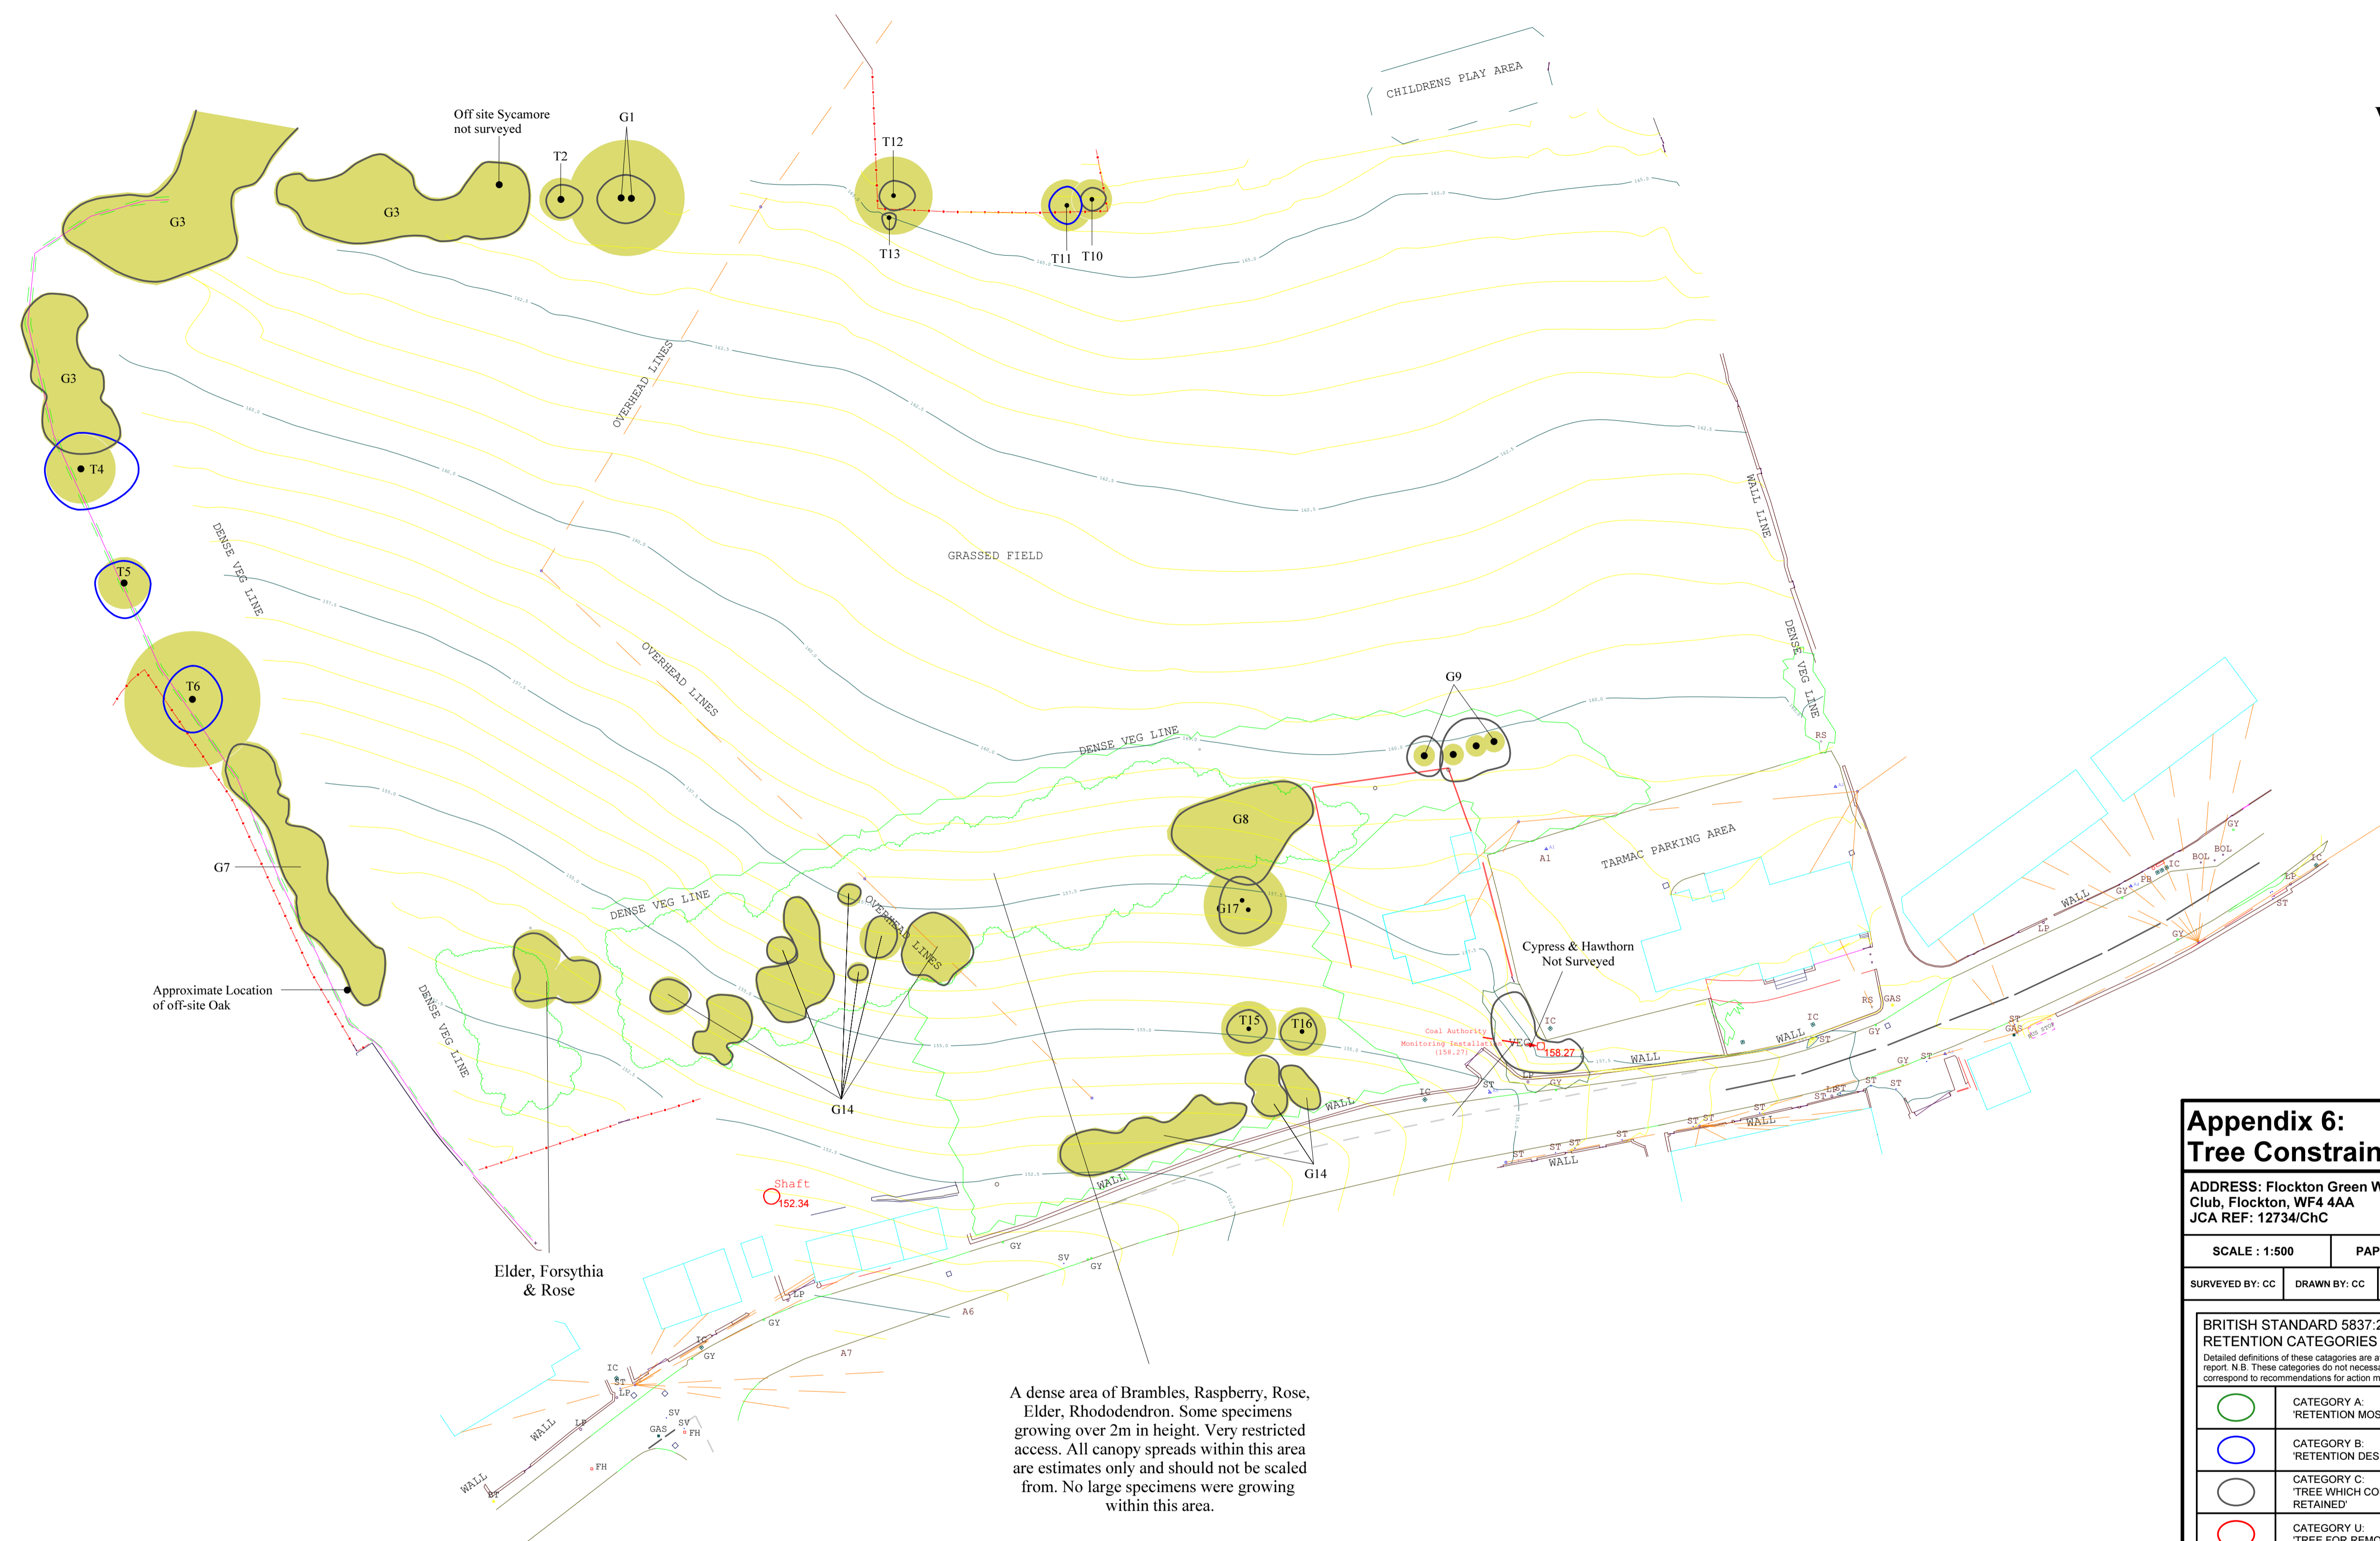
**Appendix 6:
Tree Constraints Plan**

A dense area of Brambles, Raspberry, Rose, Elder, Rhododendron. Some specimens growing over 2m in height. Very restricted access. All canopy spreads within this area are estimates only and should not be scaled from. No large specimens were growing within this area.
