Cellars Clough, Marsden

Road Safety Audit
Stage 1
August 2018

Project No: 1048

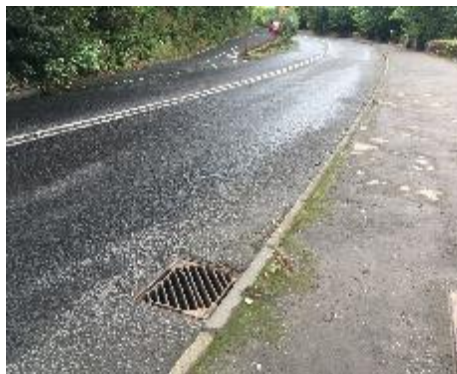
A62 Manchester Road west of
access road

Detail: There are several gullies along the north side of the A62 Manchester Road where the carriageway is being widened (See Images below). There are no details of any proposed drainage or the relocation of the gullies. If the carriageway is not drained adequately there is a risk of flooding / standing water which may lead to vehicles losing control. This problem is exacerbated during the winter months due to low temperatures and freezing conditions.

Recommendation: Relocate the existing gullies to the proposed channel line and provide adequate drainage elsewhere if needed.

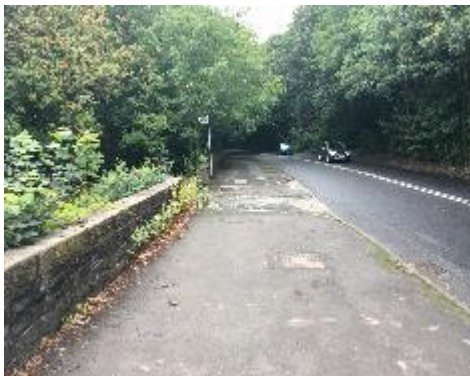
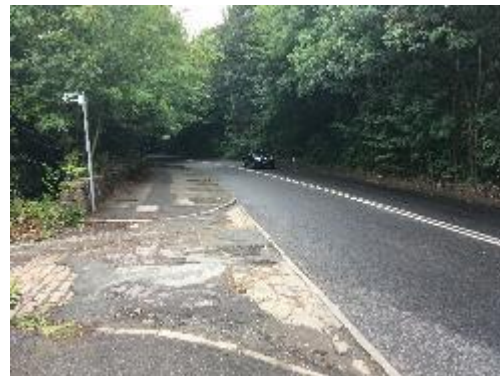
Detail: There are several manholes in the footway along Manchester Road in the area where the carriageway is being widened. There are no details of the relocation of the manholes and some appear to be along the proposed kerb line. If these manholes cannot be relocated or adjusted they will create a hazard for pedestrians.

Recommendation: All manholes should be relocated / adjusted to be flush with any proposed levels.

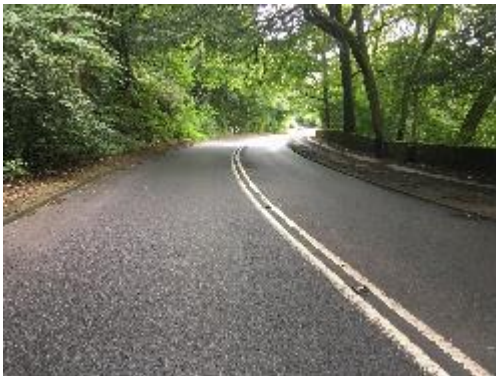
A62 Manchester Road looking West

Detail: There is an abundance of vegetation including large mature trees on both sides of the carriageway on the A62 Manchester Road, east of the access road. This creates dark areas and obscures any light emitted from the street lighting. A new refuge is proposed on the bend approaching the junction and if lighting is not adequate there is a risk this could be struck or vehicles approaching from this direction may not see queuing traffic in the new right turn pocket for the junction resulting in shunt type collisions.

Recommendation: Ensure the lighting levels are adequate for the proposed layout and there is advance warning of the junction.

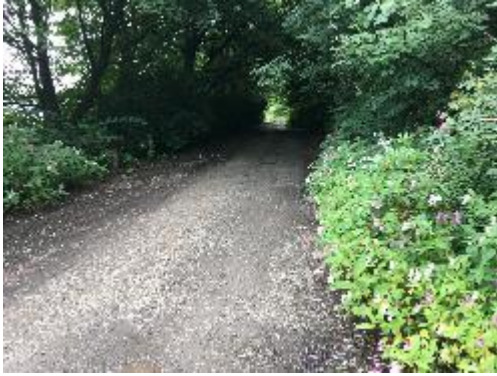
*Access Road looking East towards
Manchester Road*

Detail: There is heavy vegetation along the full length of the access road creating dark areas and overhanging into the carriageway (See Images below). No lighting details have been provided and it is unclear whether this road will be illuminated. It is also unclear how much vegetation is being removed to accommodate the changes to the road. If the levels of vegetation remain there is a risk of collisions between vehicles as they may not see each other or move into the path of oncoming vehicles to avoid the vegetation.

Recommendation: Ensure the lighting levels are adequate and the vegetation is removed / cut back to accommodate the predicted levels of traffic using this road.

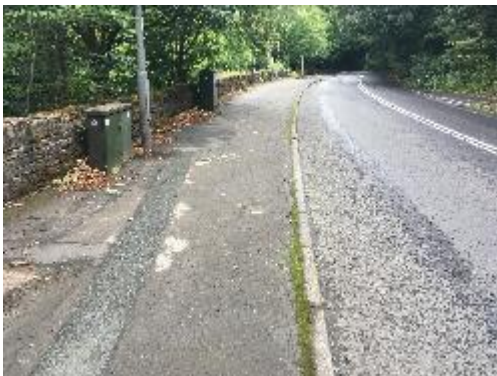
A62 Manchester Road looking East

Detail: There is what appears to be a dropped crossing which is assumed to be for maintenance vehicles to access the BT / Communication Cabinets (See Images below).

This dropped crossing is within the area which is proposed for carriageway widening and at present is within the double white line system. There are no details showing that this has been considered. If a maintenance vehicle cannot pull off the carriageway and has to park in the live running lane this could create a hazard for passing vehicles and a danger to the operative.

Recommendation: Ensure the dropped kerb has been considered so maintenance vehicles can access the communications cabinets.

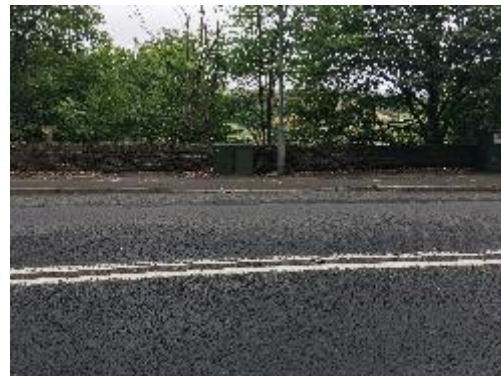
*A62 Manchester Road – BT Cabinets /
dropped crossing*

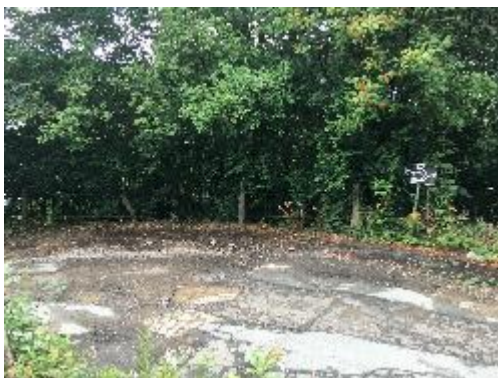
Detail: A new vehicle restraint barrier and pedestrian guard-rail is proposed along the new footway on the access road but the embankment between chainage 0 and 30 is unprotected. This could lead to an errant vehicle negotiating the bend leaving the carriageway with an increased risk of severity.

Access Road looking at section without proposed restraint system

Recommendation: Extend the safety fence to chainage 0.

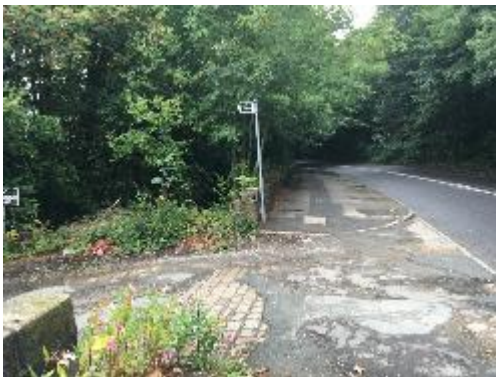
*Manchester Road looking East
towards bend*

Detail: Although the carriageway is being widened and a 90-metre visibility splay is shown, there is a stone wall on either side of the access and it is unclear if this is being removed to improve visibility. There is also heavy vegetation to the east of the access road, outside the highway boundary including large mature trees which obscure sightlines around the bend on Manchester Road, when pulling out of the junction; especially for larger vehicles. It is also not clear whether this vegetation is being removed or cut back.

Recommendation: Ensure the sightlines in both directions are adequate and comply with DMRB and the vegetation is cut back adequately.

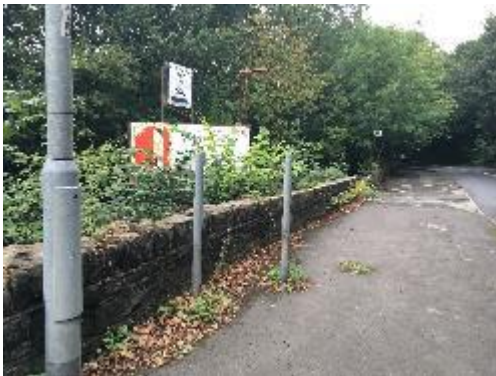
Manchester Road looking East

Detail: There are some posts in the footway to the west of the access road which are assumed to have had a chevron board on at some time (See Image below). If the footway is reduced at this point to 1.9 metres as shown on Drawing No.1048:101 there is a risk that the footway will not be wide enough for pedestrians with pushchairs or wheelchair users if the chevron board is reinstated. This may result in pedestrians stepping into the road. It may also obscure the sightlines when exiting the junction. There are chevron boards further west along the road which may also need relocating if the footway cannot accommodate them.

Recommendation: Determine if the chevron board is needed and if it is to be re-erected, ensure it does not obscure sightlines or reduce the footway to an unacceptable width. Check the footway width at the existing chevron boards.

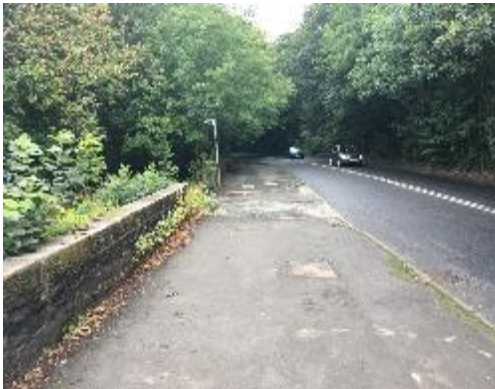
A62 Manchester Road looking towards access road.

Detail: The access road has a severe bend near to the junction with the A62 Manchester Road with a steep gradient at the start. The forward visibility when turning in from the west is blind and due to the layout and topography there is a risk of collisions between vehicles at this point, especially larger vehicles which require a bigger turning circle. It is also unclear whether the stone wall is to remain at the back of the footway on the A62 which also restricts visibility.

Recommendation: Improve the access in and out to minimise conflict between vehicles.

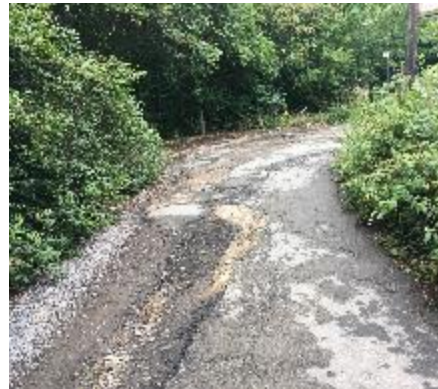
Access Road approaching blind bend towards Manchester Road

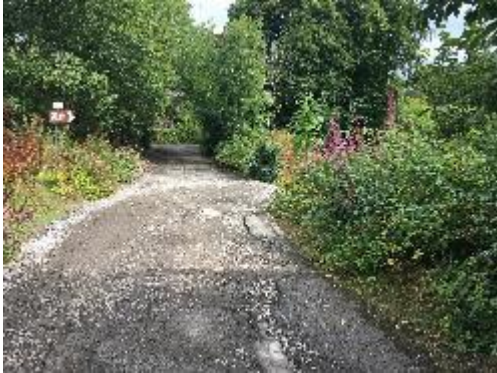
*Access Road at J/W Entrance to
Healing Centre*

Detail: The access road to the new development also serves a Healing Centre and at the junction with the access to the Healing Centre there is limited visibility due to overgrown vegetation and the layout of the road. There are no details shown of any priority at this intersection and there is a risk that vehicles will be in conflict if increased traffic is using the road. Drawing No.1048:101 also appears to show that the pedestrian guard rail extends across this access.

Recommendation: Ensure the vegetation is cut back adequately to improve sight lines, the pedestrian guard rail does not obstruct the access and provide priority Give Way markings.

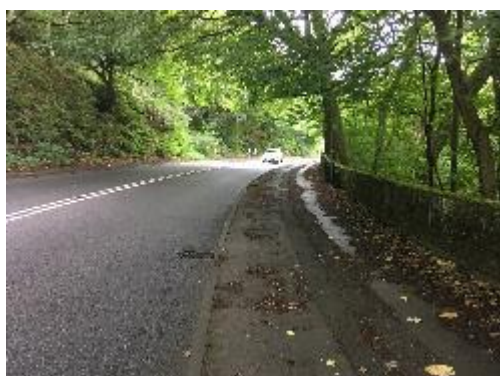
A62 Manchester Road at location of proposed refuge.

Detail: The proposals show a new refuge island on the western approach to the junction with the access road, in the central hatching. It is proposed to be positioned opposite a public footpath which is signed and accessed from Manchester Road through a gap in the stone wall (see Image below). There are no dropped crossings shown on either side of the carriageway at this location and there is no footway on the southern side of Manchester Road so it is assumed that this refuge is not intended for pedestrians. The refuge may encourage pedestrians to cross at this location if it is not made clear that it is not intended for this purpose.

Recommendation: If the refuge is not intended for pedestrians to use as a crossing point make this clear or improve the standard of the refuge and facilities for pedestrians at this location.

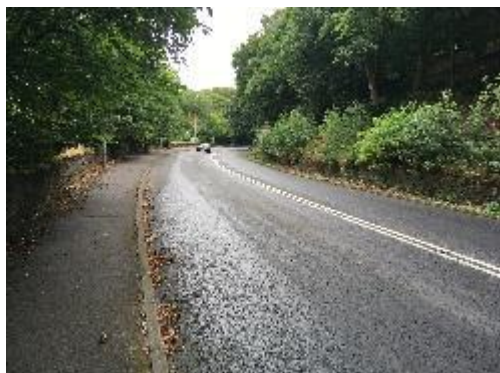
Detail: The proposals show some new hatching, a new right turn pocket and direction arrows. The existing lining is a double white line system through the series of bends that the scheme extends (See Image below). The double white lines prevent overtaking through this series of bends and restrict parking. If this is not included in the proposals, there is a risk of collisions from inappropriate overtaking with an increased risk of severity.

*Double white line system on A62
Manchester Road looking East*

Recommendation: Include the double line system in the proposed layout.

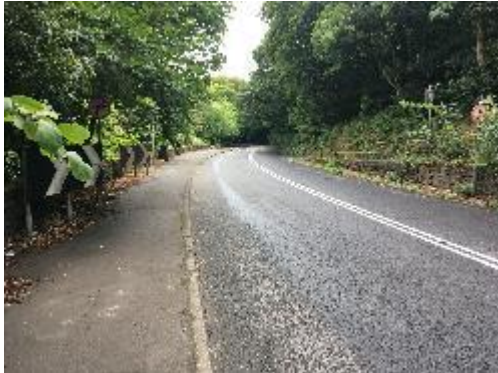
*A62 Manchester Road looking East
approaching j/w Stubbin Road*

Detail: The proposals show a gap in the hatching on Manchester Road at the junction with Stubbin Road. There is a no right turn ban into Stubbin Road and this may encourage drivers to use the gap to turn right. The signs indicating the no right turn are also obscured by vegetation (See Image below). Traffic wishing to turn right in two stages from Stubbin Lane will be able to sit in the hatched area.

Recommendation: Extend the hatching, consider additional road markings to discourage this manoeuvre and trim back any vegetation obscuring the signs.
