## **Pre-Demolition/Major Refurbishment Asbestos Survey Report**

**PA Welding Ltd**

Victoria Mill, Fisher Green, Honley, Holmfirth, West Yorkshire, HD9 6DU

Survey Date: 18th May 2016

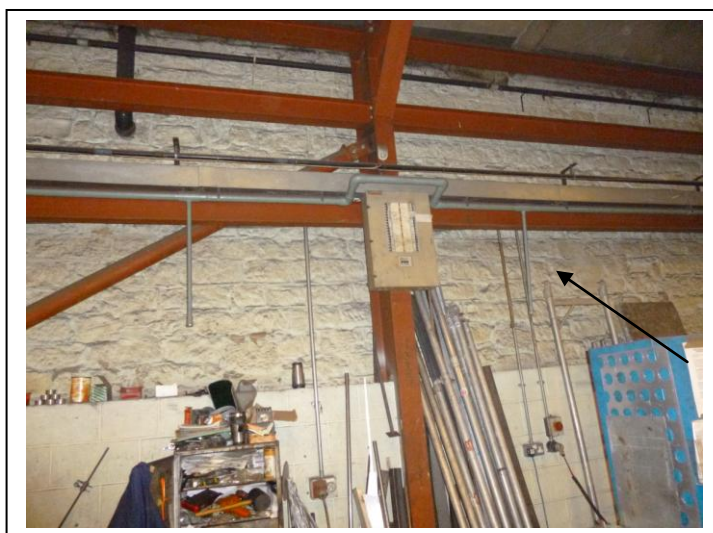
| Material / Item | Back Wall Coating to Stone |

| Recommendations / Comments:<br>No asbestos materials have been located, no further action required. |

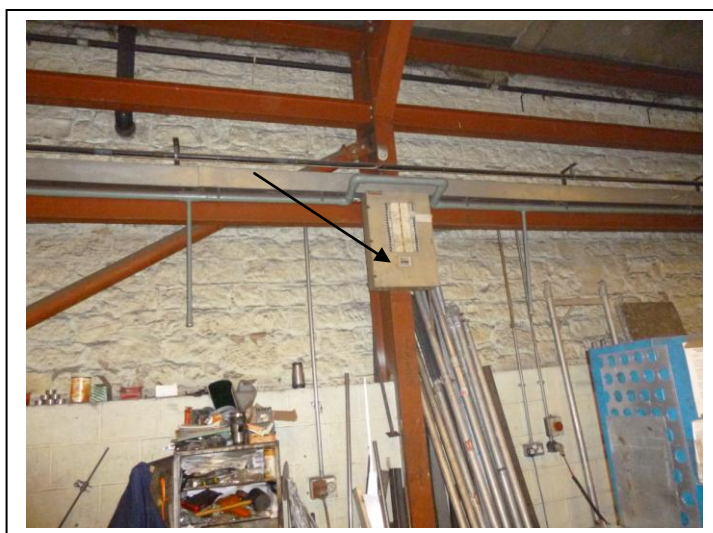
| Material / Item | Electric Boxes |

Recommendations / Comments:  
Access denied due to live cables, no asbestos suspected.

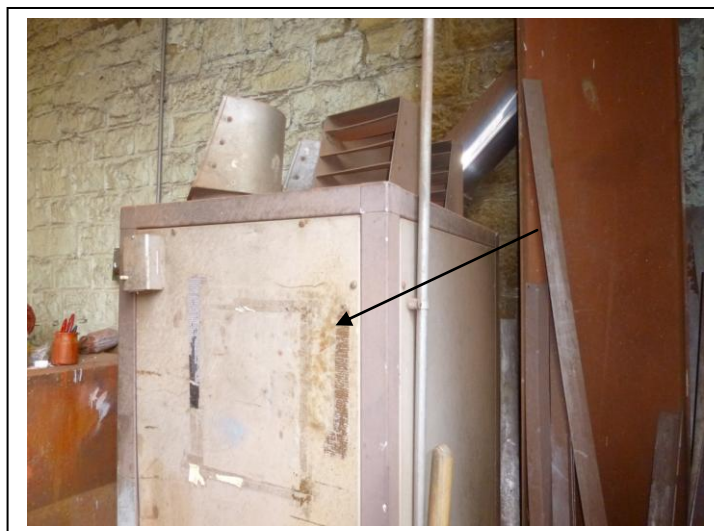
| Material / Item | Floor Heater |

| Recommendations / Comments:<br>No asbestos materials have been located, no further action required. |

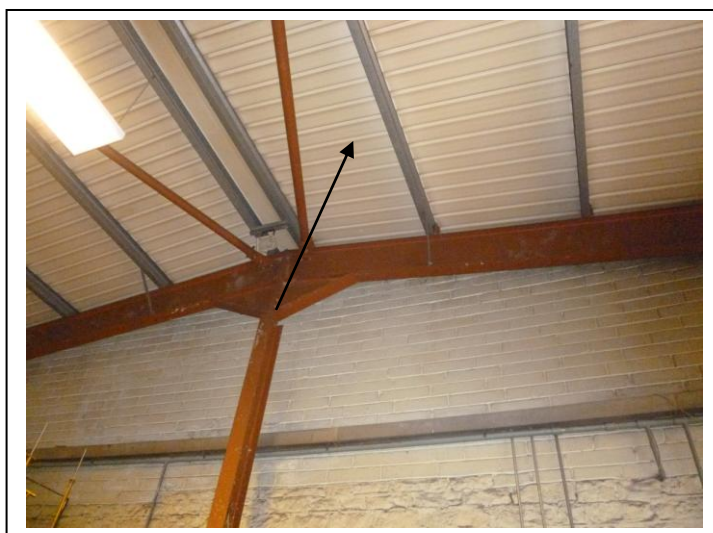
| Material / Item | Roofing Material |

| Recommendations / Comments:<br>No asbestos materials have been located, no further action required. |

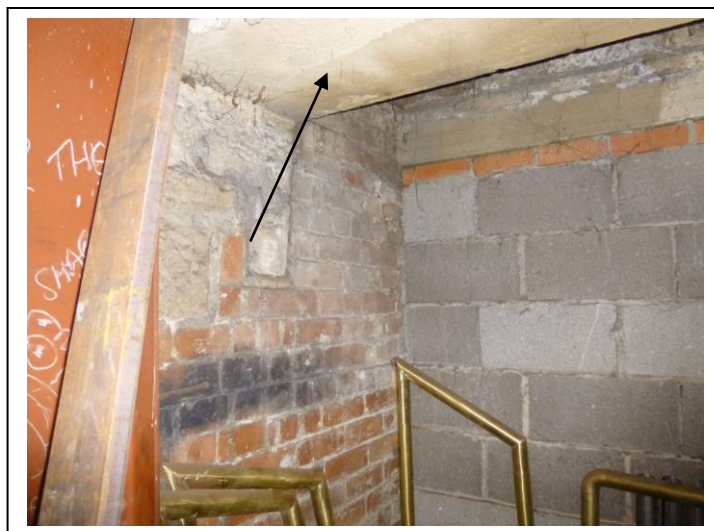
| Material / Item | Far Wall Recess 2 |

| Recommendations / Comments:<br>No asbestos materials have been located, no further action required. |

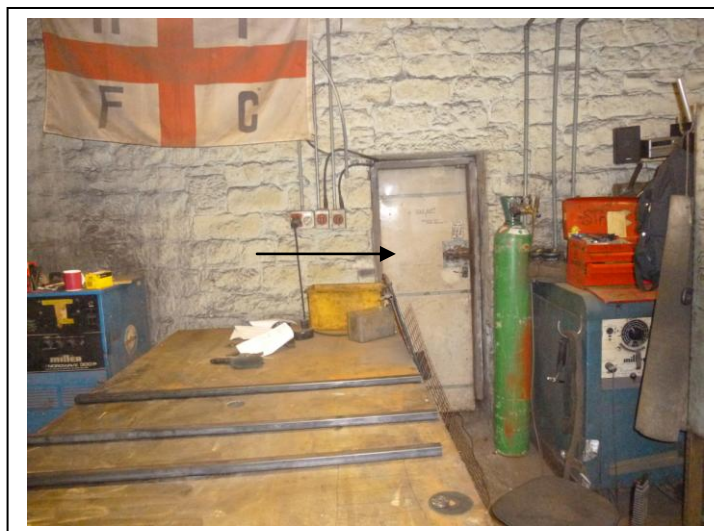
| Material / Item | Far Wall Single Door |

| Recommendations / Comments:<br>No asbestos materials have been located, no further action required. |

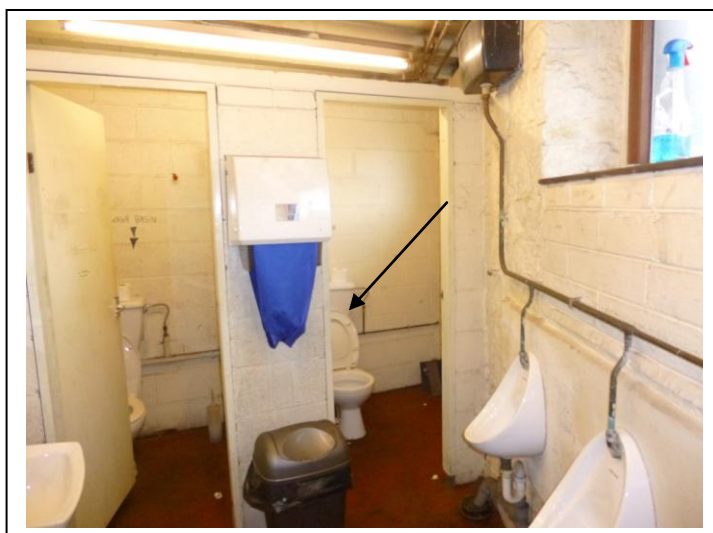
| Material / Item | Cistern Tanks |

| Recommendations / Comments:<br>No Asbestos Detected, no further action required. |

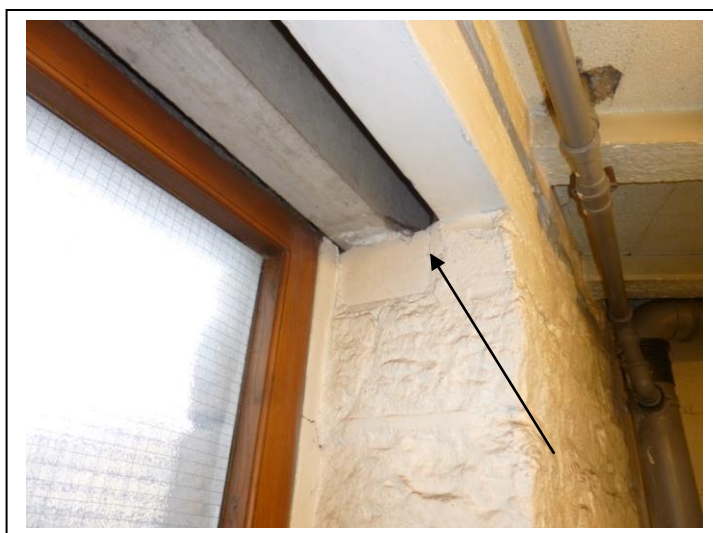
| Material / Item | Window Lintel |

| Recommendations / Comments:<br>No asbestos materials have been located, no further action required. |

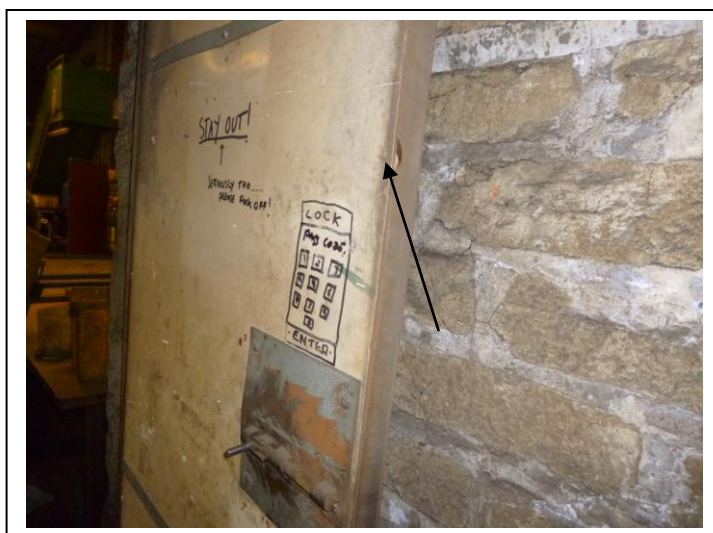
| Material / Item | Door Panelling |

| <b>Recommendations / Comments:</b><br>No asbestos materials have been located, no further action required. |

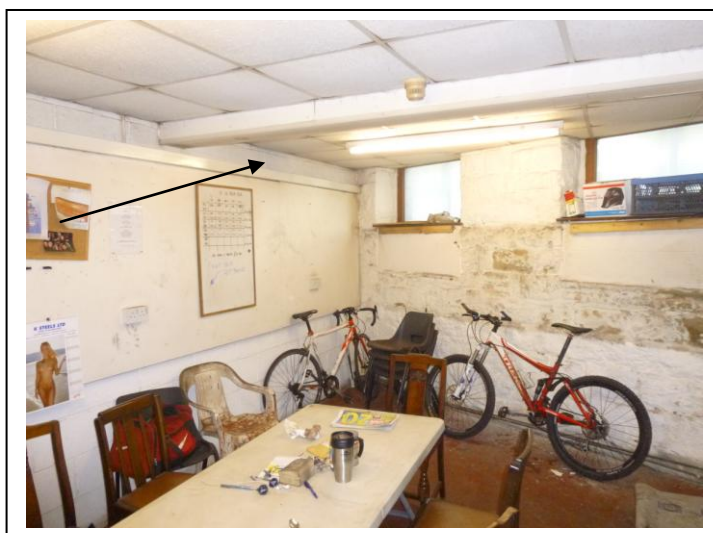
| Material / Item | Walls/Ceilings/Floors |

| Recommendations / Comments:<br>No asbestos materials have been located, no further action required. |

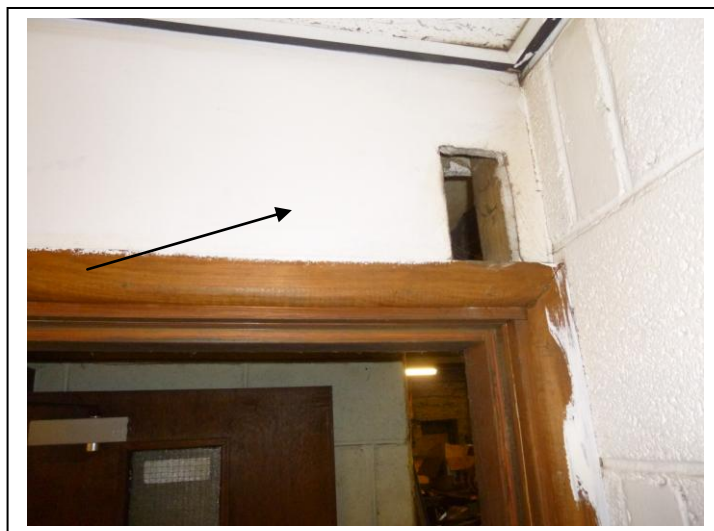
| Material / Item | Door Panelling |

| Recommendations / Comments:<br>No asbestos materials have been located, no further action required. |

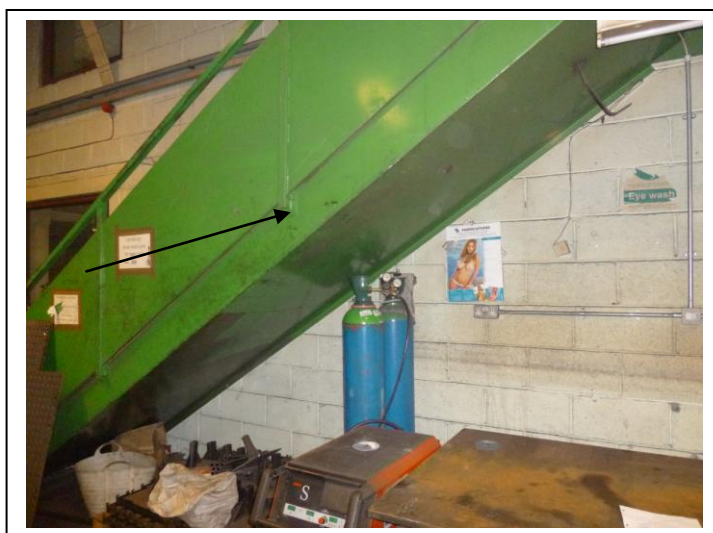
| Material / Item | Stairwell |

| Recommendations / Comments:<br>No asbestos materials have been located, no further action required. |

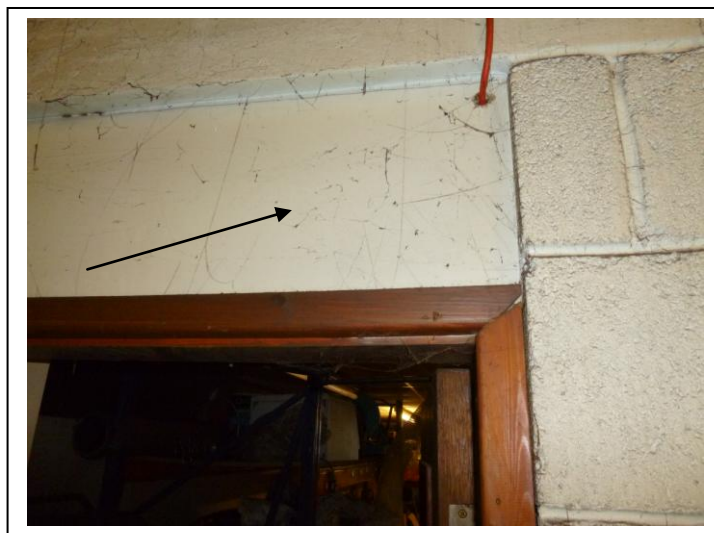
| Material / Item | Door Panel |

| Recommendations / Comments:<br>No asbestos materials have been located, no further action required. |

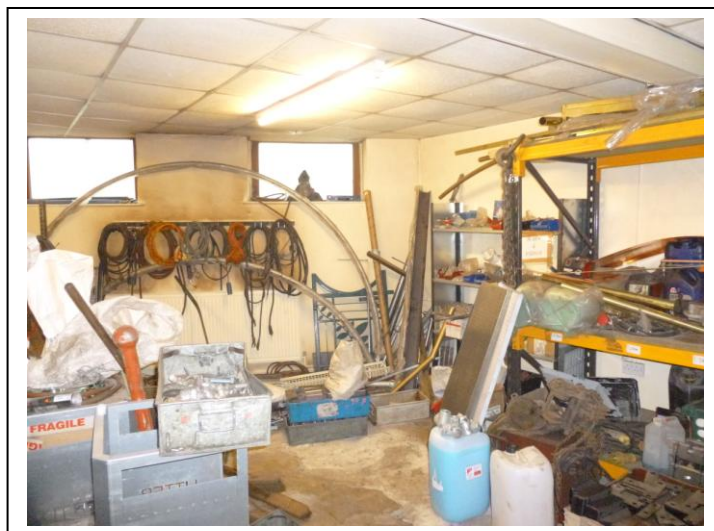
| Material / Item | Walls/Ceilings/Floors |

| Recommendations / Comments:<br>No asbestos materials have been located, no further action required. |

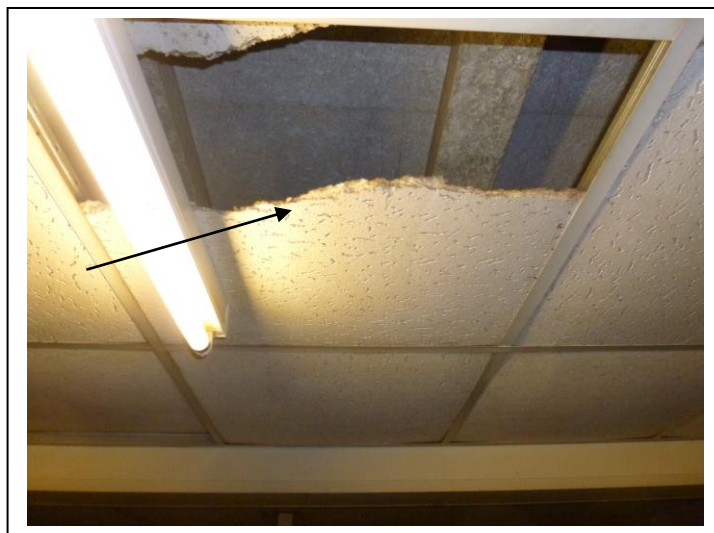
| Material / Item | Ceiling & Void |

| Recommendations / Comments:<br>No asbestos materials have been located, no further action required. |

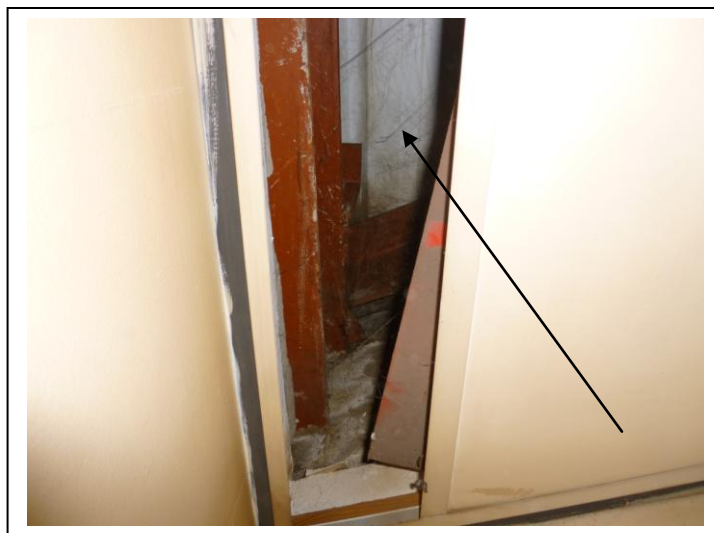
| Material / Item | Ceiling & Void |

| Recommendations / Comments:<br>No asbestos materials have been located, no further action required. |

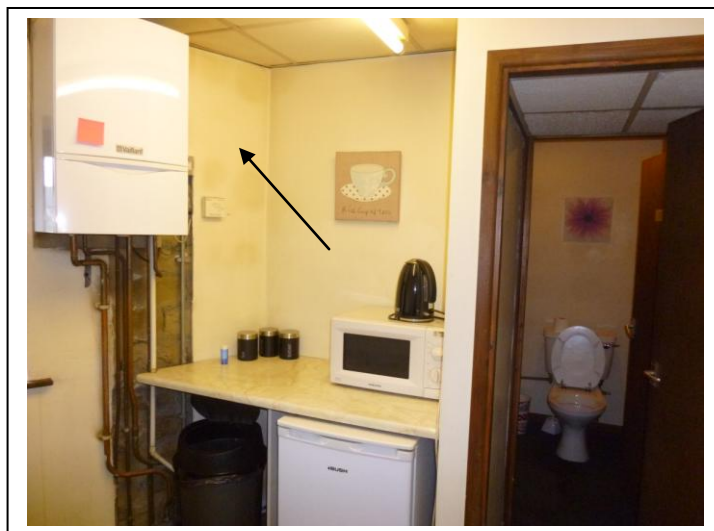
| Material / Item | Walls/Ceiling/Floors |

| Recommendations / Comments:<br>No asbestos materials have been located, no further action required.<br>Boiler was installed recently. |

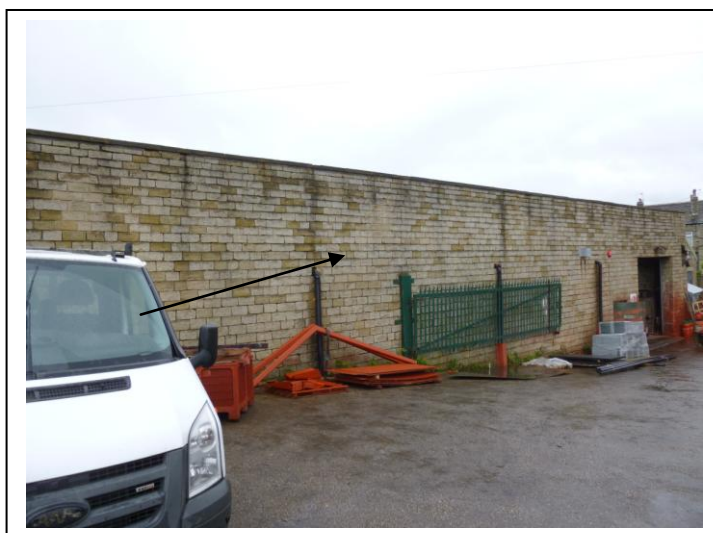
| Material / Item | All |

| Recommendations / Comments:<br>No asbestos materials have been located, no further action required. |

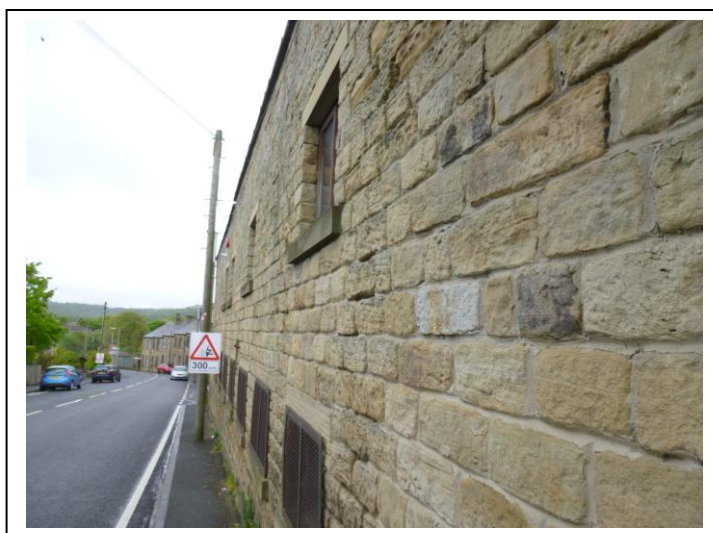
| Material / Item | All |

| Recommendations / Comments:<br>No asbestos materials have been located, no further action required. |

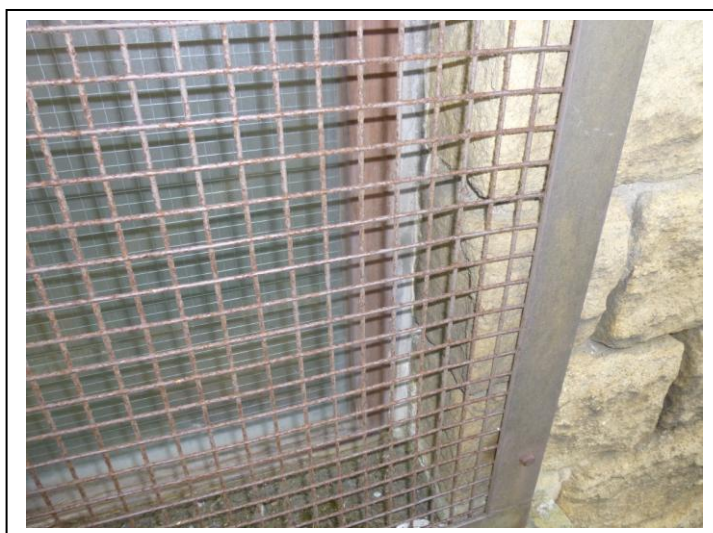
| Material / Item | Windows Putty |

| Recommendations / Comments:<br>No asbestos materials have been located, no further action required. |
