**ARBORICULTURAL REPORT
to BS 5837:2005
at
Thirstin Road
Honley
Huddersfield
West Yorkshire**

Architecture + Design Partnership LLP

10061/AJB

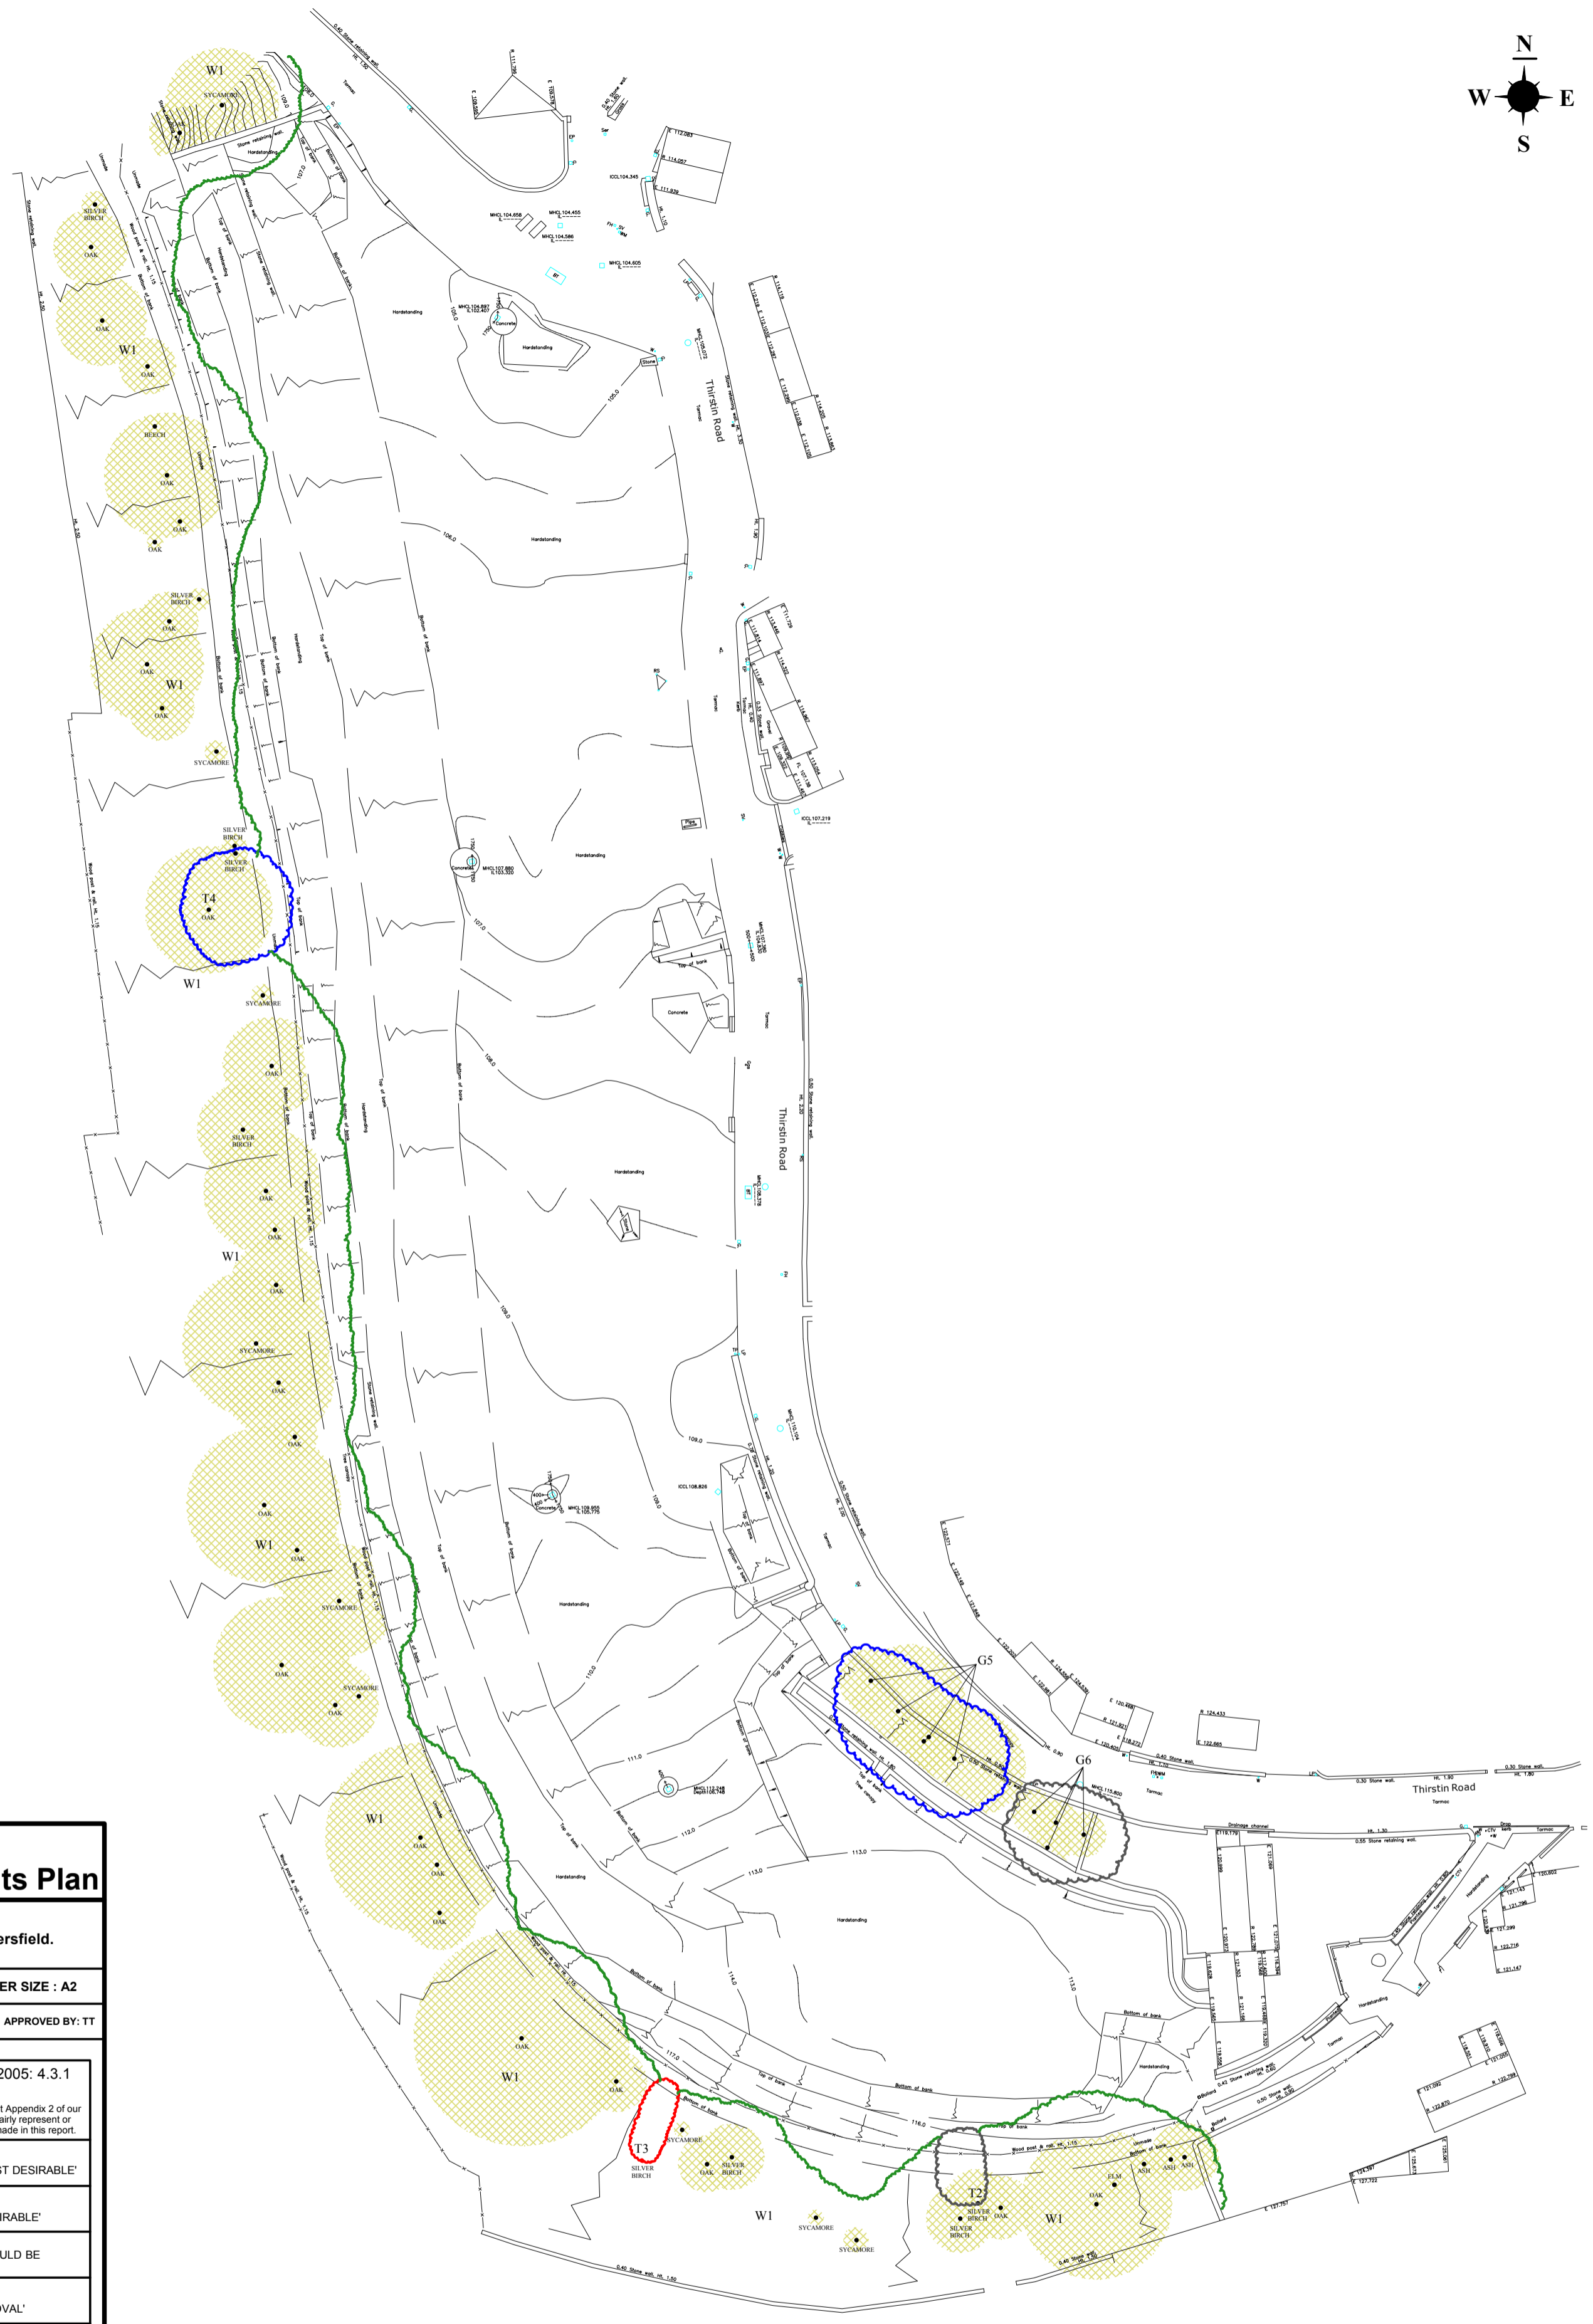
Appendix 6: Tree Constraints Plan

- 6.6 Care should be taken at the design stage to ensure that the retained trees are protected. The protection of retained trees can be achieved by the creation of a Construction Exclusion Zone based on the Root Protection Area of a tree. The Root Protection Area of each tree or group is marked on the Tree Constraints Plan at **Appendix 6**.
