### STRUCTURAL INSPECTION REPORT

REF: MAC-S-945

1, Macauly Road  
Birkby  
Huddersfield  
HD2 1AX

To comment upon the nature of the structural movement on the side elevation above the kitchen door up to second floor level as highlighted in the client's mortgage valuation report reference JSO/AJN/V3488e/08/5/k dated 19/11/2008.

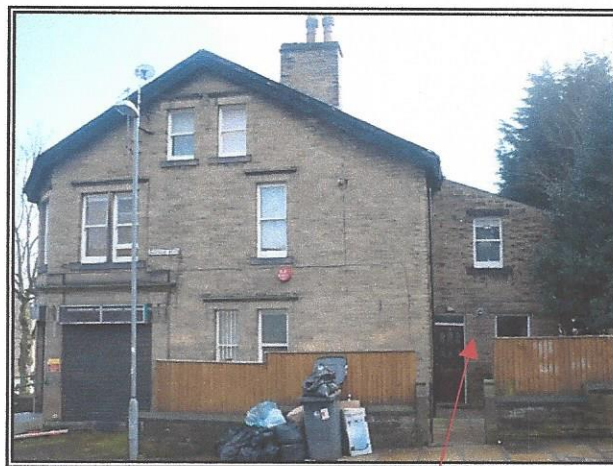
**Structural Movement  
1, Macauly Road, Birkby,  
Huddersfield.**

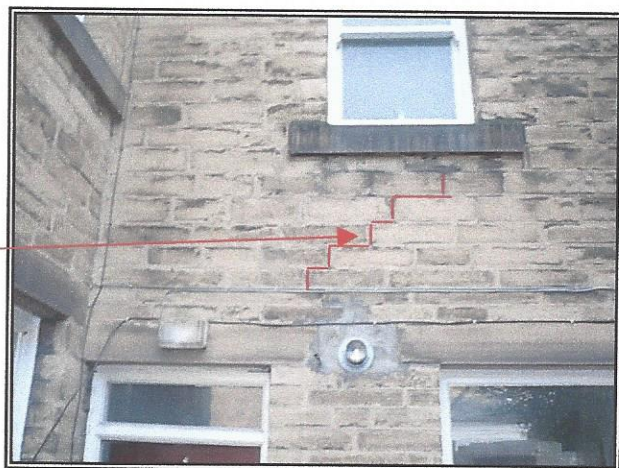
External Inspection of the property showed that there was evidence of past structural movement which has caused cracking to the mortar joints above the side entrance door.

This cracking was of a stepped nature, covered seven courses of stone and was approximately 2.0mm wide in places.

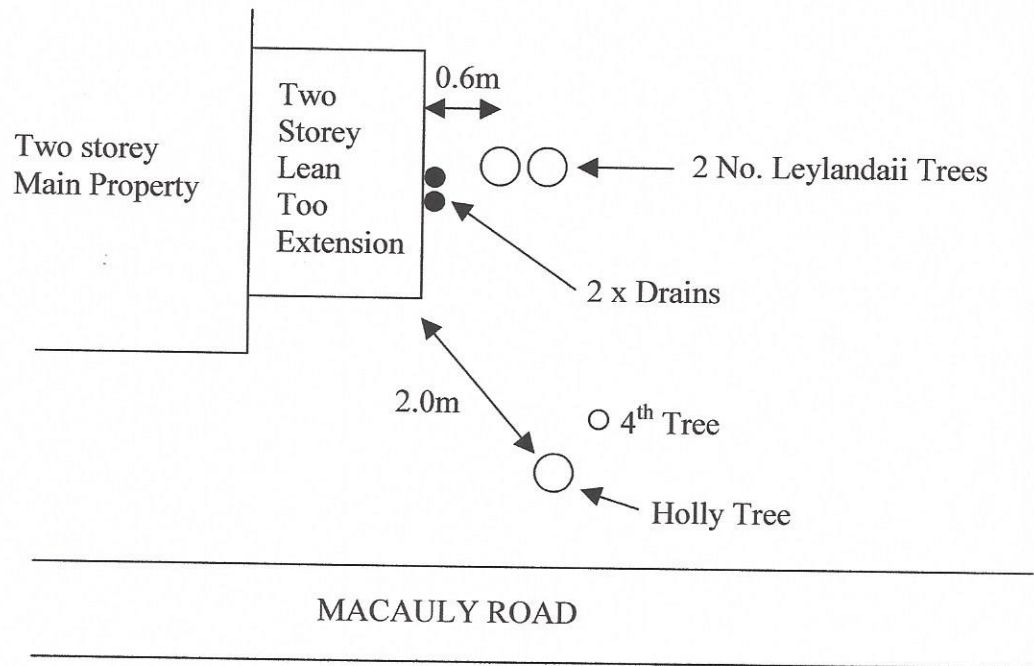
**PLAN SHOWING LOCATION OF TREES & DRAINS RELATIVE TO  
LEAN TO EXTENSION**

Two 8.0m high Leylandii Trees were located 0.6m from the rear wall, a 7.0m high Holly tree was located 2.0m from the front corner of the lean too extension and a fourth smaller tree was also located next to the Holly Tree.

Two drains were located adjacent to the rear elevation.

It is possible that these drains could have been damaged by the root structure of the trees adjacent to the building.

It is our recommendation that a drainage survey is undertaken to determine whether any defects are present within the drainage system.

Any defects noted should be repaired by a specialist drainage contractor.
