**PRELIMINARY APPRAISAL SURVEY
AT
5 Two Gates
Holme Lane
Slaithwaite
Huddersfield
HD7 5UJ**

Mr. & Mrs. Dyson

PRELIMINARY APPRAISAL SURVEY OF 5 TWO GATES, SLAITHWAITE, HUDDERSFIELD HD7 5UJ

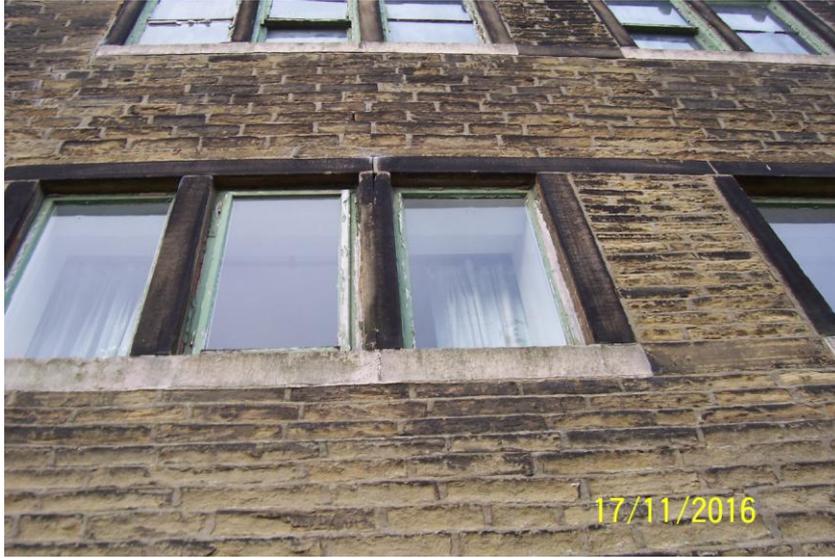
There is evidence of significant outward bulging movement to the front elevation wall between the ground floor and first floor windows, internal cracking and misalignment was noted around the windows at first floor level, we believe this to be long standing and there is no evidence of significant progressive structural movement. The likely cause is consolidation over time of the internal rubble fill and inadequate lateral restraint. The floor joists span from front to back and are providing inadequate lateral support to the gable end walls. Bulging is most pronounced at ground to first floor ceiling level, considering the extent of the movement and its visual appearance, we would recommend this section of walling approximately 20m² in total, is carefully demolished and rebuilt up to first floor level at the same time replacing the cracked and weathered stone, cills and mullions. Temporary support to the upper section of walling is to be maintained at all times.

Plate 1
Bowling to front elevation wall, requires demolishing and rebuilding. All elevations require re pointing.

The complete dwelling requires re pointing using traditional methods and materials. Any localised areas of structural weakness should be repaired using crack stitching techniques with stainless steel Helifix bars. More information on this type of repair can be found on the Helifix Website.

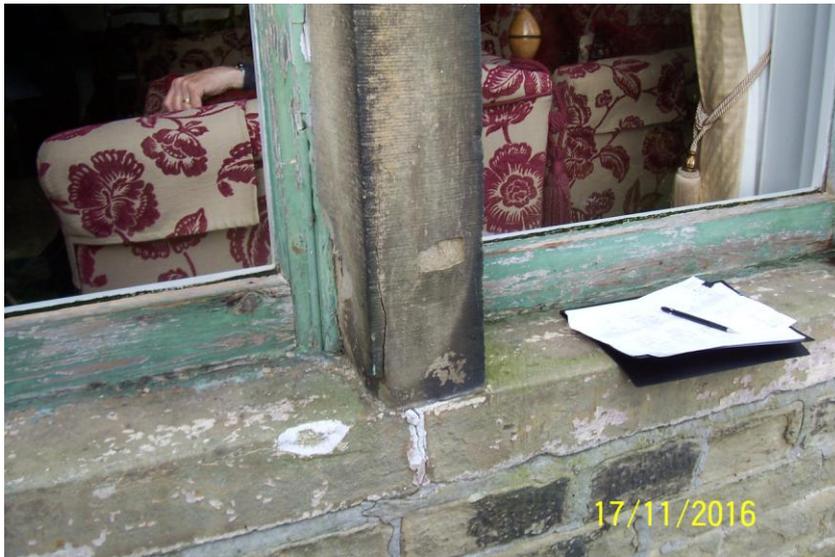
Plate 2
Defective stone mullions, cills and heads require re aligning and or replacement.

Several stone mullions require re alignment, of particular note were the stone mullions to the first floor windows on the left hand gable wall. Realignment and or replacement of all defective stone mullions, cills, heads and jambs will be required. A closer inspection of the condition of the high level stonework will be required once scaffolding has been erected and access is available.

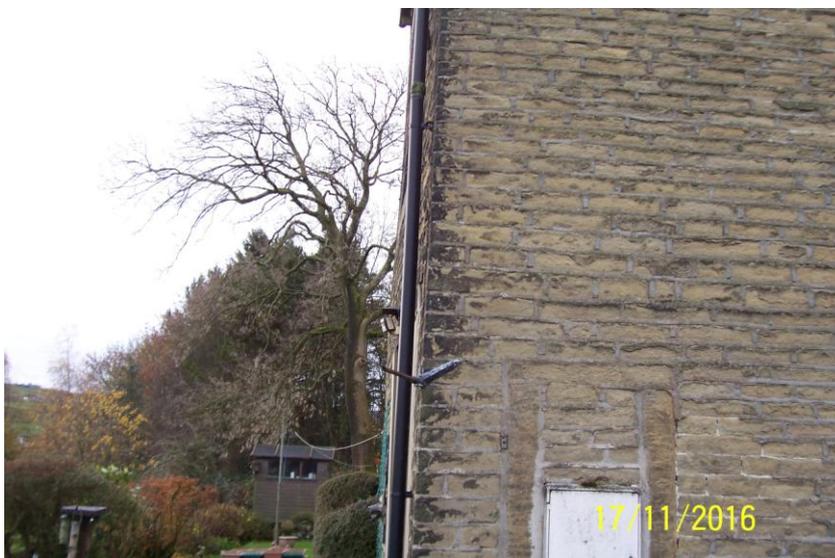
Plate 3
Bowling to front elevation wall

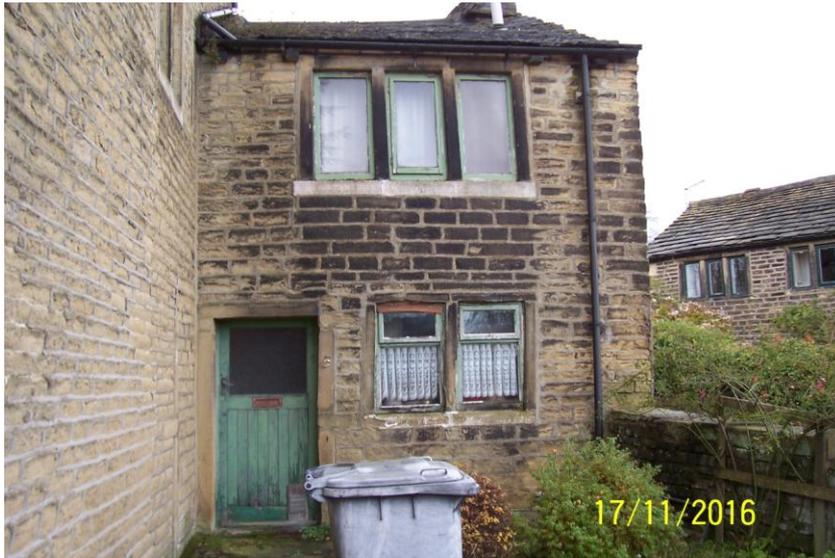
Plate 4
Side extension to be demolished and rebuilt.

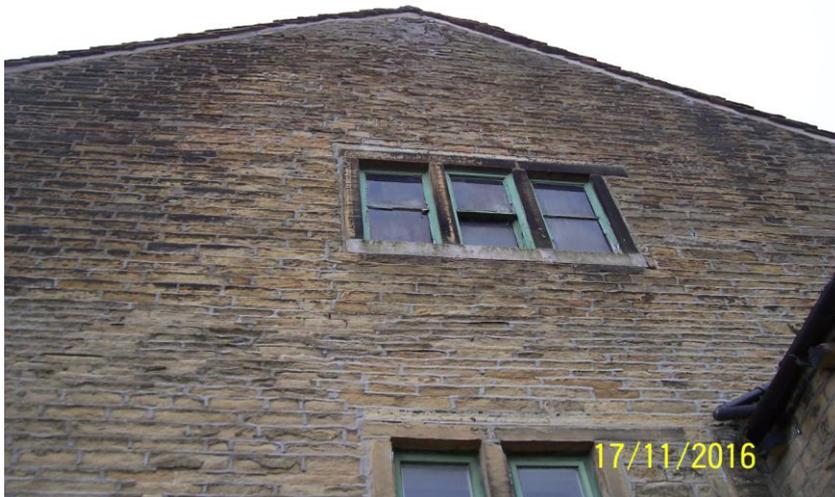
Localised structural cracking and loose stonework was noted at the apex of the right hand side gable wall. We recommend the upper section of wall is rebuilt from approximately 2metres downwards. A further inspection of the wall construction in this area is required once access is available.

Plate 5
Right hand side gable wall elevation requires reducing from apex down and rebuilding

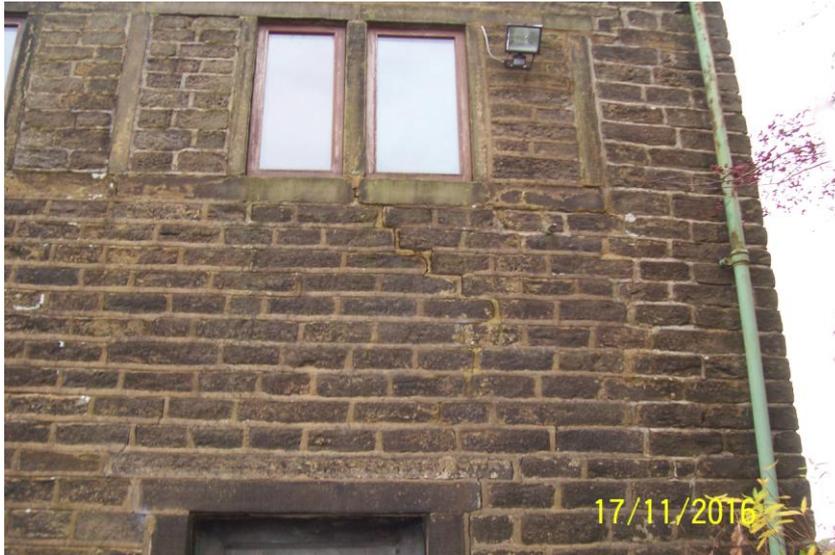
Localised area of structural cracking was noted to the rear elevation. We recommend these areas are raked out, strengthened with stainless steel helifix bars and re pointed with a good quality epoxy mortar.

Plate 7
Localised structural cracking to rear elevation.

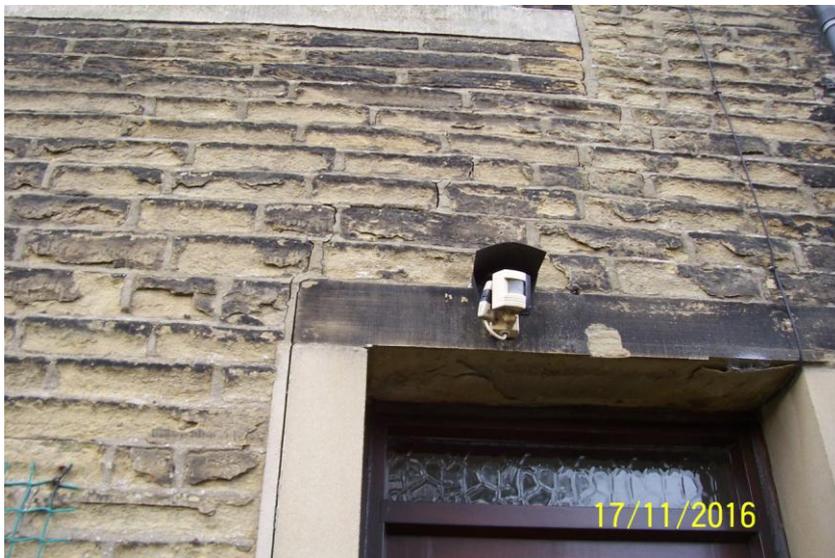
Plate 8
Localised structural cracking above door to front elevation.

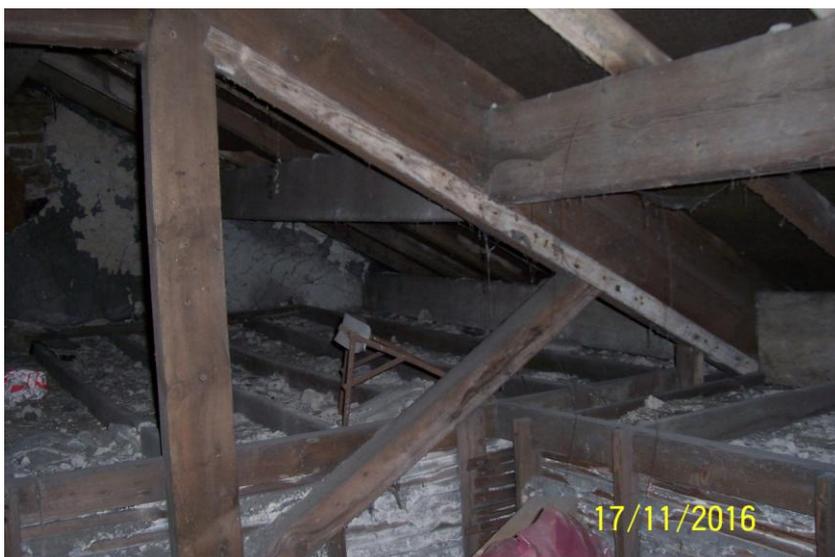
The main roof is a traditional cut pitched roof structure constructed from 1no main principal rafter, collar and struts at mid span, which support 6no purlins. The purlins are traditionally jointed and pegged to the principal rafter and built into the gable ends, the purlins in turn support the common rafters. The common rafters sit on the front and rear elevation timber wall plates. The condition of the timber wall plates and rafter feet could not be ascertained at the time of inspection, it is likely that an element of repair will be required during replacement of the roof covering. Sagging of the rear pitch was noted and will require additional rafters installing to provide re alignment during replacement of the roof covering. The roof timbers show no signs of stress or distortion and appears relatively stable. Inspection of the roof timbers identified localised areas of wood boring beetle infestations, some of which appeared active and will require treatment. We recommend the roof structure is inspected by a PCA approved timber specialist for beetle infestations, following stripping out and exposure during the renovation programme. An insurance backed guarantee should be obtained for all timber and damp proofing treatments.

Plate 9
Traditional cut roof structure.

We would recommend during replacement of the roof covering ventilation is incorporated to prevent condensation forming within the roof void.

We would recommend a minimum of 300mm of rock wool roof insulation is installed at joist level in the roof void.

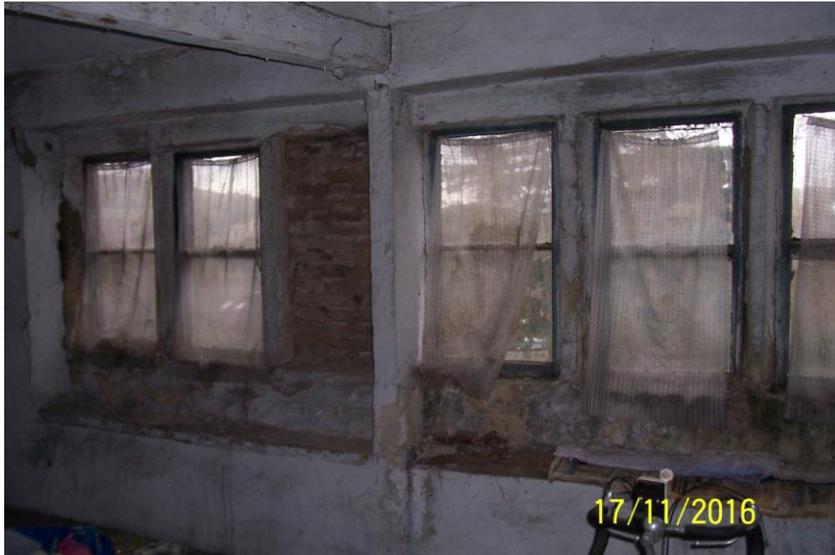
Plate 10
Internal surfaces require a system of dry lining, damp proofing and insulation.

We understand that all plasterwork is to be removed from the walls and a suitable system of internal dry lining is to be specified incorporating a method of structural damp proofing and insulation. Structural damp proofing is required to wall

areas below ground floor level incorporating a cavity drain membrane, channelling and sump pump. An insurance backed guarantee should be obtained for all damp proofing treatments.

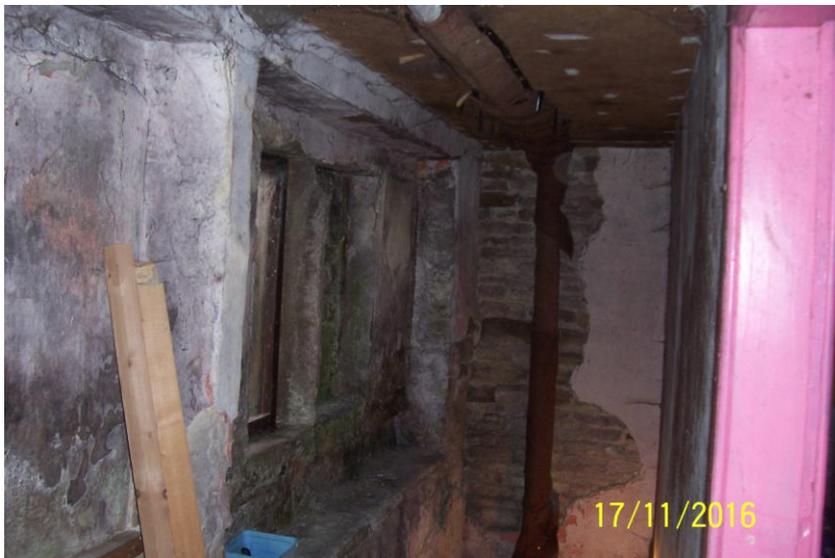
Plate 11
Internal surfaces require a system of dry lining, damp proofing and insulation.

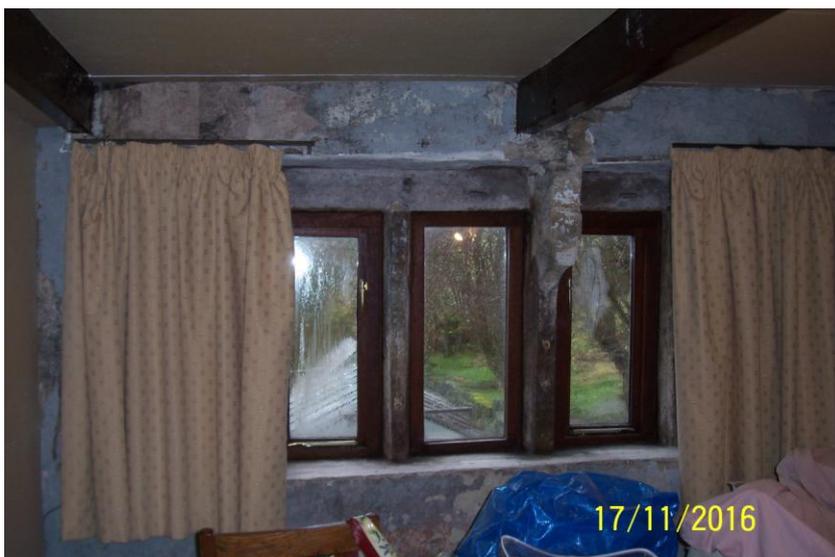
Plate 12
Misalignment of mullions on first floor windows, left hand gable wall.
