## **STRUCTURAL INSPECTION REPORT**

**DATE: 16<sup>th</sup> December 2016**

**REF: MDL – 1508**

81a, Huddersfield Road  
Holmfirth  
HD9 3AS

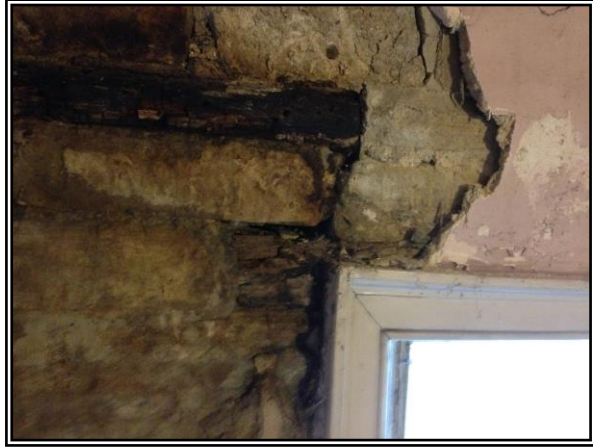
**Photo 1**

Inspection of the end of the timber roof truss which bears onto the front elevation, and timber window lintels above the windows at second floor level confirmed that wet rot defects were in evidence.

The two timber window lintels, which measured only 75mm deep have also suffered from structural deflection under stress from the weight of the masonry and roof loads above.

Rotten ends to window lintels.

The timber lintels over the window openings should be replaced with new reinforced concrete lintels.

Unfortunately, the depth of the existing timber lintels is only very shallow at 75mm deep, and replacement timber lintels on a like for like basis will not have adequate structural strength to support the load above. Furthermore, installing deeper timber lintels, which would be in the region of 200mm to 225mm deep, would disrupt too much of the masonry and 'through stones' above the window openings.

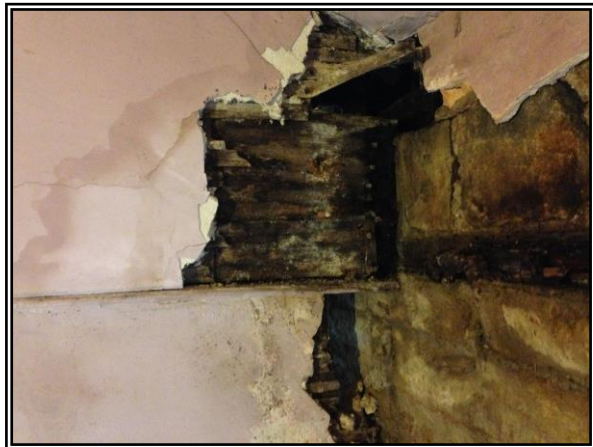
**Photo 2**

Rotten end of truss chord sitting into front elevation of property.

With regards to the end of the truss member, we would advise that the existing rotten section of timber is cut out, with a new piece of timber being reinserted in its place.

Steel flitch plate brackets will then be installed to splice the retained and new section of timber together. The steel flitch plate brackets will also bear into the existing front elevation of the property to provide bearing support onto the external wall.

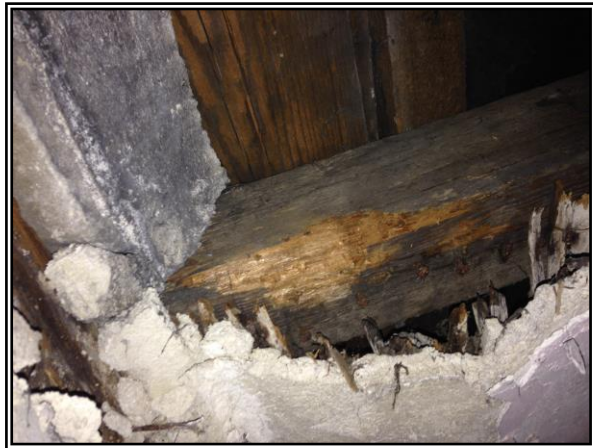
**Photo 3**

Inspection of the roof rafters at eaves level was very limited, but evidence of wet rot defects were once again noted.

Rotten ends of roof rafters.

When the structure has been fully stripped back, with all the roof structure being exposed, further rot defects will most likely become evident. At this time we would advise that a full inspection of the roof structure timbers are undertaken by a timber specialist with any recommended treatments being undertaken.
