**Former Mill Building**

**Dobroyd Mills**

**Jackson Bridge, Hepworth**

**Client:** Mr Z Hinchcliffe  
**Project Number:** 15271  
**Date:** 22<sup>nd</sup> May 2016

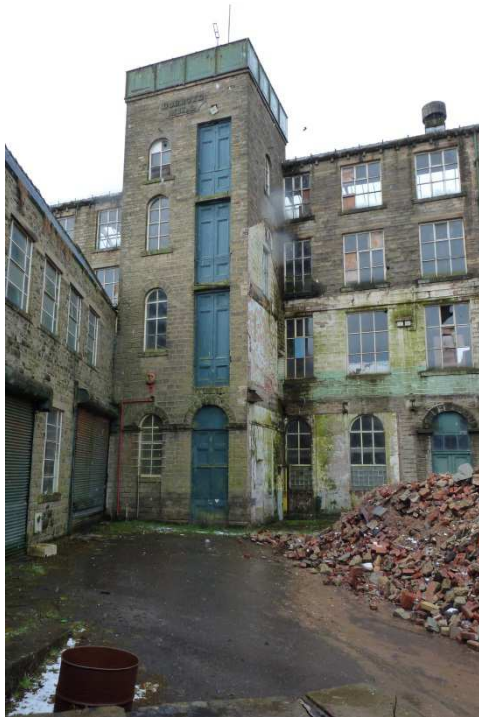
- 5.2 The four storey building has an external stair at mid-point along the east elevation serving all floors, however no access to the upper flights was available from this staircase; the treads were noted as being of solid stone at ground floor level.

External staircase with water tank at the top

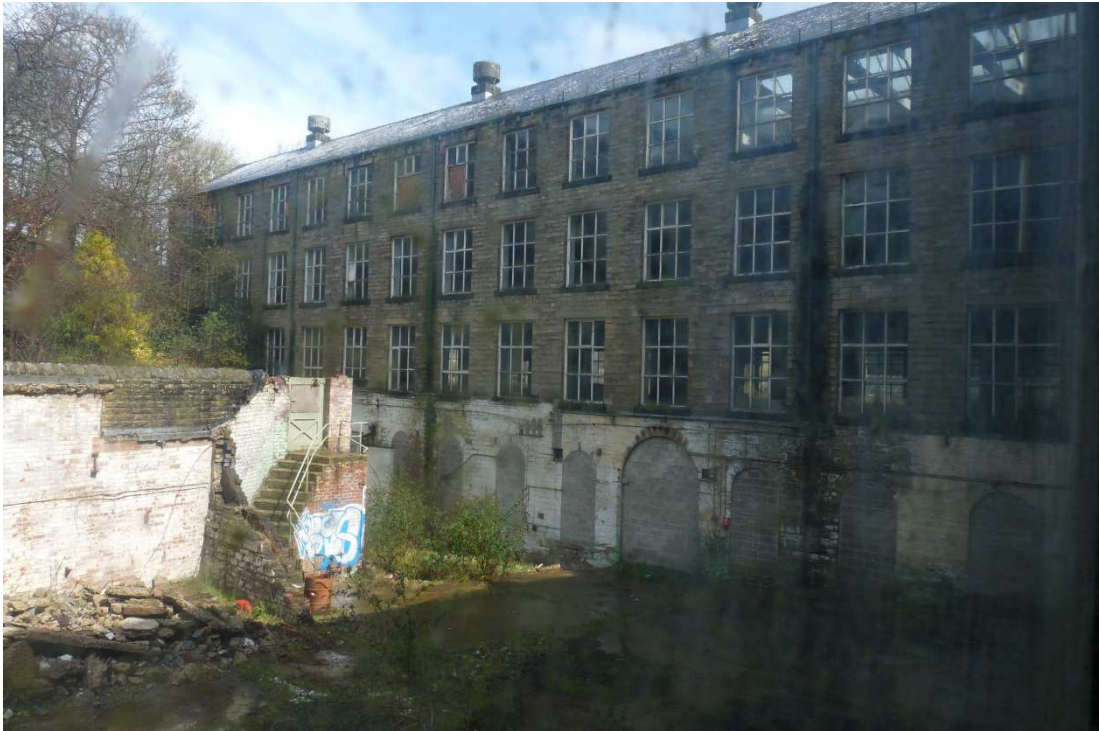
Rear view of the mill (southeast elevation), previous ground level extensions now demolished

- 5.4 The whitewashed wall reveals the extent of a now demolished extension, the large central blocked up arch provided access through the mill.
- 5.5 Primary access to the mill is via the factory extension to the south of the mill and due to the change in levels across the site, this provides level access to the top floor of the mill.

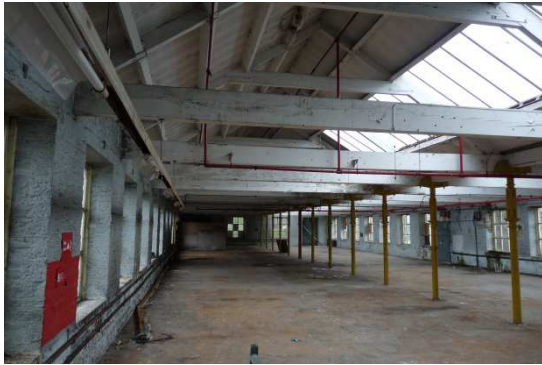
- 6.1 The double ridged roof is supported by pairs of timber trusses that have no vertical or diagonal members; the central row of cast iron columns, painted yellow, supports the truss ends at the valley line.
- 6.2 The timber floor is generally level and has been historically repaired in some areas as well as having various openings through the floor to accommodate the mill machinery.

Timber roof trusses

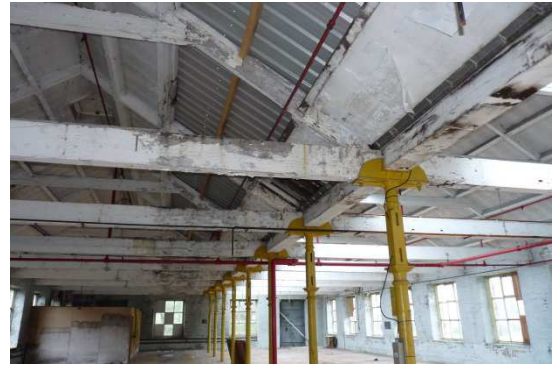
Central valley and new roof sheeting

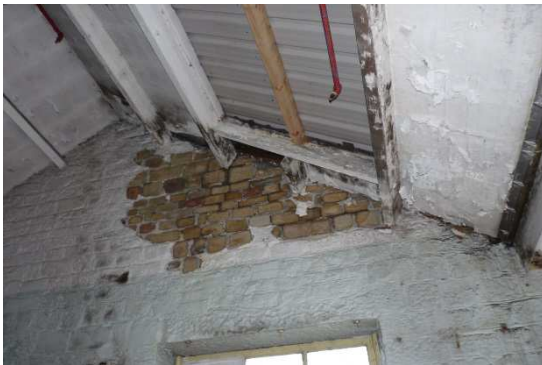
- 6.3 Timber purlins support timber rafters and roof lights which are on the eastern roof slopes. Some more recent repairs have been carried out using new timber and modern profiled metal sheeting.

New roof sheeting

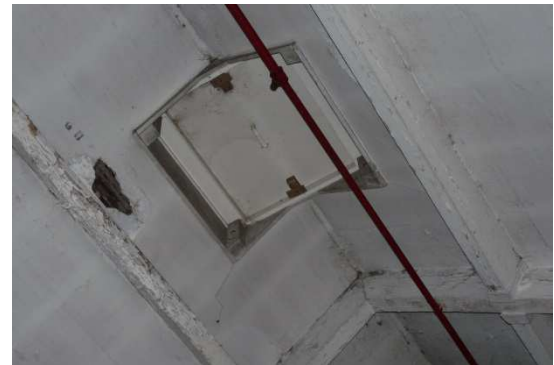
Access to ridge vents

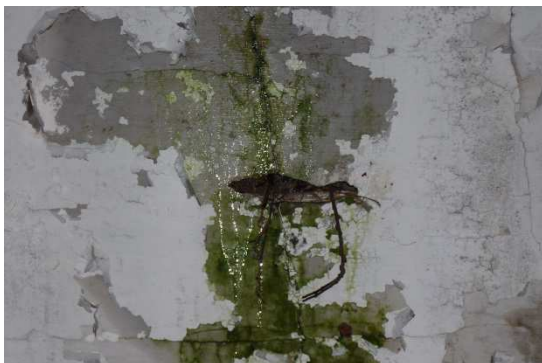
- 6.4 There is some deterioration of the timber floor where leaks have not been repaired however the 3<sup>rd</sup> floor is generally dry.

Birds in the roof and leak

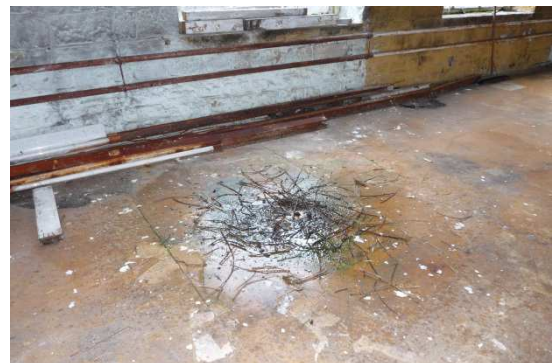
Water and twigs on the floor under the leak

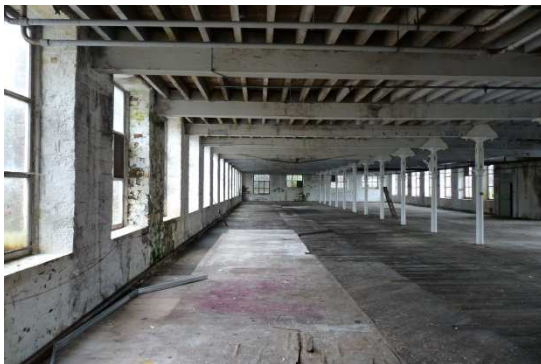
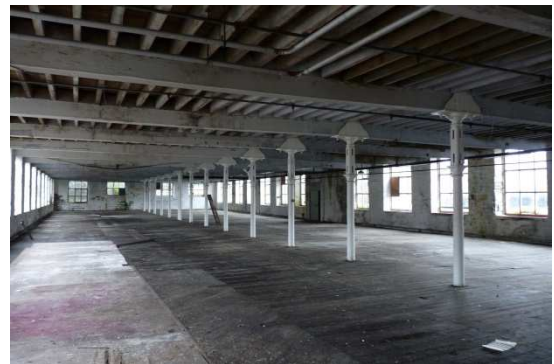
- 6.5 The timber floors is typical of mill floors; a central row of cast iron columns, painted white, supports primary timber beams which are seated in column heads with location bolts to the underside. Timber joists span onto the primary beams.
- 6.6 The timber floor is generally level and has been historically repaired in some areas as well as various openings through the floor to accommodate the mill machinery. There is some damp penetration which can be attributed to lack of good maintenance since the building was vacated.

Views looking towards the north gable

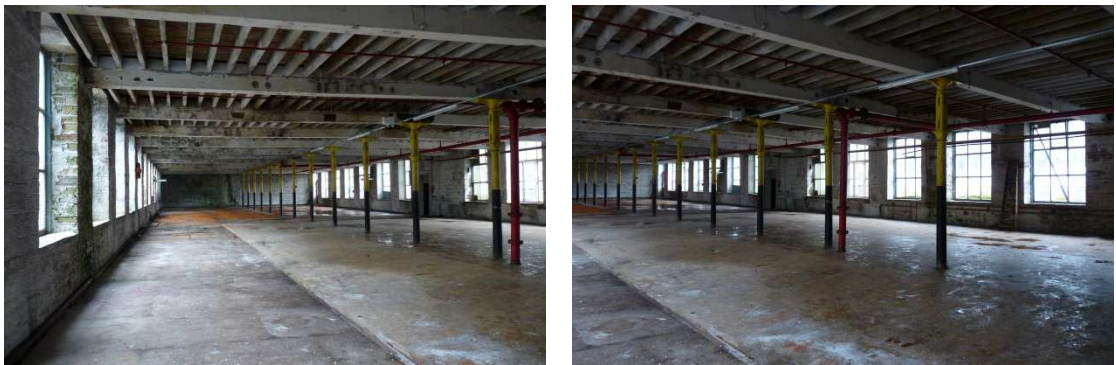
- 6.8 The floor construction differs from the others in that a concrete wearing surface is present; sections of it appear to have been overlaid with steel sheeting; again a central row of cast iron columns, painted yellow and black, supports primary timber beams above.
- 6.9 The floor is generally level and has evidence of corrosion of steel sheeting previously laid over the floor which has corroded during its life evident by the rust staining on the floor surface; the outline of steel sheets can be seen now the sheets have been removed.

Views looking towards the north gable

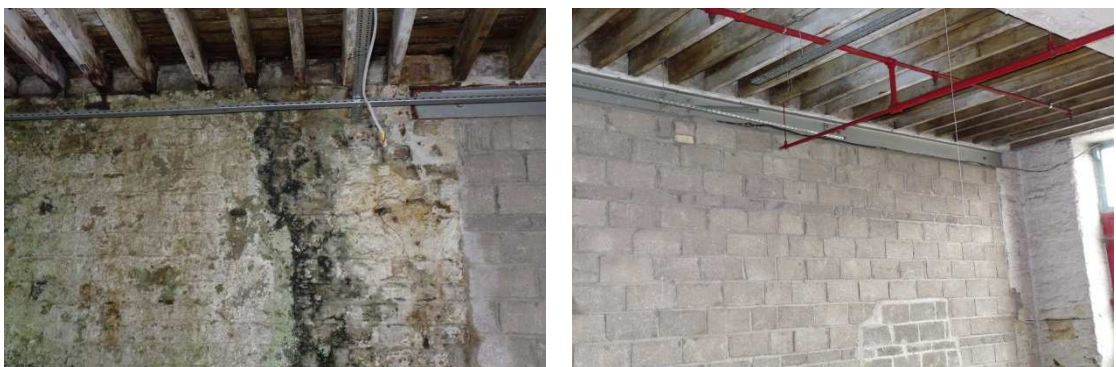
- 6.10 The right-hand side of the north gable has been rebuilt in new concrete blockwork and there is evidence of water ingress at the left of the new wall.

North Gable: water ingress and damp on the existing wall and part re-built wall

- 6.11 The second floor joists over are built into the gable wall and are showing signs of damp and deteriorated timber at their bearings.

- 8.3 Historic alterations to openings in the gable walls will require repairing with bonded masonry to match the existing materials.
- 8.4 The roof and floor timbers should be checked by a timber specialist for infestation and deterioration from wet or dry rot.

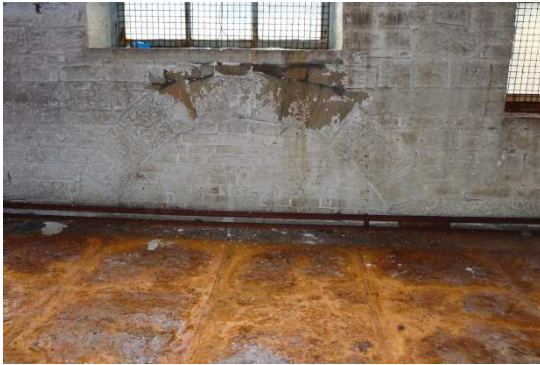
Rust staining on the floor; note an infilled arch below the window

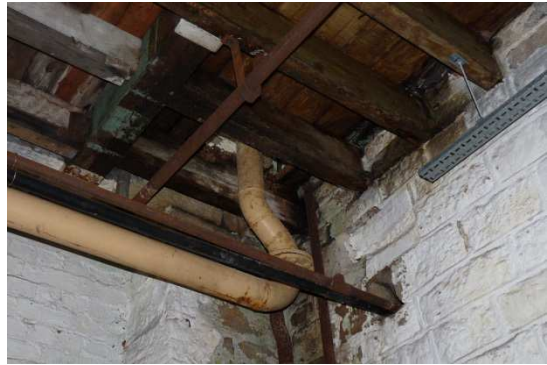
Water ingress through a floor opening

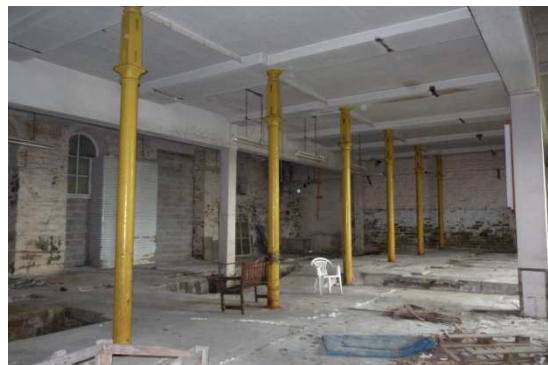
View of the northwest corner

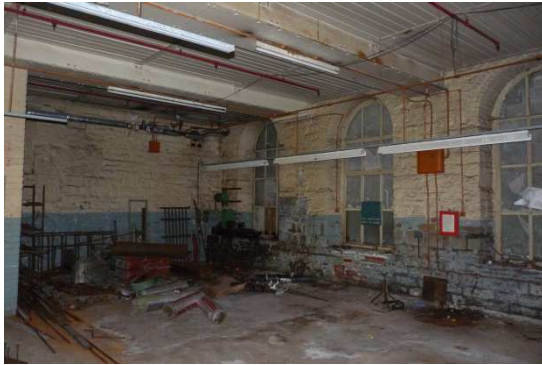
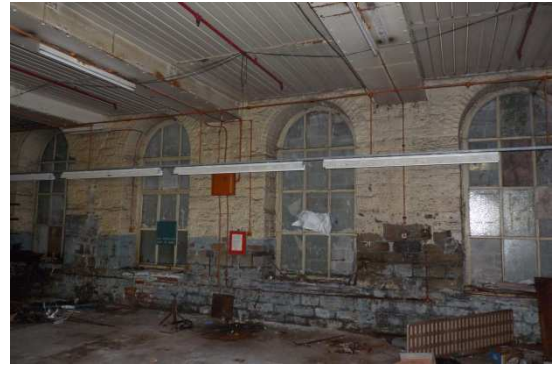
- 6.13 Where column are located within a floor duct, concrete has been used to around the column base.
- 6.14 The 1<sup>st</sup> floor beams have been boxed out with a metal lath and plaster covering making no part of the 1<sup>st</sup> floor structure visible. We were unable to determine the condition of the underside of the floor.
- 6.15 The remaining part of the ground floor appears to have been used as a workshop. Here the 1<sup>st</sup> floor structure and cast iron columns have been strengthened. Pairs of steel beams can be seen under the floor and the columns have pairs of heavily battened steel channels around them.

View of the south west corner; pairs of steel beams under the 1<sup>st</sup> floor

- 8.6 The cladding to the floor support structure at the underside of the 1<sup>st</sup> floor should be opened up to allow a structural inspection of the beams and columns.
