Our Ref: E17/6874/MD/001

Date: 15 November 2017

Re: Proposed development on former Dewsbury Fire Station, Huddersfield Road

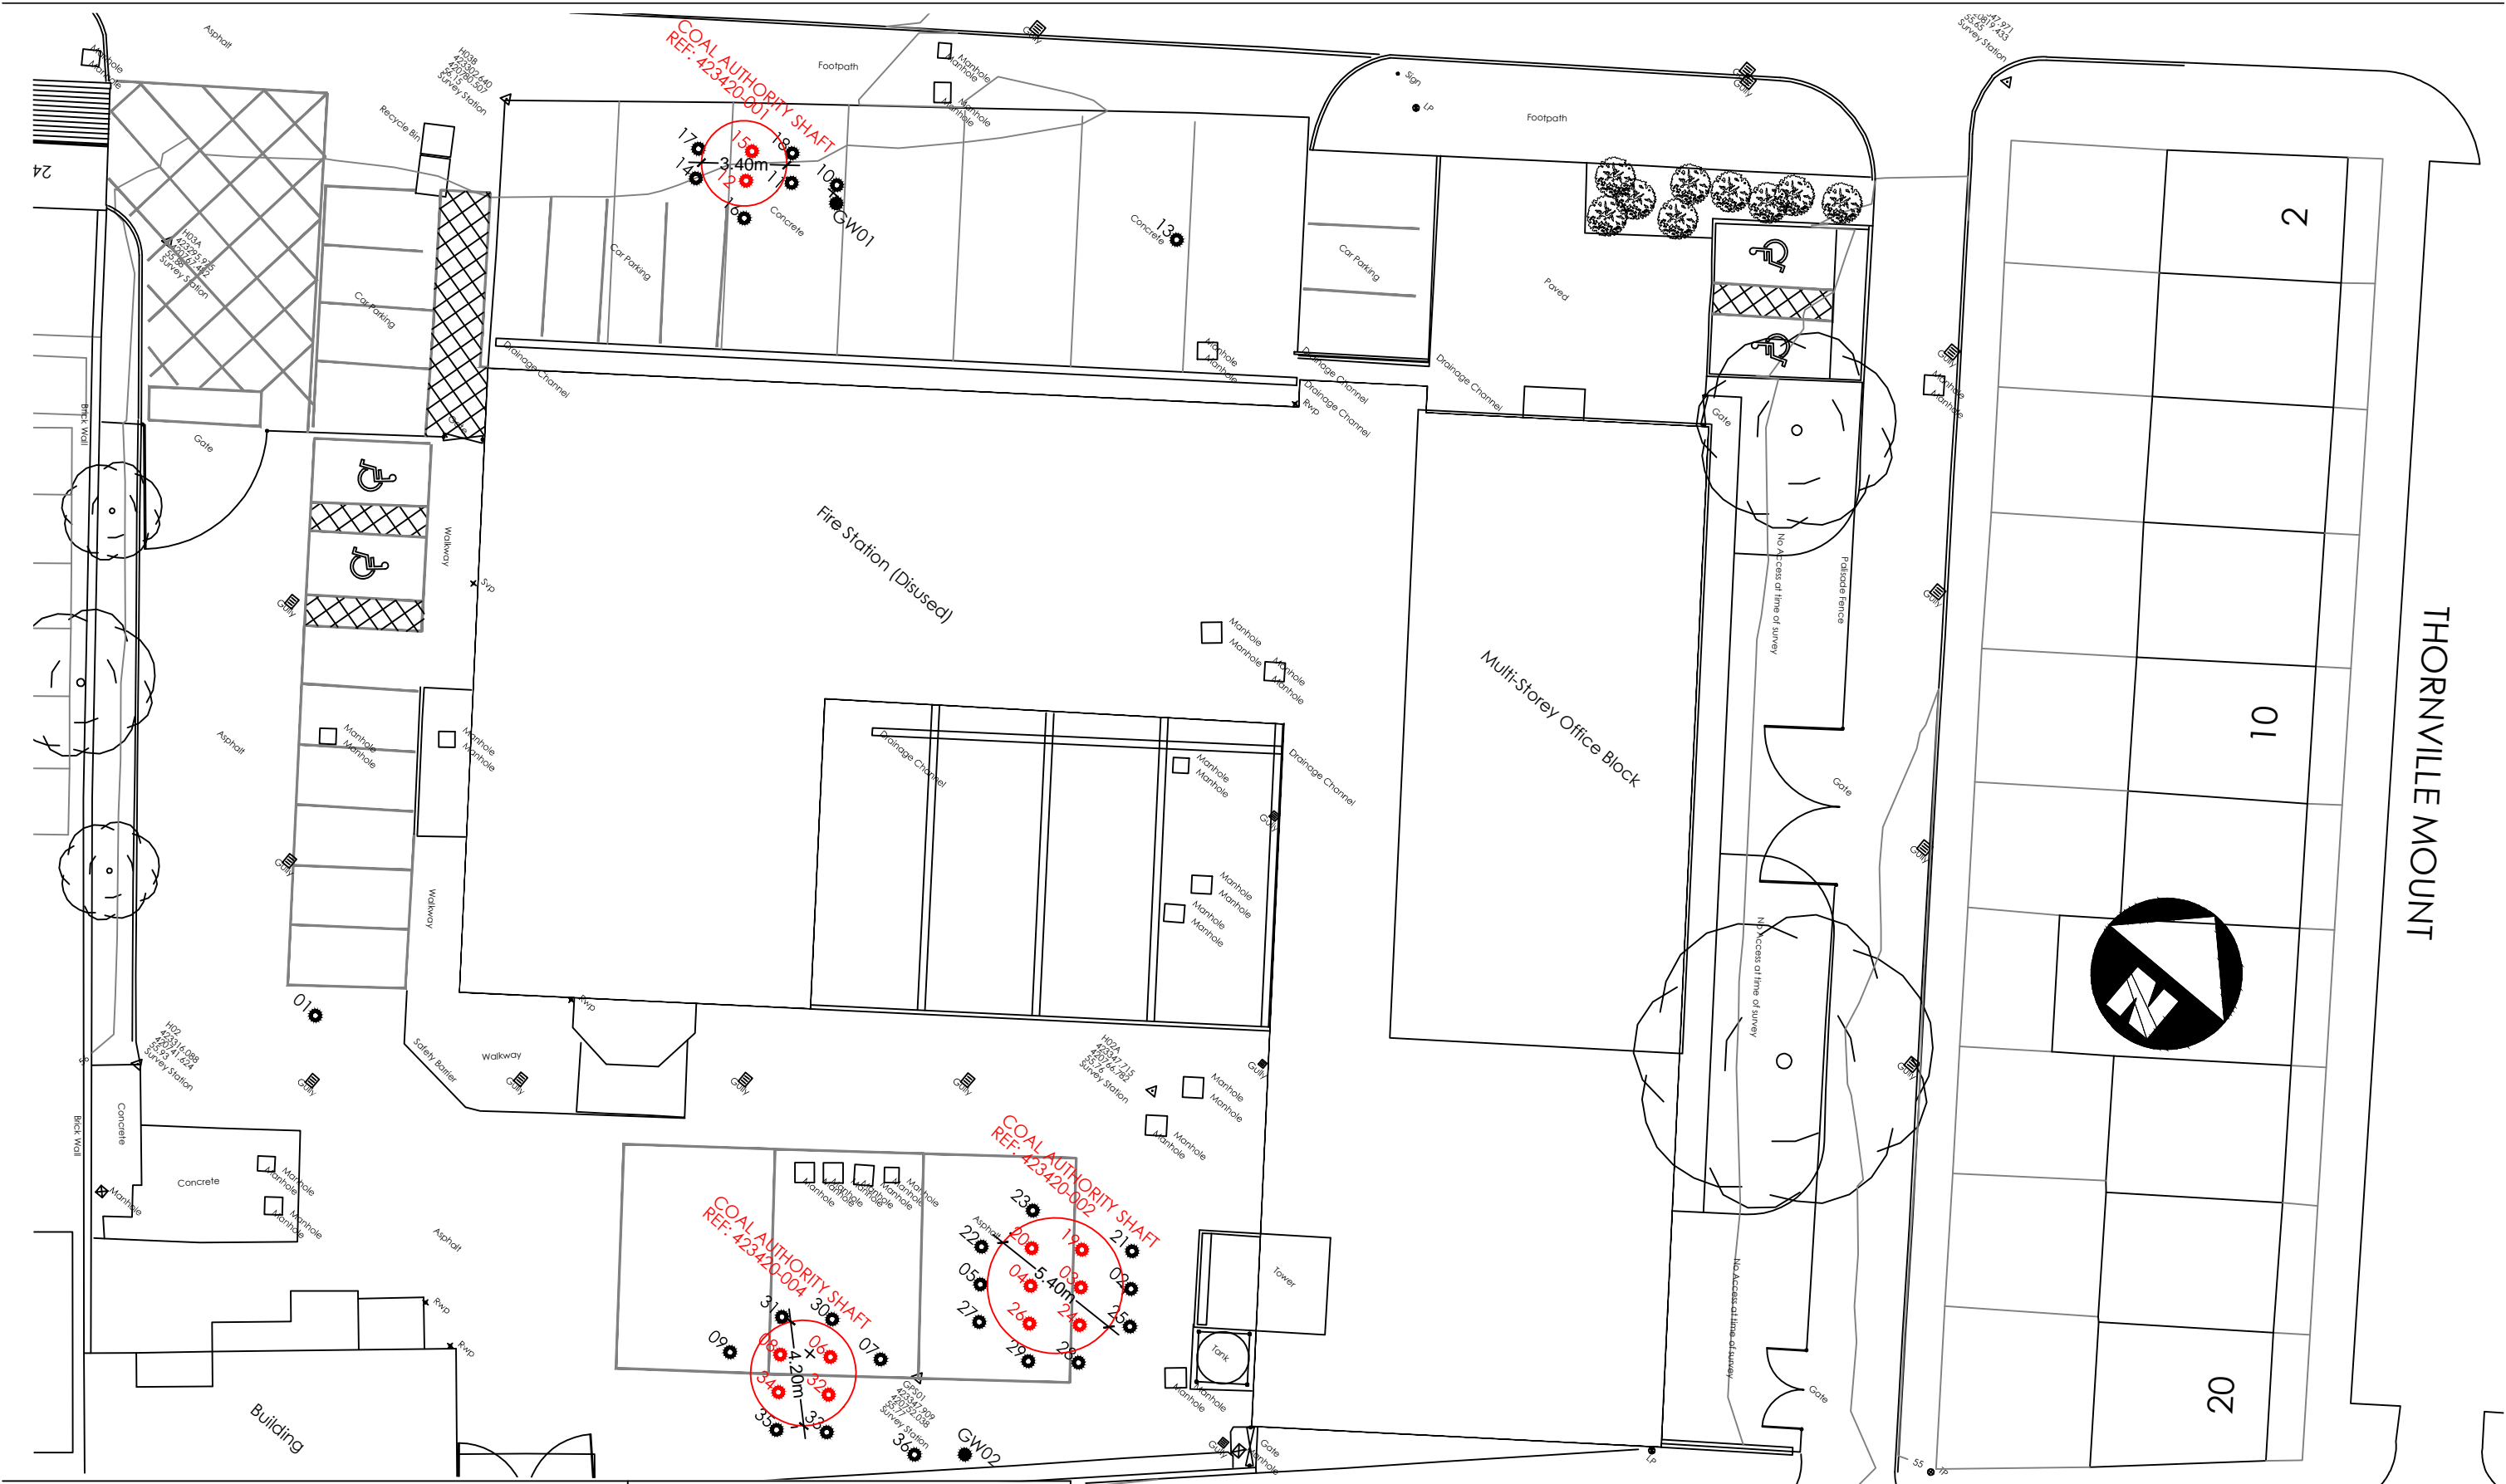
Client	WSG Holdings Ltd
Project	Dewsbury Fire Station
Detail	Borehole Location Plan
Scale	1:250@A3
Dwn	MD
Chkd	
Date	Nov'17
Dwg No.	E17/6874/03

A site survey indicating the locations of the investigatory boreholes and the borehole logs is attached to the rear of this letter.

Approximate maximum shaft diameter 3.4m

Approximate maximum shaft diameter 5.4m

Approximate maximum shaft diameter 4.2m

From the above, it would appear that although the shafts have been backfilled and capped, the cap has been constructed off made ground and not natural bedrock. In addition to this, the cap does not appear to extend sufficiently beyond the footprint of the shaft.

Following demolition of the buildings, a site strip should be undertaken at the location of the shafts as the current concrete caps to the shafts are considered inadequate by modern standards.

Once the diameter of the shafts and the depth to bedrock has been established, a reinforced concrete mineshaft cap can be designed and submitted for approval by The Coal Authority prior to construction on site.

The building should be located away from the existing shafts and the proposed foundations should be taken down to the mudstone bedrock to avoid loadings being transferred to the shaft. The final location of the building should be agreed with the Coal Authority and Kirklees Council.
