# Woodhead Road Honley

Road Safety Audit

Stage 1

October 2018

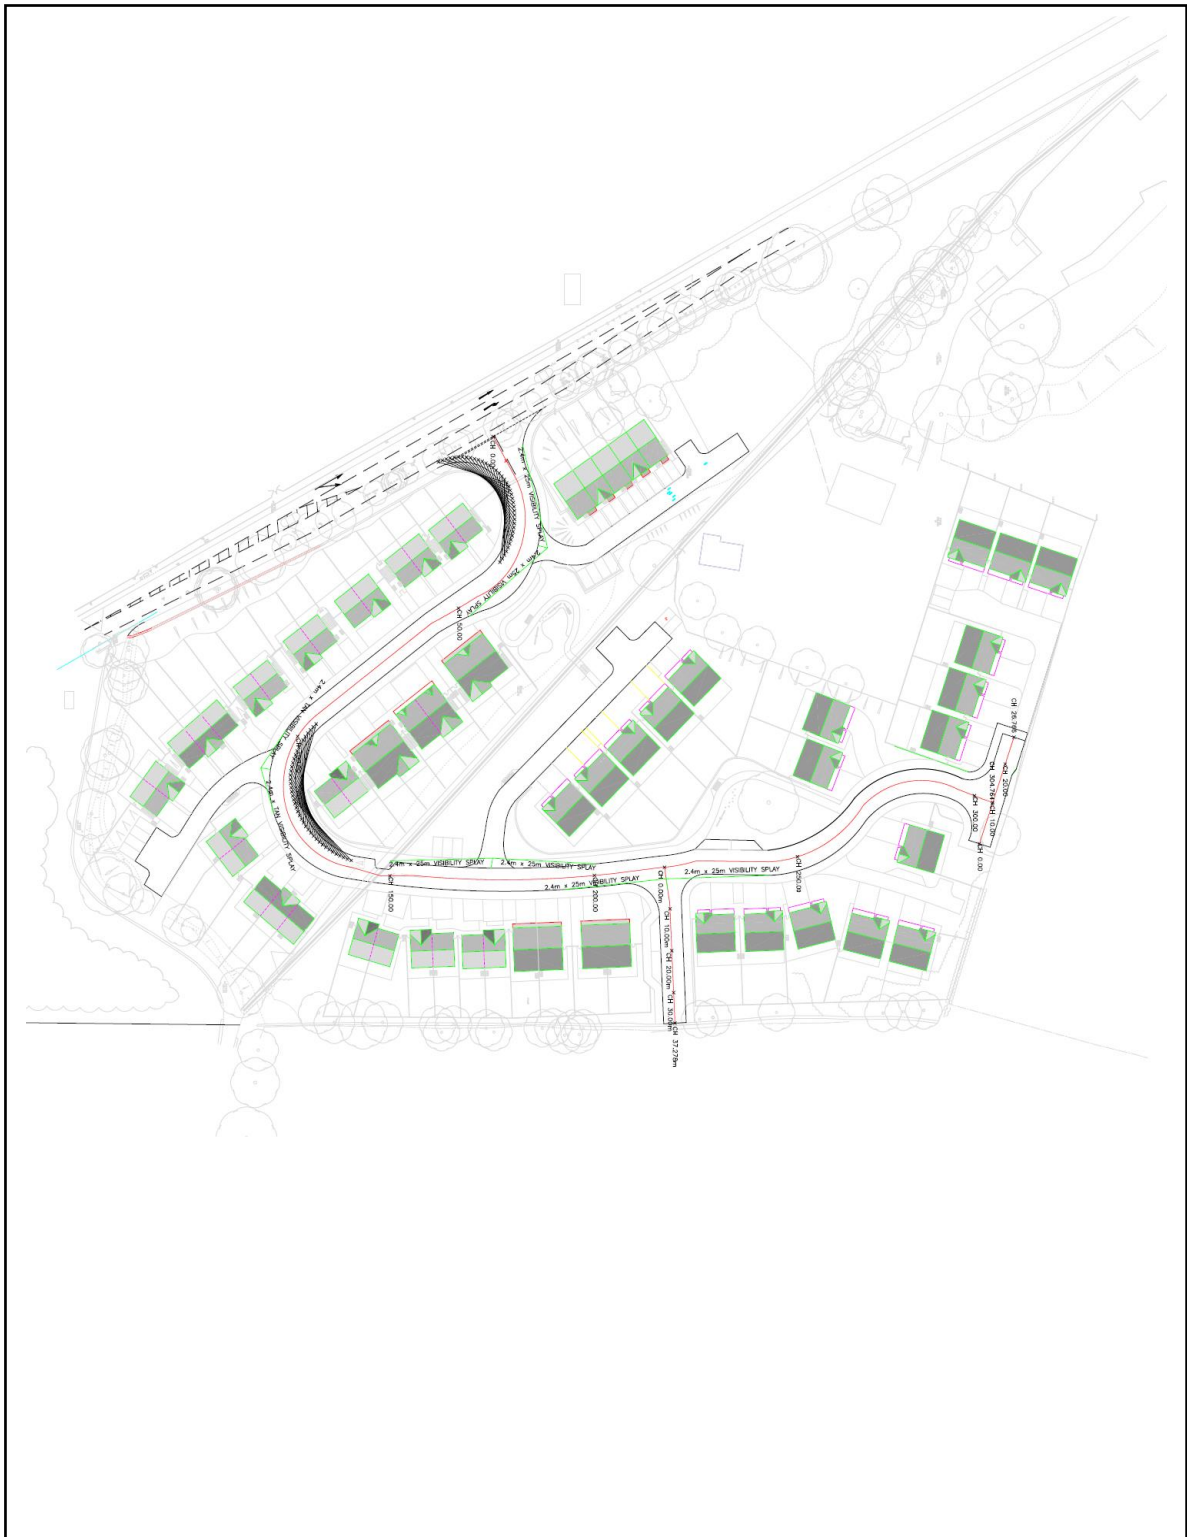
**Figure 1** indicates the extents of the scheme considered under this Stage 1 Road Safety Audit in accordance with the Audit Brief.

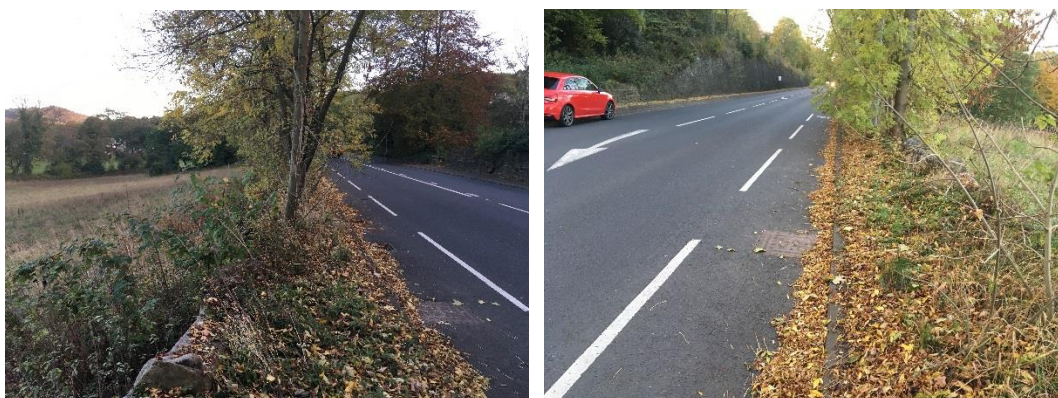
**Location:** New Access Road at j/w Woodhead Road

**Summary:** Risk of collisions between vehicles exiting the site and vehicles travelling along Woodhead Road due to lacking visibility.

**Detail:** The visibility splay at the new access road at its junction with Woodhead Road is not shown and given the speed of traffic on Woodhead Road and the restricted visibility from the adjacent trees (See images below) there is a risk of collisions with vehicles pulling out of the junction into the path of an oncoming car.

**Recommendation:** Ensure the visibility splay is adequate for the speed of the road and all obstructions in the verge removed or vegetation cut back sufficiently.

Visibility splays shown on the drawing 2.4 x 160 metres.

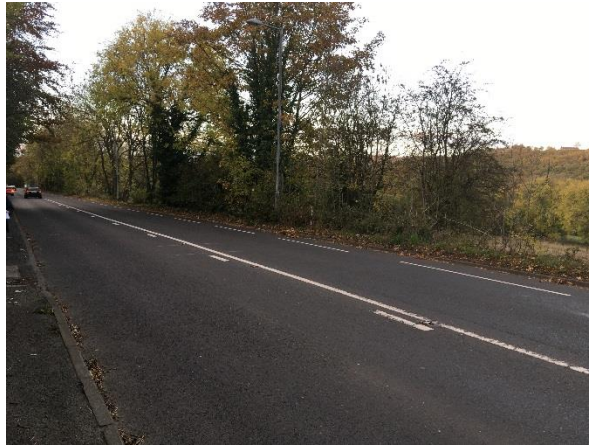
**Location:** Woodhead Road on both approaches to new junction at proposed development.

**Summary:** Risk of collisions resulting from inappropriate overtaking.

**Detail:** Drawing No. 773-01 Rev H shows some new hatching, a new right turn pocket and direction arrows. The existing lining on Woodhead Road includes a double white system (See image below) which starts along the frontage of the site and carries on through the bends to the south, which has not been included in the proposals. It was observed on site that vehicles often travel well in excess of the posted speed limit and make dangerous overtaking manoeuvres along this straight section of road. If the double white lines do not extend far enough as they do now there is a risk that vehicles will try and overtake as soon as they can after the bend increasing the risk and severity of a collision.

**Recommendation:** Include the double line system in the proposed layout.

Accepted – drawing amended.
