**ARBORICULTURAL REPORT  
to BS 5837:2012  
at  
The Workshop  
Off Kings Cliffe Road  
Huddersfield  
West Yorkshire  
HD2 2RR**

**Client:**  
Roheena Akhtar

**JCA Ref:**  
14218/TT

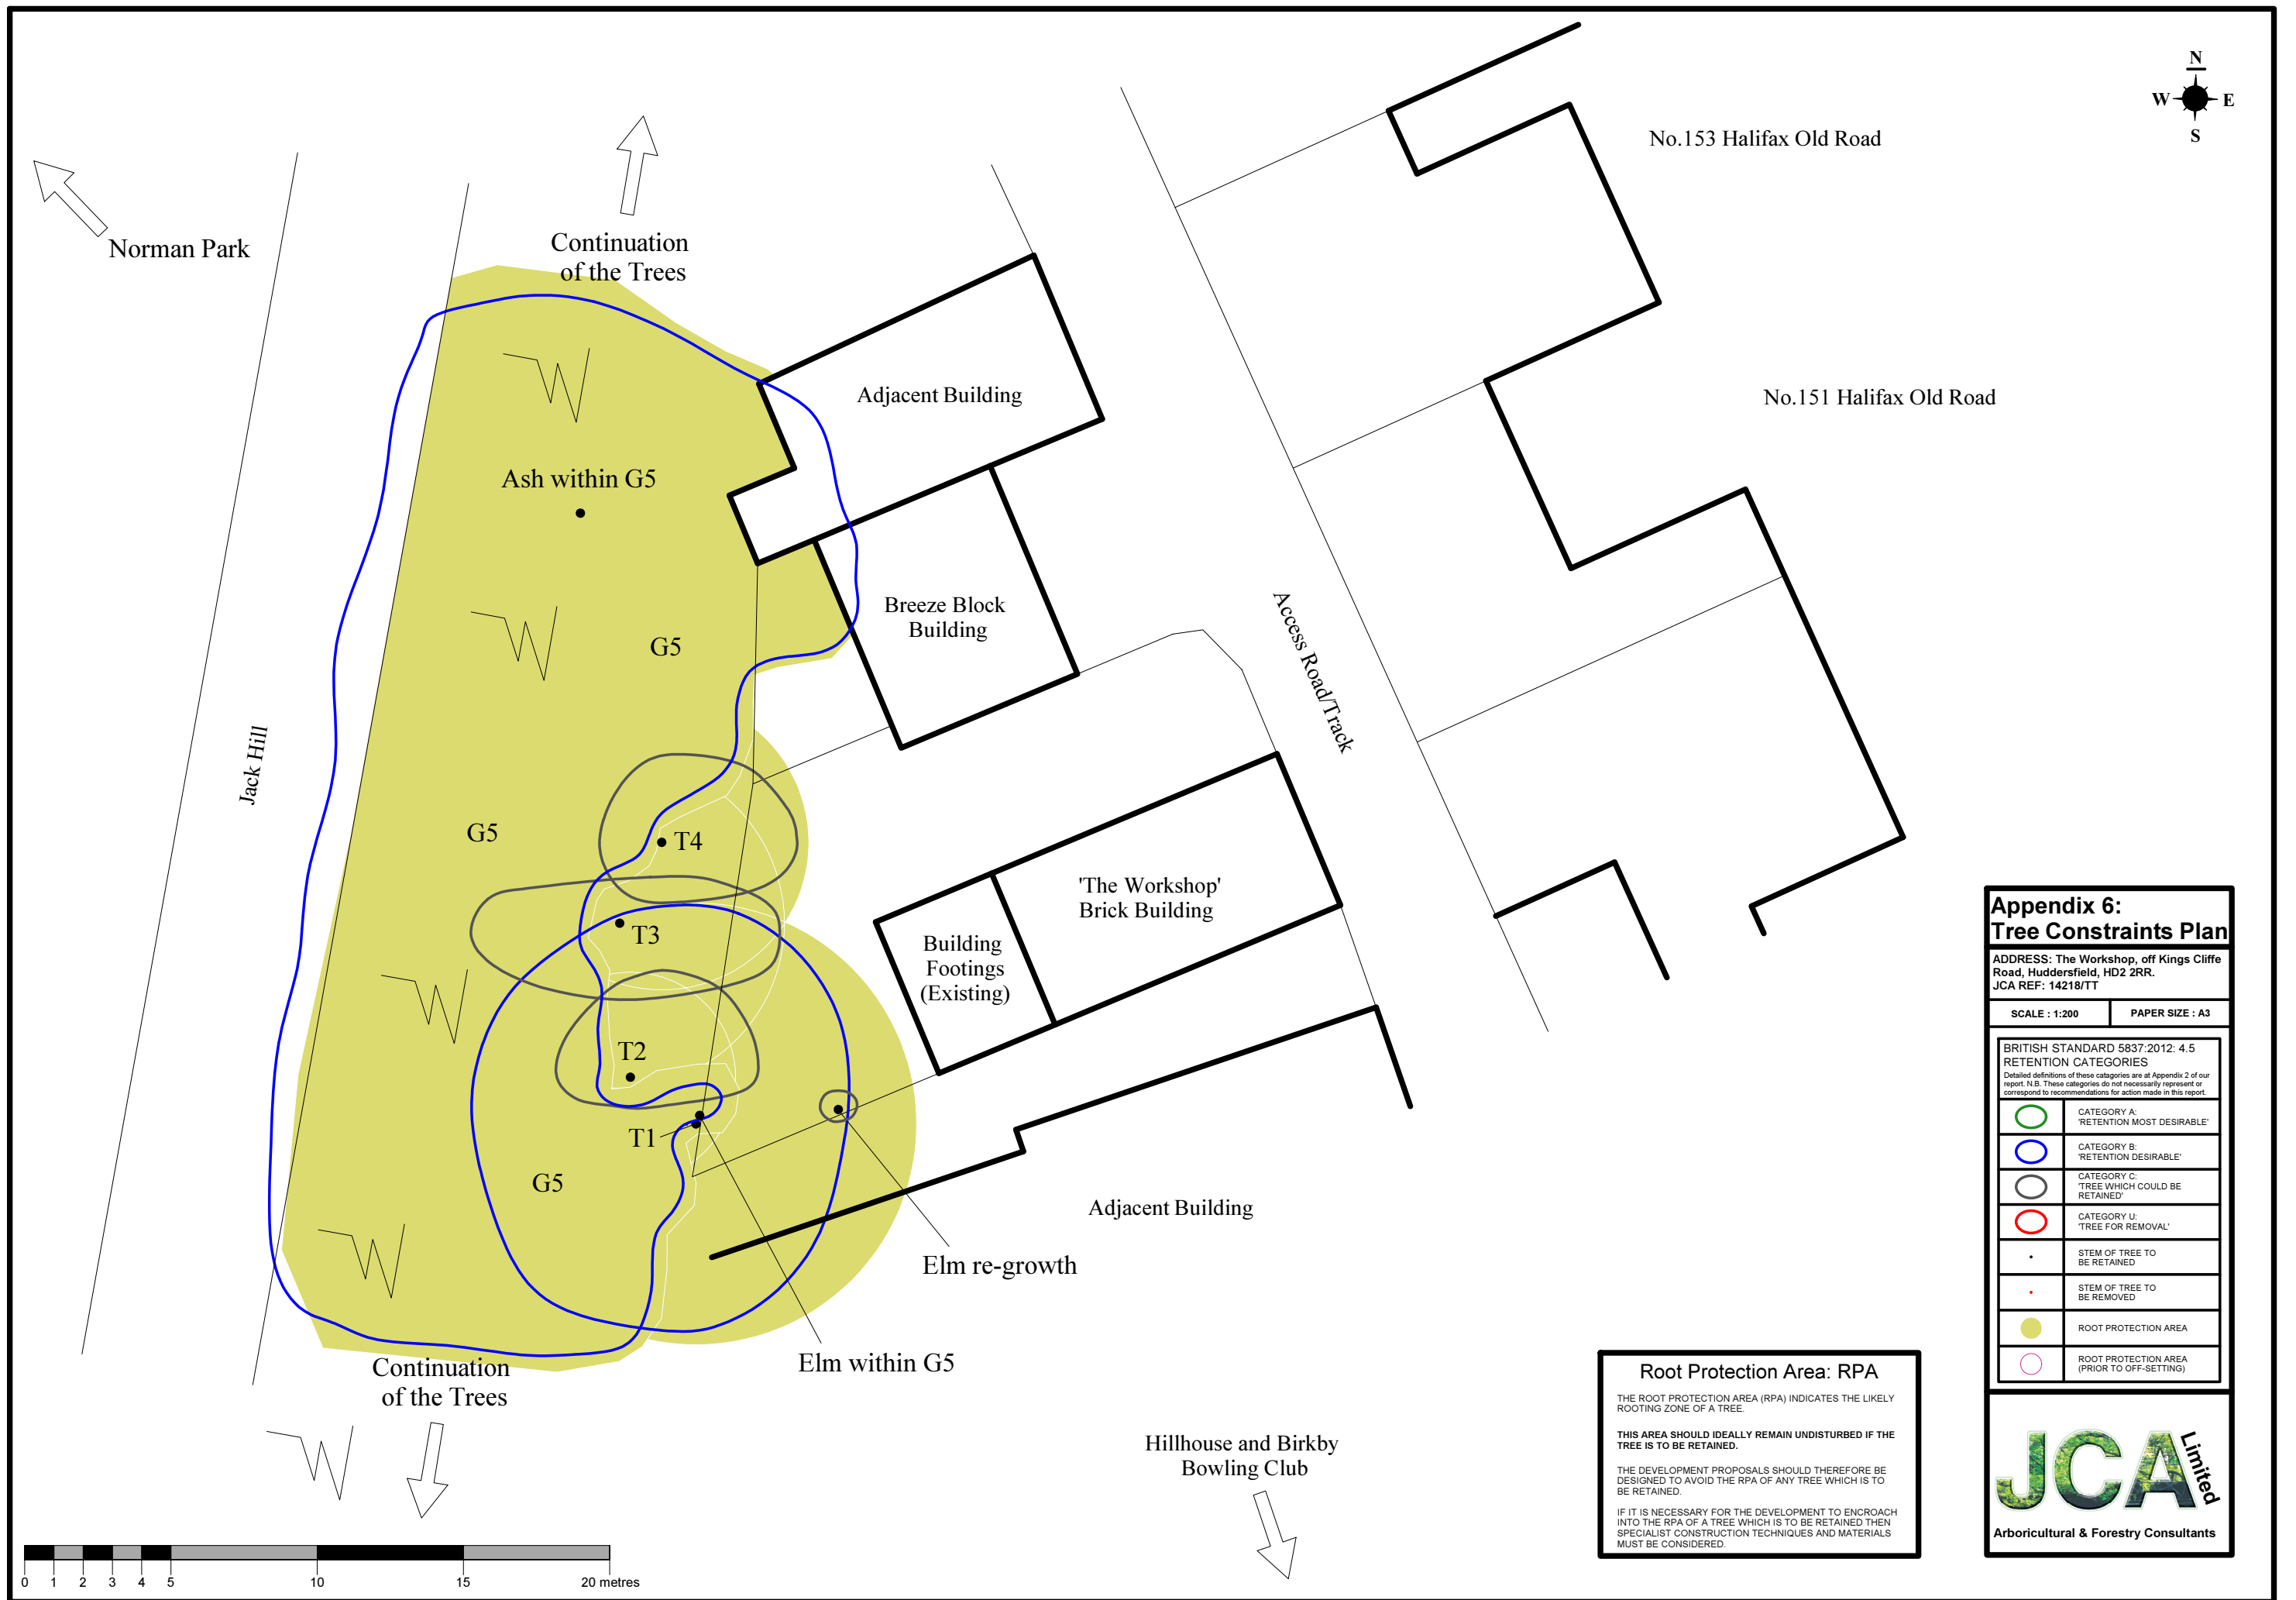
| <b>Appendix 6: Tree Constraints Plan .....</b> | <b>20</b> |

- 5.5.3 The location of each tree is plotted on the associated Tree Constraints Plan at **Appendix 6**. This plan identifies the retention category of each tree (Retention A: green canopy, Retention B: blue canopy, Retention C: grey canopy, Retention U: red canopy), the crown spread, and also the associated rooting zone (Root Protection Area or RPA shown in gold). In order to enable the survival of trees shown to be retained within any proposals, both the canopy of the tree and its RPA must be completely avoided wherever possible. This relates to not just the location of new buildings, but also to the location of new areas of hard standing, proposed utility routes and any ground level changes (both excavations and soil piling). Where this is not possible, specialist construction methods and materials will need to be used.
