## Laund Road, Salendine Nook Stage 1/2 Road Safety Audit

May 2018

Project 1387

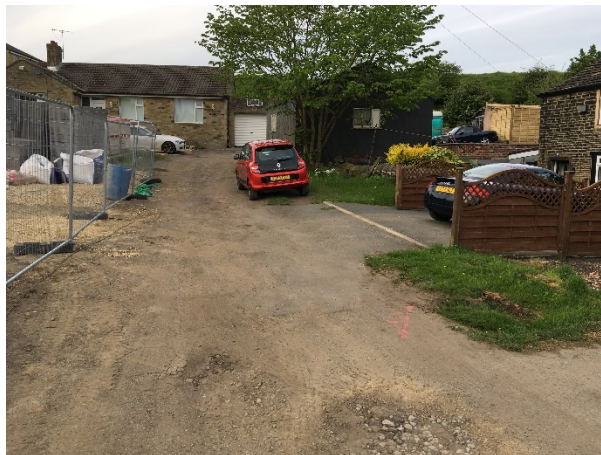
**Location:** New Access Road in front of existing row of cottages.

**Summary:** Risk of excessive water running into adjacent driveways to existing properties resulting in ice in freezing conditions.

**Detail:** The drawings show a narrow block paved margin with a vehicular dropped crossing and edging in front of the existing driveways that lead to the stone cottages. It appears that the road and surface water will fall in the direction of these properties. There is only one gully specified along this section and there is concern that during heavy rainfall this will not be adequate to catch all the surface water.

Ensure the drainage and gullies are adequate to catch the expected amount of surface water from the highway.

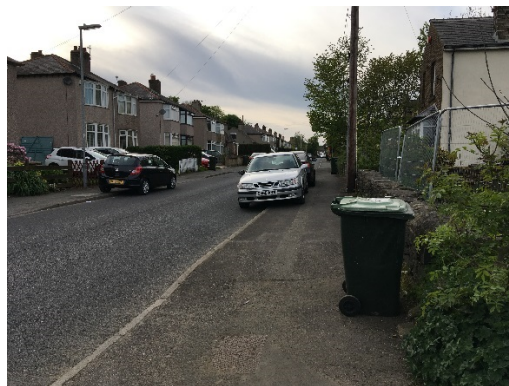
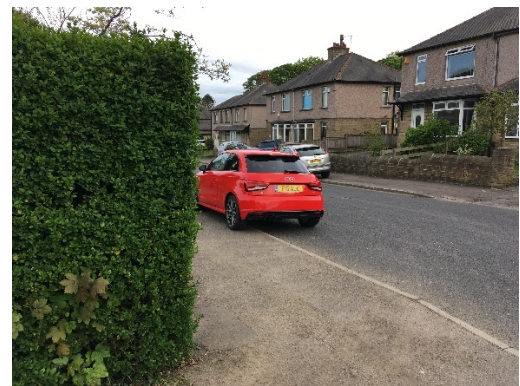
**Location:** Junction at New Access Road with Laund Road

**Summary:** Risk of collisions with vehicles and / or pedestrians on main road due to limited visibility and speed of existing traffic.

**Detail:** No details have been provided regarding visibility for egressing vehicles at the new access road. There is an existing stone wall and vegetation to the north east of the access and a privet hedge to the south west. It is unclear if these features are to remain which all restrict visibility. The Audit Team also noted that there is on street parking on Laund Road at both sides of the proposed access (see images below).

The speed of traffic on Laund Road appeared to be higher than the 30mph speed limit in force and if vehicles are emerging from the new road without adequate visibility there is a risk of collisions with passing pedestrians masked by the hedge or traffic on the main road.

The proposals should include adequate visibility splays and restrict parking if necessary.

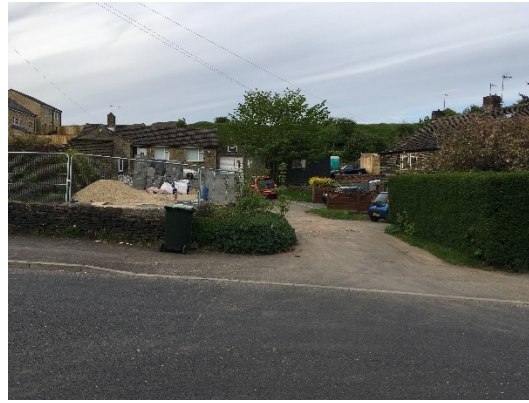
**Location:** New Access Road at junction with Laund Road

**Summary:** Risk of pedestrians failing to negotiate junction resulting in conflicts with turning vehicles.

**Detail:** No detail has been provided regarding the access arrangements at the new junction. The drainage drawing indicates a different layout to the Section 38 drawing; which shows the footway on Laund Road continuing through the new junction without any provision for pedestrians. If the footway does continue there is a risk that pedestrians will not be aware of vehicles emerging from the site or if it is proposed as a standard junction layout, then no details are shown for pedestrian dropped crossings.

**Recommendation:** Ensure the new junction layout is to standard and has appropriate provision for pedestrians.
