# **Laund Road, Salendine Nook**

## **Designers Response to Stage 1/2 Road Safety Audit**

Project 1387

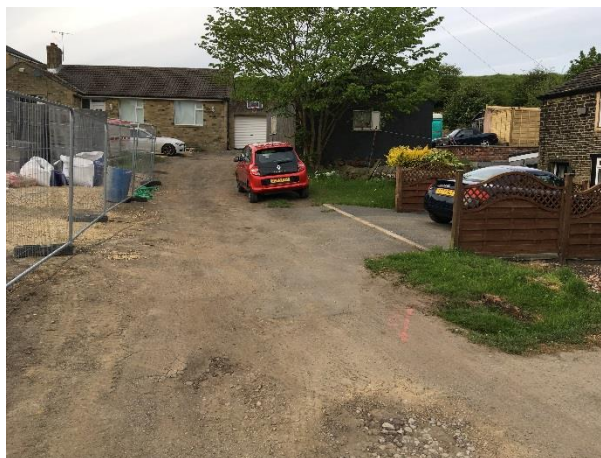
**Location:** New Access Road in front of existing row of cottages.

**Summary:** Risk of excessive water running into adjacent driveways to existing properties resulting in ice in freezing conditions.

**Detail:** The drawings show a narrow block paved margin with a vehicular dropped crossing and edging in front of the existing driveways that lead to the stone cottages. It appears that the road and surface water will fall in the direction of these properties. There is only one gully specified along this section and there is concern that during heavy rainfall this will not be adequate to catch all the surface water.

Ensure the drainage and gullies are adequate to catch the expected amount of surface water from the highway.

Gully provision is considered suitable to cater for the drained area of highway. Kerbs contain a 25mm upstand, and together with appropriate cross fall and end fall, surface water would be collected within the channel and drained within the gullies provided.

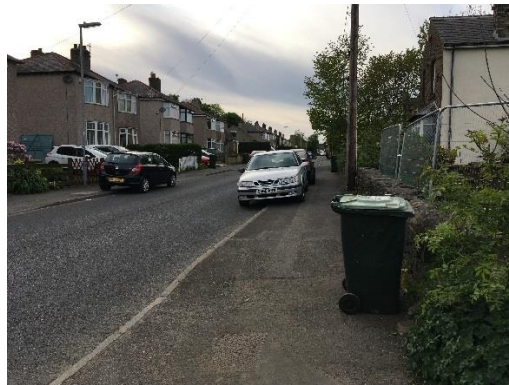
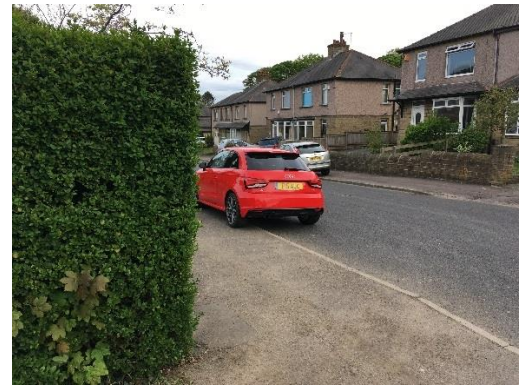
**Location:** Junction at New Access Road with Laund Road

**Summary:** Risk of collisions with vehicles and / or pedestrians on main road due to limited visibility and speed of existing traffic.

**Detail:** No details have been provided regarding visibility for egressing vehicles at the new access road. There is an existing stone wall and vegetation to the north east of the access and a privet hedge to the south west. It is unclear if these features are to remain which all restrict visibility. The Audit Team also noted that there is on street parking on Laund Road at both sides of the proposed access (see images below).

The speed of traffic on Laund Road appeared to be higher than the 30mph speed limit in force and if vehicles are emerging from the new road without adequate visibility there is a risk of collisions with passing pedestrians masked by the hedge or traffic on the main road.

The proposals should include adequate visibility splays and restrict parking if necessary.

Visibility splays of 2.4m x 43m are provided on both sides of the access in full accordance with the requirements of Manual for Streets. Visibility has been agreed with KMC Highways Officers/ Local Planning Authority as part of the planning process.

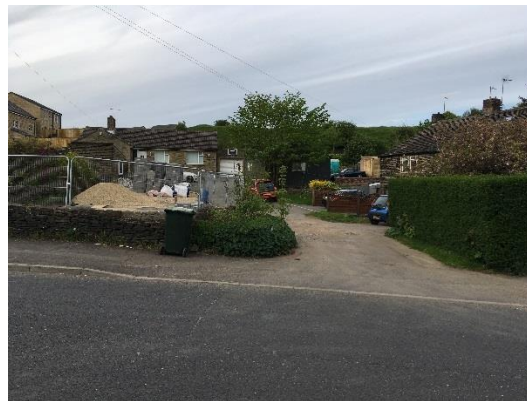
**Location:** New Access Road at junction with Laund Road

**Summary:** Risk of pedestrians failing to negotiate junction resulting in conflicts with turning vehicles.

**Detail:** No detail has been provided regarding the access arrangements at the new junction. The drainage drawing indicates a different layout to the Section 38 drawing; which shows the footway on Laund Road continuing through the new junction without any provision for pedestrians. If the footway does continue there is a risk that pedestrians will not be aware of vehicles emerging from the site or if it is proposed as a standard junction layout, then no details are shown for pedestrian dropped crossings.

**Recommendation:** Ensure the new junction layout is to standard and has appropriate provision for pedestrians.

The site access takes the form of a footway/ vehicular crossing. Therefore, pedestrian routes through the junction are clearly defined.
