# RICS **Building Survey**

34 Thornhill Road, Huddersfield, HG3 3DD

5<sup>th</sup> April, 2018

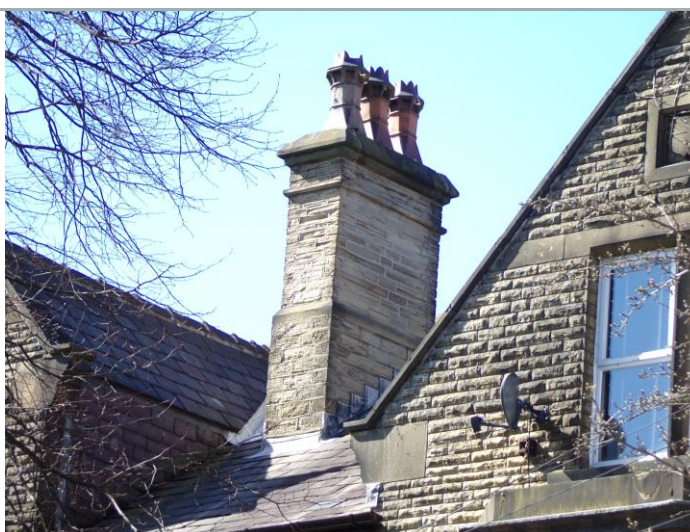
Central chimney stack

- The chimney pots to the central chimney stack are open and unprotected. This will lead to rain water entering the flues and consequent damp penetration and deterioration internally. Protective cowls should be fitted to the pots to reduce the risk of future defects developing.
- The mortar pointing to the south gable stack is weathered below the gutter line. Repointing is required to reduce further deterioration, damp penetration and structural problems arising.
- Some of the stones to the south gable stack are weathered below the gutter line. All affected masonry should be cut out and replaced to reduce further deterioration, damp penetration and structural problems arising.

**Condition Rating 3.** The need to provide a safe working platform and other difficulties associated with working at height makes repairs relatively expensive. I also refer you to my comment in Section J - Risks.

The chimney pot bedding mortar to the central stack could not be properly seen but is very exposed and may have deteriorated. This should be checked as soon as the opportunity arises.

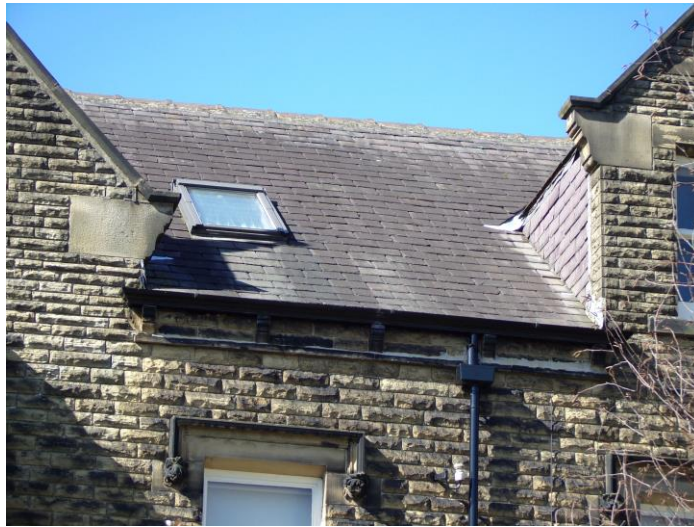
Front roof slope

- Some of the mortar pointing to the ridge tiles is cracked and starting to loosen and some

repair is needed in order to prevent damp penetration and damage from wind uplift.

- A few slates and are loose. Localised repair is needed.

**Condition Rating 2.** The need to provide a safe working platform and other difficulties associated with working at height makes repairs relatively expensive.

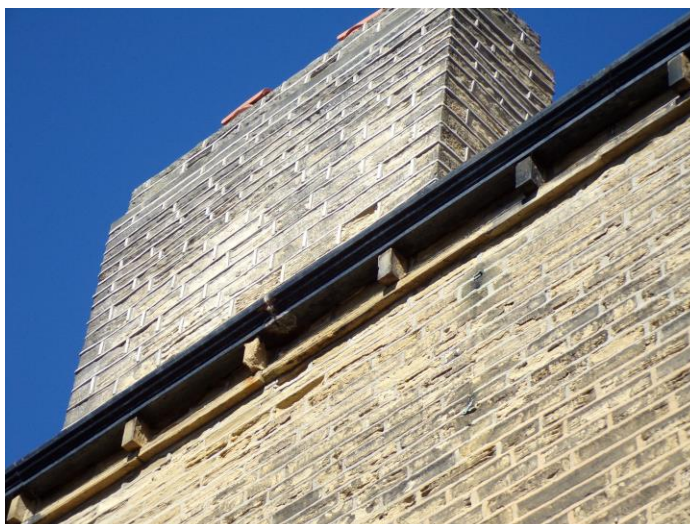
- Several gutter downpipe joints are stained and possibly leaking. Resealing is required.
- The rainwater fittings show signs of rusting. Some repairs are required.
- The fittings to the rear contain some debris. The fittings need clearing to reduce the risk of blockage and overflowing.

**Condition Rating 2.** The need to provide a safe working platform and other difficulties associated with working at height makes repairs relatively expensive.

**Corrosion to cast iron gutter.**

As it was not raining at the time of my inspection I am unable to be certain that all of the joints are free from leakage. I recommend the fittings are inspected during wet weather to enable any leakage to be identified and rectified.

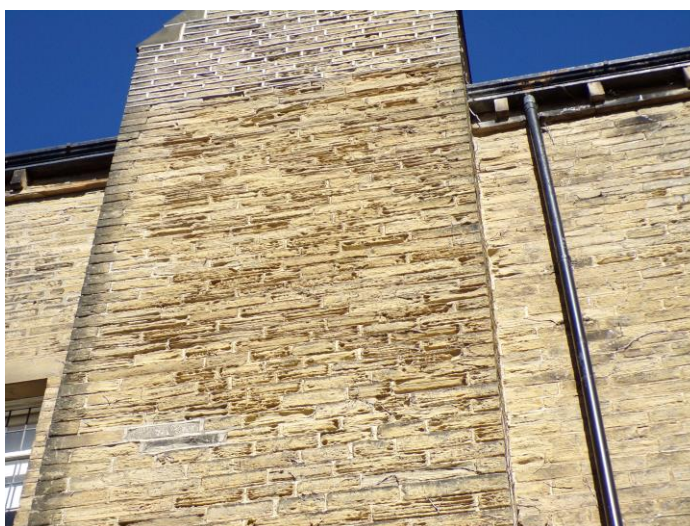
- The stone masonry to the south elevation, including the chimney stack, is decaying in areas. The decay is advanced in some locations and there will be a significant risk of damp penetration and more significant defects developing. Repair of the stonework will be required and this will involve chopping out the badly affected stones and replacing in new.
- Ivy is growing on the walls to the south-east elevation. This will cause damage. I recommend its removal. Some related repairs might be required.

**Condition Rating 3.** The need to provide a safe working platform and other difficulties associated with working at height makes repairs relatively expensive. I also refer you to my comment in Section J - Risks.

**Poor pointing and weathered masonry to chimney stack**

When undertaking pointing it is essential that the joints are raked out sufficiently, usually to a depth of not less than 20 mm so that the new mortar is given sufficient key. Failure to do this can result in the new pointing simply cracking and falling out over a relatively short timescale. The new mortar should not be too weak, but conversely it should not be stronger than the stones to which it is applied. A common misconception is that mortar requires a large proportion of cement in the mix, but too rich a cement content can cause serious problems. This work should only be entrusted to an experienced bricklayer.

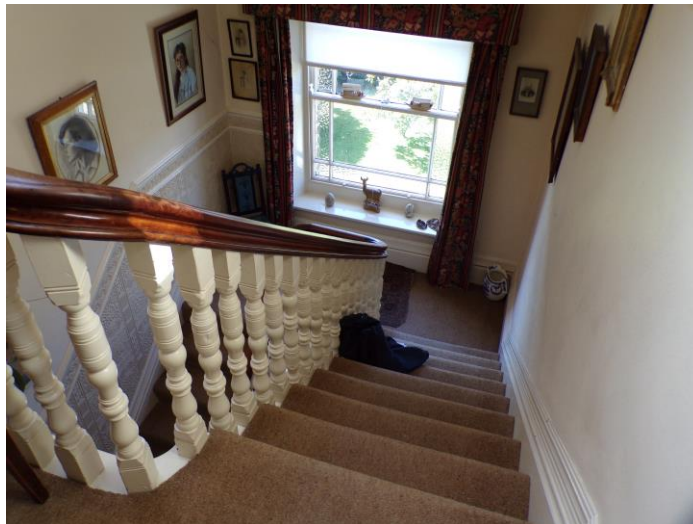
### Condition Rating 3.

Glazing to stairwell window

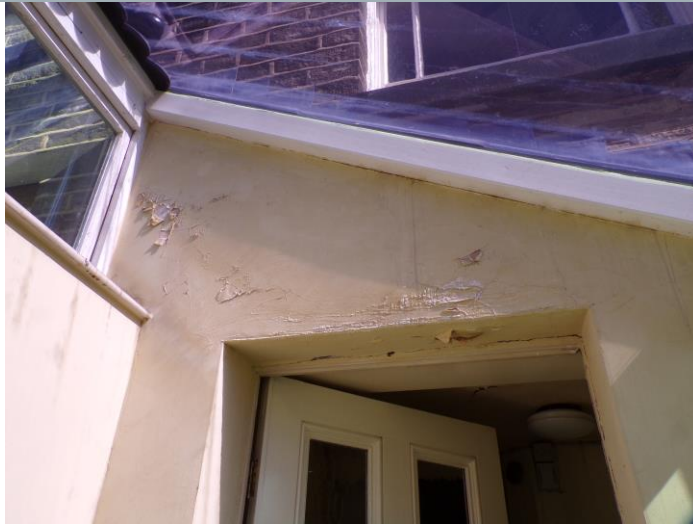
Evidence of damp to the conservatory

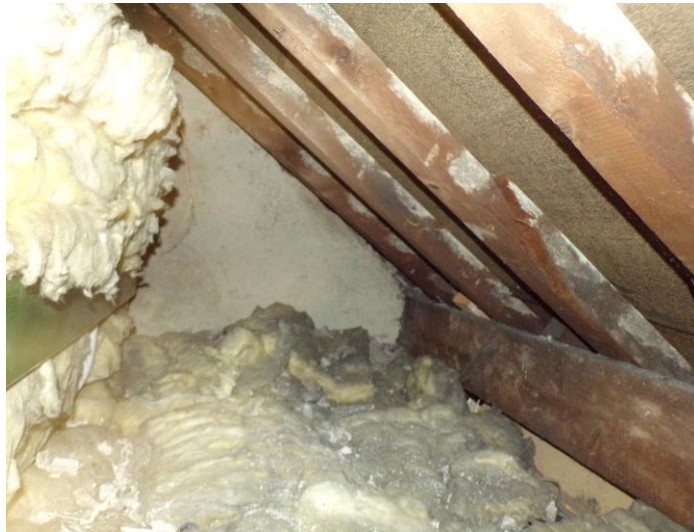
**Roof void**

The roof structure is original and in reasonable order for its age but as the timbers are old and slightly undersized by modern standards, some minor deflection and undulation has occurred. This is not unusual in a property of this age and no structural repair is currently needed. Normal maintenance will be required.

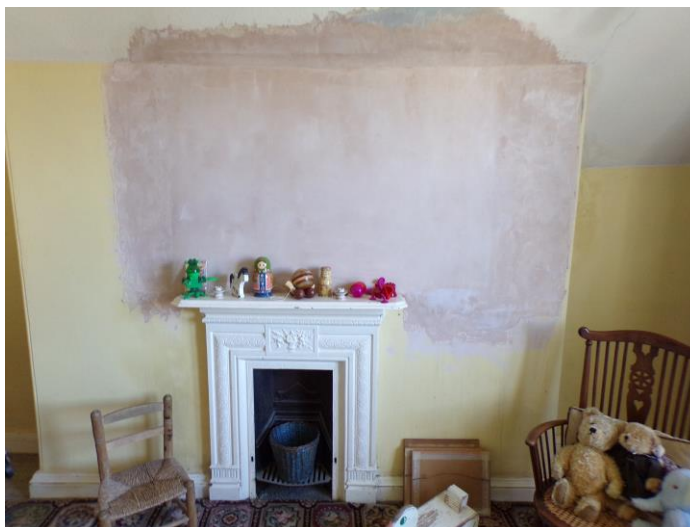
**Previous wall repairs**

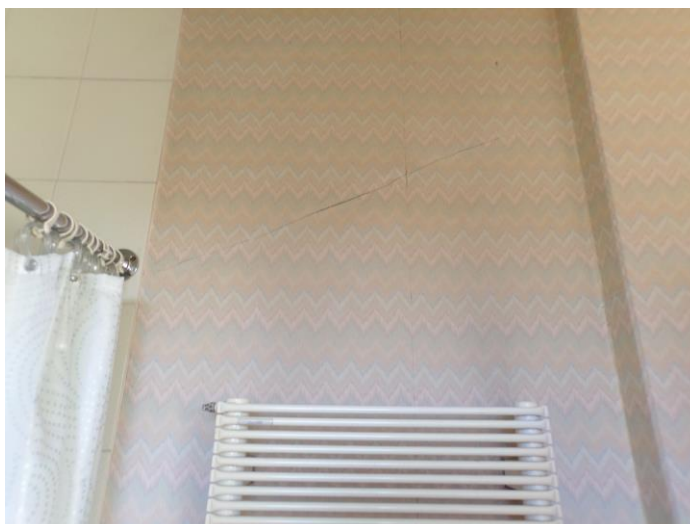
**Cracking of plaster in bathroom**

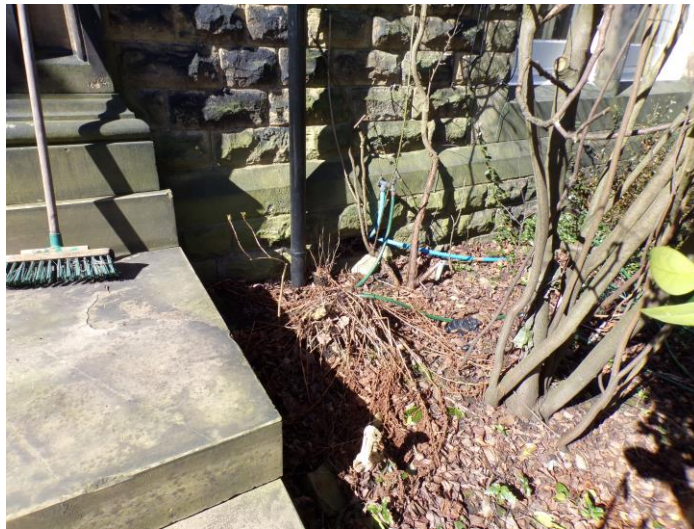
Ventilation to sub-floor

- Some floors creak when walked over and some surfaces are not entirely level. This is not serious and is common in floors of this type. There is evidence of wear and tear to the floor finishes from normal use.
- The mosaic tiled finish to the entrance vestibule is slightly damaged. Localised repair is needed.
- Sub floor ventilation levels are adequate although these should be checked and cleared of all obstructions / nearby vegetation.

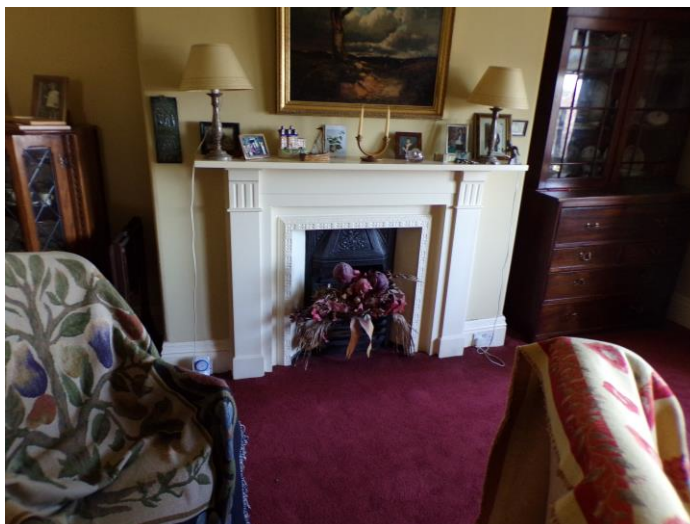
### Condition Rating 3

Unused fire place

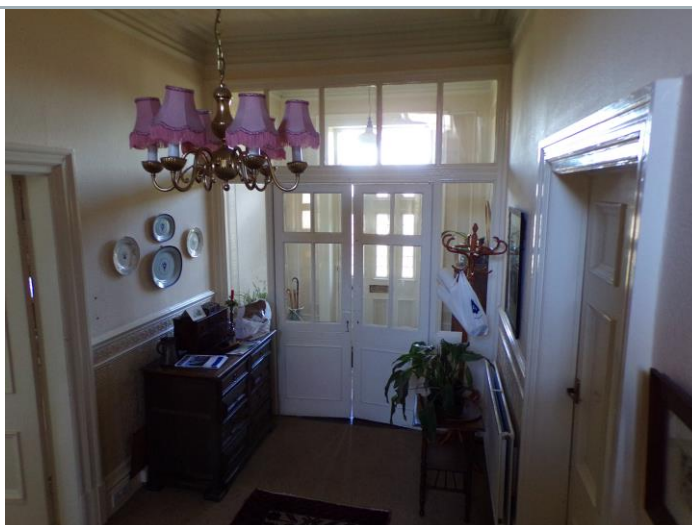
Glazing to vestibule doors and side screen

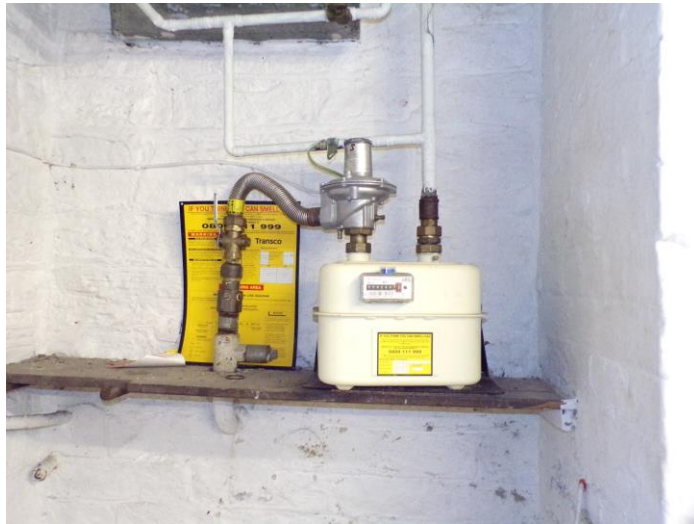
**Gas meter**

I saw no areas of concern however, I do not know if there is a current test certificate for the installation. Your Legal Adviser should establish whether there is a current test certificate. If not then it should be checked before purchase and you should instruct a Gas Safe registered engineer to test the installation for safety and carry out any necessary works. I refer you to Section J. **Condition Rating 3.**

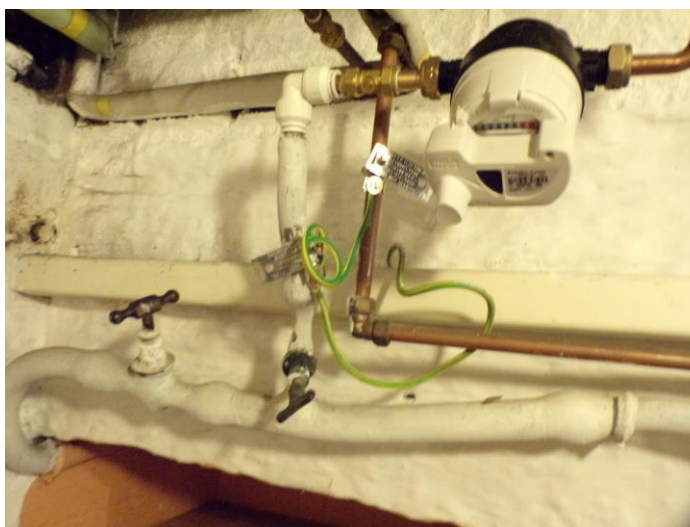
**Water stop tap and meter**

- G3** The property has a mains water supply connected. 3
- Water** The external stop tap could not be found. I recommend that you contact the local water company to advise you on its location.
- The internal stop tap is in the cellar and a water meter has been fitted.
- Where visible, the supply pipework appears to be lead. The internal distribution pipework is copper.
- The water storage tanks are plastic and are located in the main roof space.
- I noted the following item:
- The incoming water main is believed to be of old lead type. Lead is now considered to be hazardous to health and I refer you to Section J. I recommend that you replace all lead pipework.

**Condition Rating 3.** I also refer you to my comment in Section J - Risks.

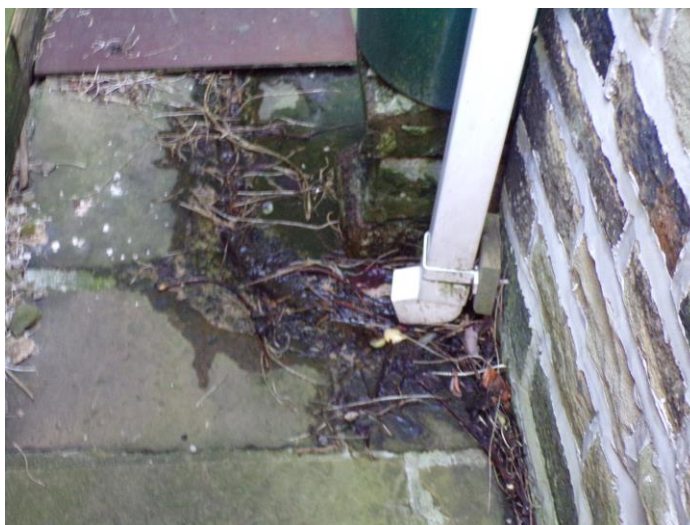
**Blocked gulley / drain**

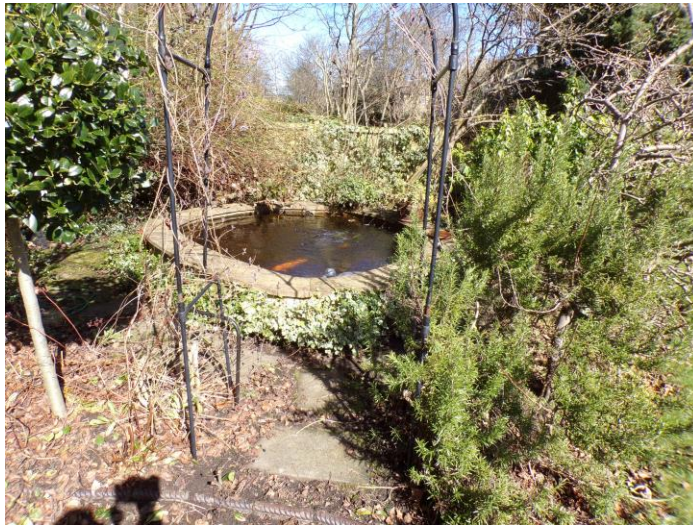
**Unprotected pond**

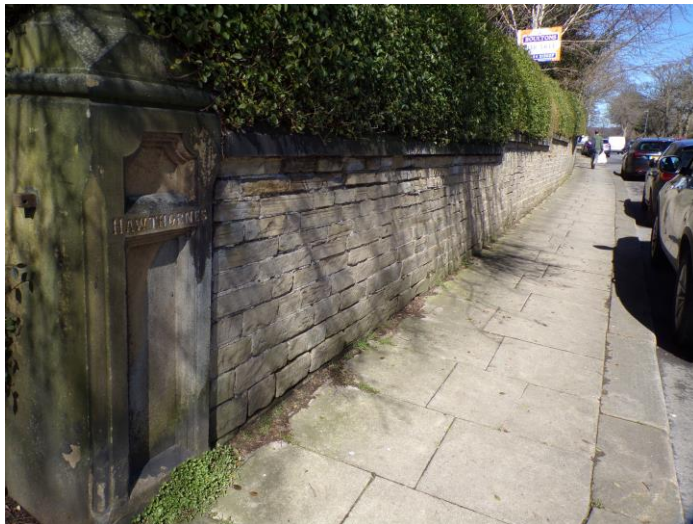
- The boundary wall to the front of property is very badly weathered and leaning. Repair required.
- The driveway has sunk in areas and is considered a safety risk. Repair is needed and may be costly.
- There is a pond with the property which is unprotected and a possible risk to children. I refer to my comments in section J – Risks

**Condition Rating 2.**

**Stone boundary wall**
