Our Ref: B22893.L001/JAW/cl

Date: 31 October 2018

**Re: Barn 2- Staley Royd Farm, Jackson Bridge, Scholes, For Mr I Conroy**

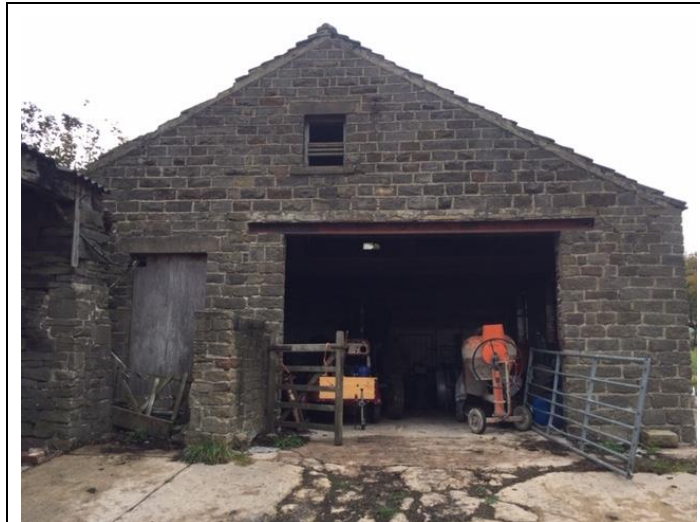
Plate 1- Front Elevation

The wall is reasonably plumb. The pointing is old and there are several fine cracks in the pointing. This elevation and other elevations will require repointing, during the conversion works. A dominant opening has been formed in this elevation and steel lintels formed across using what appear to be channel sections, back to back, with the gap between the inner and outer channels bridged by bricks. There is rusting and lamination of the steel beams and the beam appears to be slightly undersized for the size of the opening. This

beam will have to be replaced during the course of the renovation works. The verge line to the roof appears to be in good condition.

The main structural item is the steel lintel over the prominent door opening to the front elevation. This is showing signs of significant corrosion and lamination and will have to be replaced as, part of the proposed renovation works. Along the left elevation the ground is higher than the internal floor level and will be a source of damp ingress into the property. There is a possibility that a dry stone retaining wall returns around the left side of the property, however, over the years the gap between the wall and elevation of the building may have become filled with soil, etc. This area should be investigated and if a retaining wall does exist the area should be cleaned out to allow the face of the building, to be exposed and remove potential source of damp ingress, into the property.

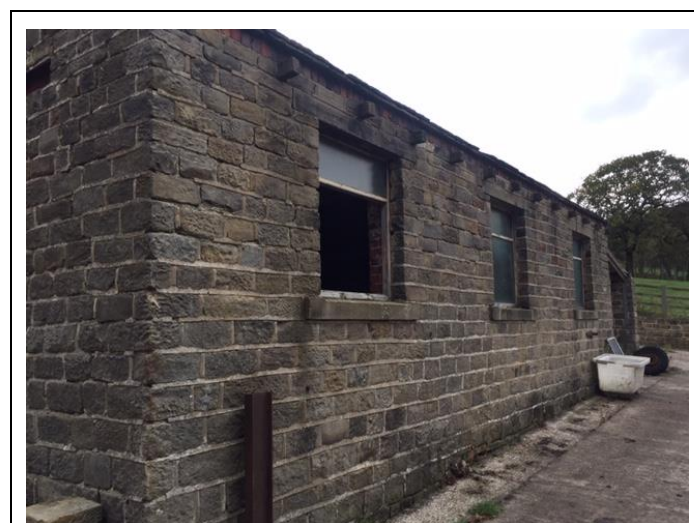
Plate 2- Right Elevation

This elevation has three windows, with stone heads and sills. See plate 2. There are no gutters to the roof. The sills appear to be reasonably horizontal. The pointing is in poor condition. The pointing is particularly poor at higher level, possibly due to rain water running down the roof onto the surface. There are a few hairline cracks in the wall, however, these are old, and movement does not appear to be progressive or significant. The most significant cracks are beneath the rear right window, here damage appears to have been caused by corrosion of a fixing to the wall. Corrosion of metal fixings causes expansion of the metal which in turn, transfers the forces into the stonework resulting in splitting of the stone.

There are some minor cracks in the elevations which do not appear to indicate any signs of significant structural movement. There is a metal fixing in the right wall which is corroding causing localised damage to the stonework and any metal fixings found in the external walls should be removed.

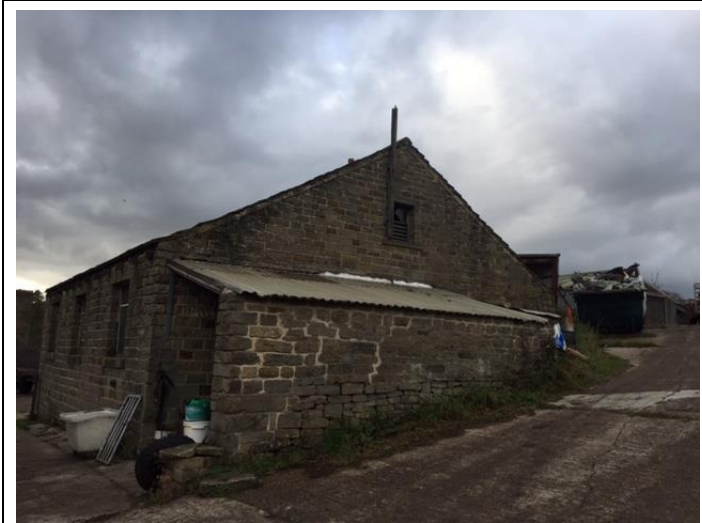
Plate 3- Rear Elevation

The pointing to the rear elevation is in good condition as at lower level the elevation has been protected by the lean-to roof. Above the lean-to roof the pointing is a little more weathered and there are loose stones close to the rear right corner at eaves level. This is where mortar has become washed away. Apart from this one area, the elevation appears to be in good condition. There are no signs of bulging or downward movement. See plate 3.

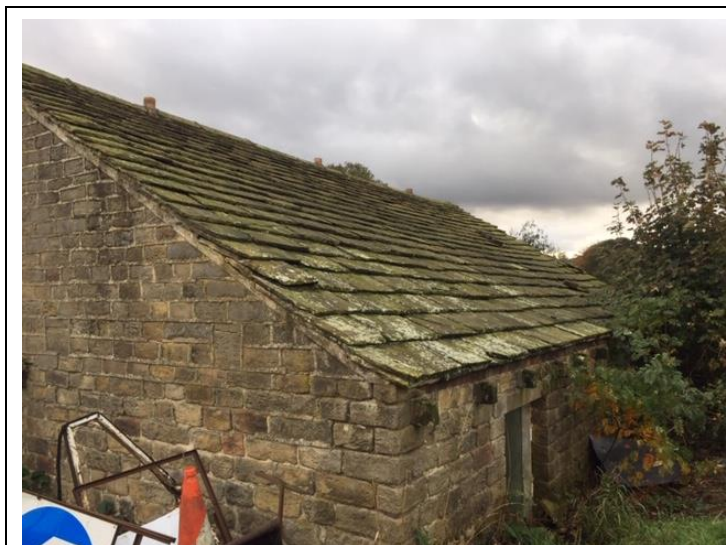
Plate 4- Left Elevation

The left elevation again has no gutter. The ground level is up to the window sill level and we presume that the ground has been filled in at this location. The retaining wall towards the rear extends further to the left side and it is possible that there is a wall behind the soil at this location. If possible, the ground at this side of the property requires lowering in order to prevent damp ingress into the building. Parts of the elevation that can be seen, appear to be in good condition, though repointing is required. See plate 4.
