JET AIRE SERVICES

GR6637 SOOTHILL

**Table of contents**Project Name:  
GR6637 SOOTHILLProject number:  
GR/6637Date:  
13/08/2019

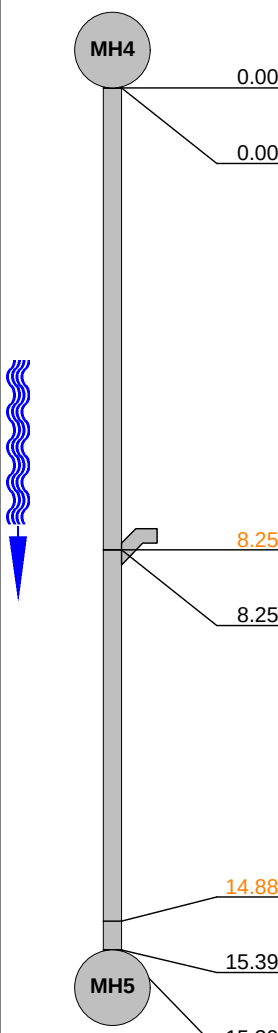
| 1:135 | Position | Observation | Grade | | | | | | |
|---|---|---|---|---|---|---|---|---|---|
| | 8.25 | Attached deposits, encrustation, from 6 to 8 o'clock, 10% cross-sectional area loss | 3 | | | | | | |
| | 14.88 | Roots, mass at joint, 10% cross-sectional area loss | 3 | | | | | | |
| 0 | 0 | 0 | 0 | 1 | 1 | 2 | 0.13 | 2 | 3 |
