## Phase 1 GeoEnvironmental Desk Study

120 Laund Road

Salendine Nook

**Report No. A0697/17**

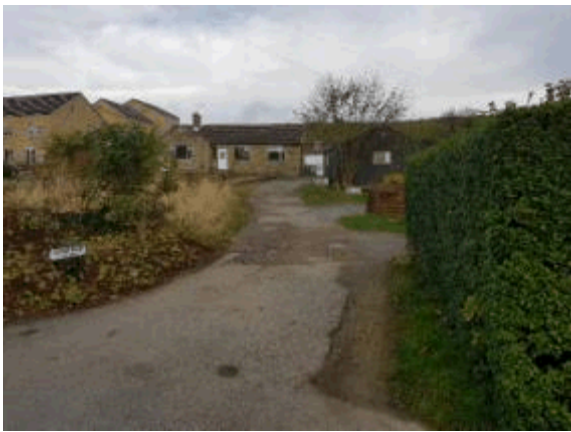
| <p align="center"><b>Plate 1 Laund Road, adjacent to the west of the site.</b></p> | <p align="center"><b>Plate 2 Access Road in the west of the site, facing northeast.</b></p> |

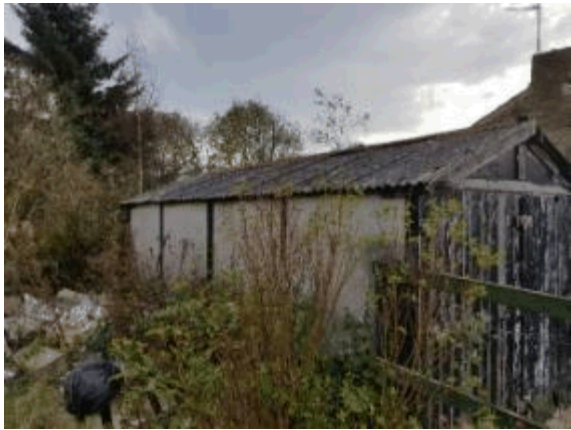
| <p><b>Plate 7</b> Domestic garage with suspected asbestos containing cement sheeting adjacent to the west of the site.</p> | <p><b>Plate 8</b> Flytipped materials and hardstood concrete pad in the centre of the site.</p> |

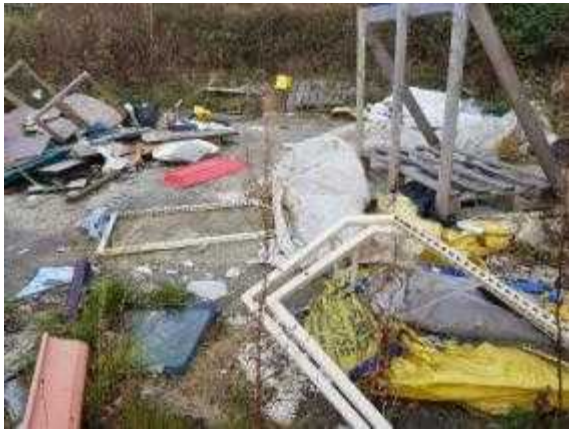
- 5.3 Several small piles of flytipped material are present to the southeast of the residential dwelling, the piles were observed to contain; plasterboard, wood, empty gas canisters, glass bottles, metal and plastic.

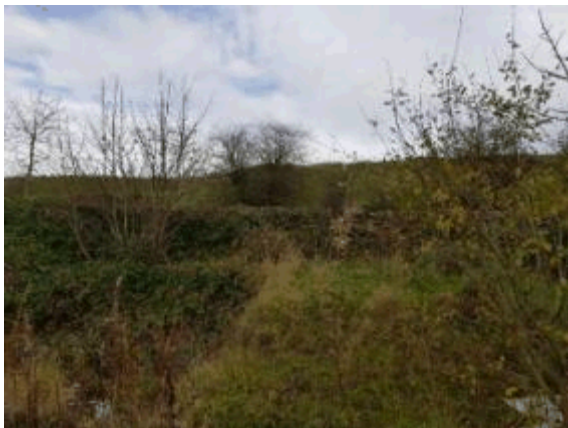
| <p><b>Plate 9</b> Low rise brick wall in the southeast of the site.</p> | <p><b>Plate 10</b> Retaining wall along the eastern boundary and adjacent open farmland.</p> |

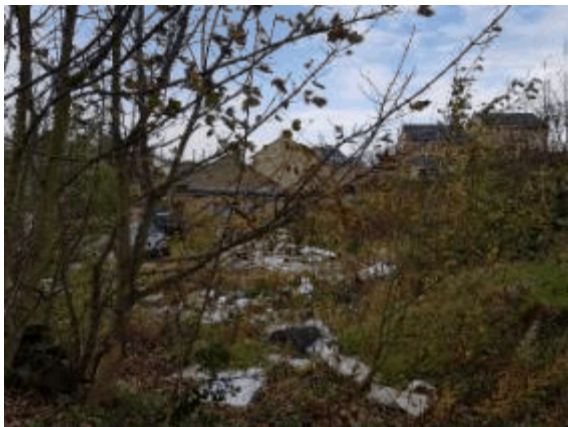
| <p><b>Plate 11</b> Overgrown vegetation and mature trees in the southeast of the site.</p> | <p><b>Plate 12</b> Looking north across the north of the site.</p> |
