## Claim Assessment Report

On behalf of **Direct Line**

**Our Reference:** IFS-DLG-SUB-18-0075953

**Risk Address:** 155 Penistone Rd., Huddersfield, HD8 0RB

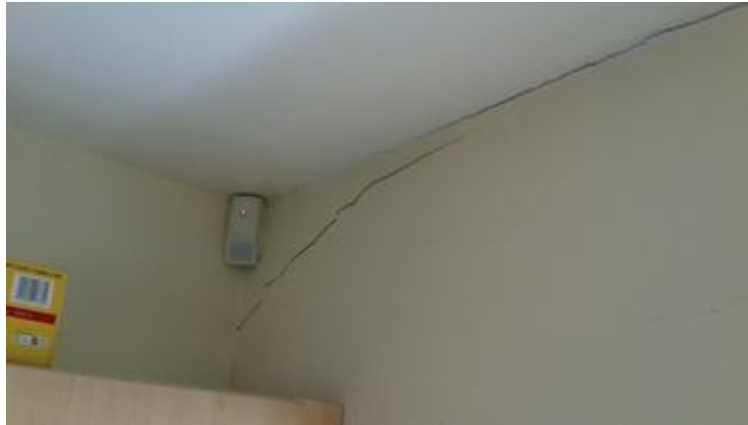
- 3mm wide horizontal and diagonal fractures adjacent the window and door openings on the rear wall.
- Several 1mm wide diagonal fractures to the left and right walls and hairline cracking to ceiling and wall junctions, which have evidence of previous repairs but have since re-opened.
- Hairline crack damage observed to the ceiling.

FIGURE 03 Kitchen - Diagonal crack damage to rear wall.

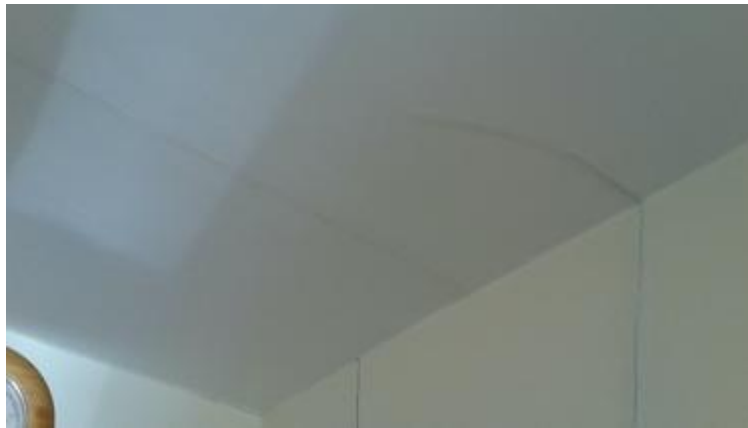
- 1mm wide crack damage to the right hand wall, which extends across the ceiling over to the left side and have evidence of previous fill repairs but have since re-opened.

FIGURE 04 Hall - Crack damage to walls and ceiling.

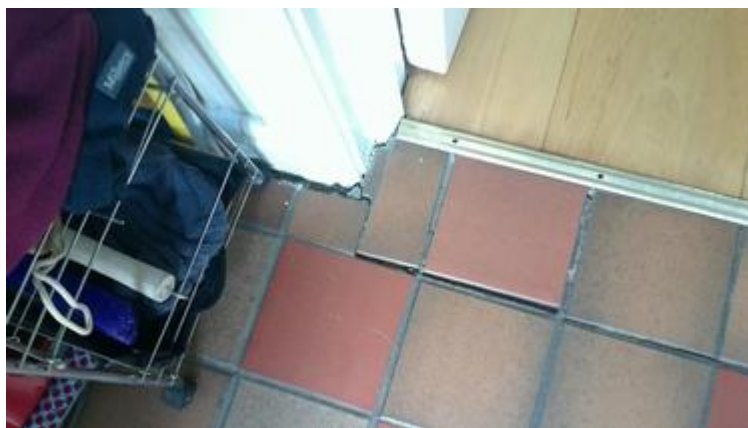
- Shear crack damage to the quarry tiles at the junction with the main property.
- Vertical tapered separations at the junction with the main property of upto 15mm wide together with cracking along the ceiling angles.

FIGURE 05 Porch - Shear crack damage to quarry floor tiles.

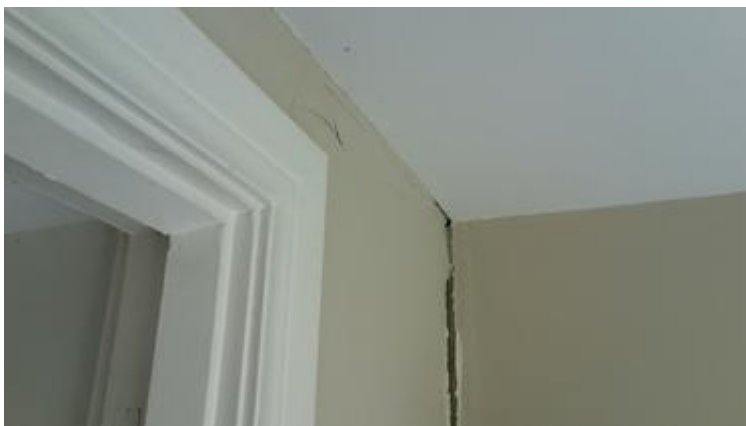
- 10mm wide tapered vertical separation at the porch junction with the main property together with 2mm wide diagonal stepped cracking to the right elevation and 10mm wide vertical separation at the gas meter housing and the masonry.

FIGURE 06 Porch - Tapered vertical separation to front right corner.

Following our recent visual inspection, we are satisfied the property has evidence of recent subsidence. The mode of failure appears to be a downward and rotational movement of the front porch away from the main property and a downward movement of the rear elevation.
