# Arboricultural Method Statement

**BE-1106.2**

**2 Hill Park, Mirfield WF14 8JB**

| <b>Date</b> | 10 <sup>th</sup> December 2019 |

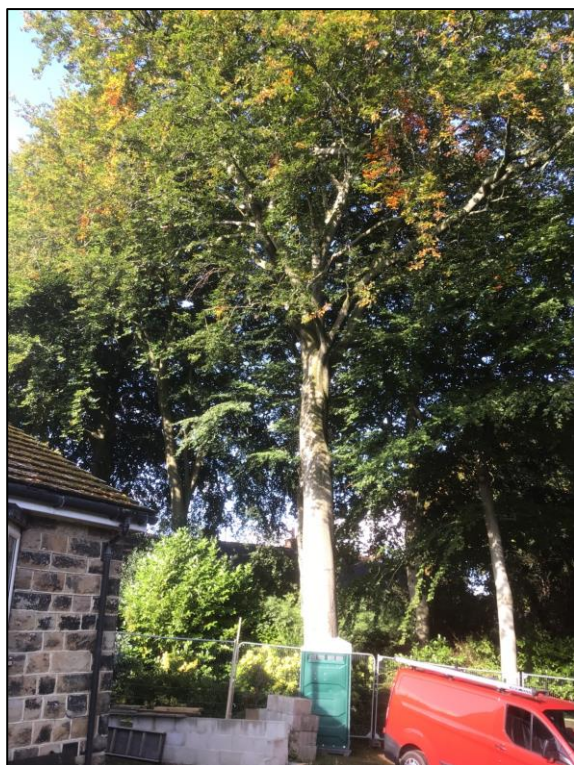
*Plate 2: T1*

11% of the RPA of T1 has been affected by the excavation. The excavation has been carried out to a depth of approximately 50 cm. As the majority of tree roots are typically located within the top 1 m of soil, it is likely that roots have been damaged due to the excavation. At the time of writing it is not, however clear what the impacts of this are. The root protection area is an arbitrary circle, and while roots would usually be present within this area, root spread is typically asymmetrical, and therefore it is not possible to determine this with certainty. Furthermore, removal of tree roots typically results in dieback of the crown which takes 2-3 years to manifest (Roberts *et al.*, 2006). Therefore, at present it is not possible to state the extent of any damage to the tree.

| Tree No. | Species | Height | CC | Stems | DBH | Crown Spread | | | | Age | Comments | SULE | Category |
|---|---|---|---|---|---|---|---|---|---|---|---|---|---|
| T1 | Beech<br><i>Fagus sylvatica</i> | 21 | 6.5 | 1 | 87 | 6 | 10 | 8 | 7 | Mature | Situated approximately 5.5m from newly installed foundations. Multiple pruning wounds on east aspect, all of which display good occlusion. Recently crown lifted on east aspect, with several secondary branches removed and/or reduced. | >40 | A1 |

Further monitoring of T1 will be required over the next three years to determine if there has been any damage due to potential root loss. Potential damage to the tree could also be mitigated by further fertilisation of the root system.

It is recommended that samples of soil within the RPA of T1 are taken and analysed for fertility (NPK plus macronutrients and pH). The RPA of T1 should then receive treatment from a fertiliser to alleviate any imbalance of fertility or pH, if identified.

The RPA of T1 should also receive treatment from a mycorrhizal fungal application, which should ideally include *Trichoderma harzianum*, a fungus which has been demonstrated to improve resistance to pathogens, and to enhance growth rates of trees (Kleifeld and Chet, 1992).

Fertilisation and mycorrhizal application should be administered by a consultant arboriculturist, and should consist of injections, applied by an injection probe, in a grid pattern at approximately 1 m intervals throughout the RPA. This should preferably be administered between April and May 2020; otherwise any time of year is acceptable.

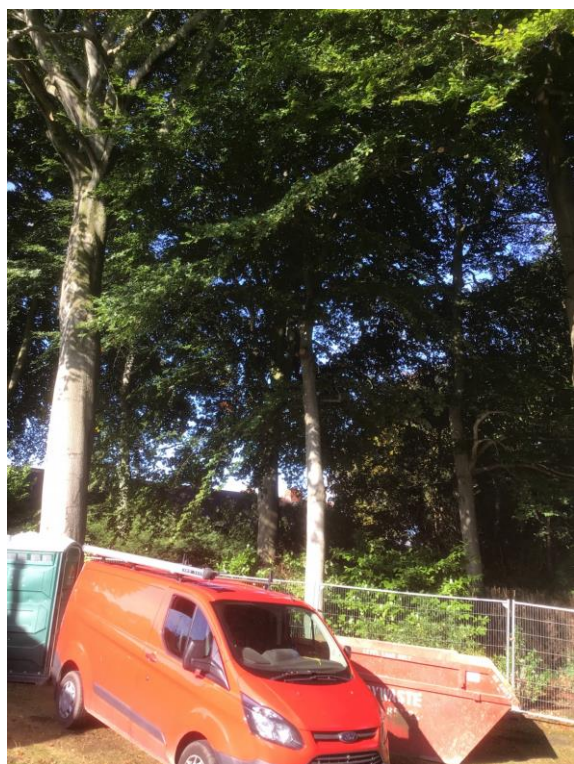
*Plate 3: T2*

The excavation within the RPAs of T2 and T3 is considered to be sufficiently minimal that it is highly unlikely that these trees would have been negatively impacted by development works.

| Tree No. | Species | Height | CC | Stems | DBH | Crown Spread | | | | Age | Comments | SULE | Category |
|---|---|---|---|---|---|---|---|---|---|---|---|---|---|
| T2 | Beech<br><i>Fagus sylvatica</i> | 11 | 2.5 | 1 | 47 | 3.5 | 5 | 4 | 3 | Early-mature | Secondary branch recently removed from east aspect of main stem at 5m. No major visible defects, though lacks qualities for higher categorisation. | >40 | B1 |

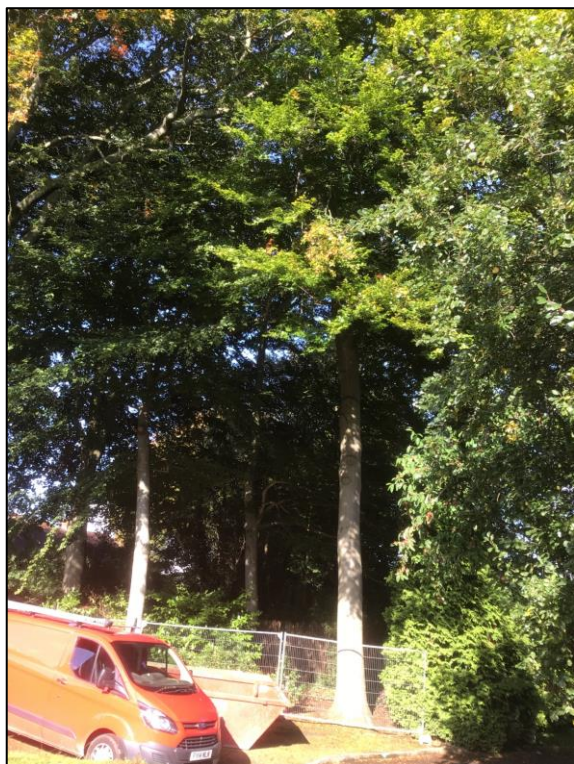
*Plate 4: T3*

| Tree No. | Species | Height | CC | Stems | DBH | Crown Spread | | | | Age | Comments | SULE | Category |
|---|---|---|---|---|---|---|---|---|---|---|---|---|---|
| T3 | Beech<br><i>Fagus sylvatica</i> | 18 | 6 | 1 | 68 | 6.5 | 9.5 | 7 | 6 | Mature | Asymmetrical crown spread, with slight lean to main stem. Multiple pruning wounds on main stem from previous crown raising works- all of which display good occlusion. Lacks qualities for Category A classification. | >40 | B1 |

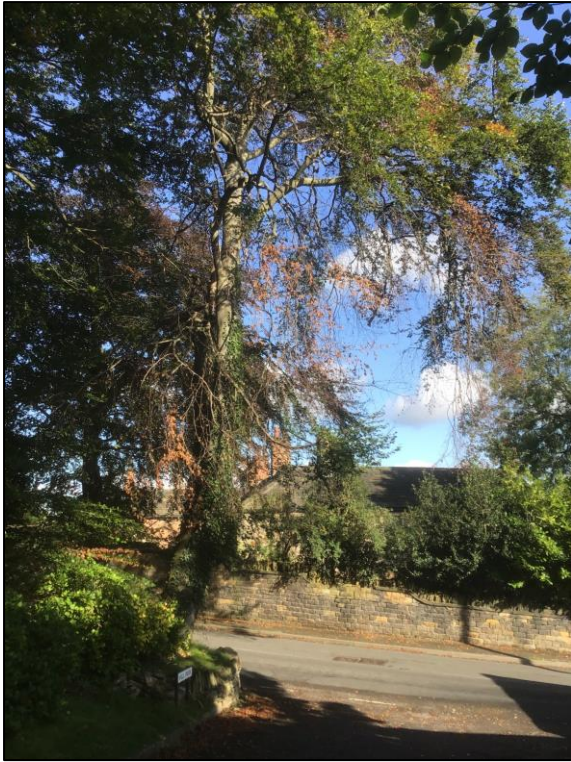
*Plate 5: T4*

Although T4 has been downgraded to Category U, this tree does not necessitate removal due to development, and any further proposed works to this tree are not discussed within this document.

| Tree No. | Species | Height | CC | Stems | DBH | Crown Spread | | | | Age | Comments | SULE | Category |
|---|---|---|---|---|---|---|---|---|---|---|---|---|---|
| T4 | Beech<br><i>Fagus sylvatica</i> | 18 | 3 | 1 | 67 | 7.5 | 7 | 6.5 | 6 | Mature | Situated in raised area adjacent to Hopton Lane. Extensive tip dieback throughout crown. Significant dead/dying secondary branch, approximately 30cm diameter, which extends north over Hopton Lane. | <10 | U |
