**Tree Safety and Tree Condition Report for:**

Ms Pam King  
Holme Valley Court  
163 Huddersfield Road  
Thongsbridge  
Holmfirth  
HD9 3TQ.

On 2<sup>nd</sup> June 2019

By Flora Harding  
Ref: OWA0115

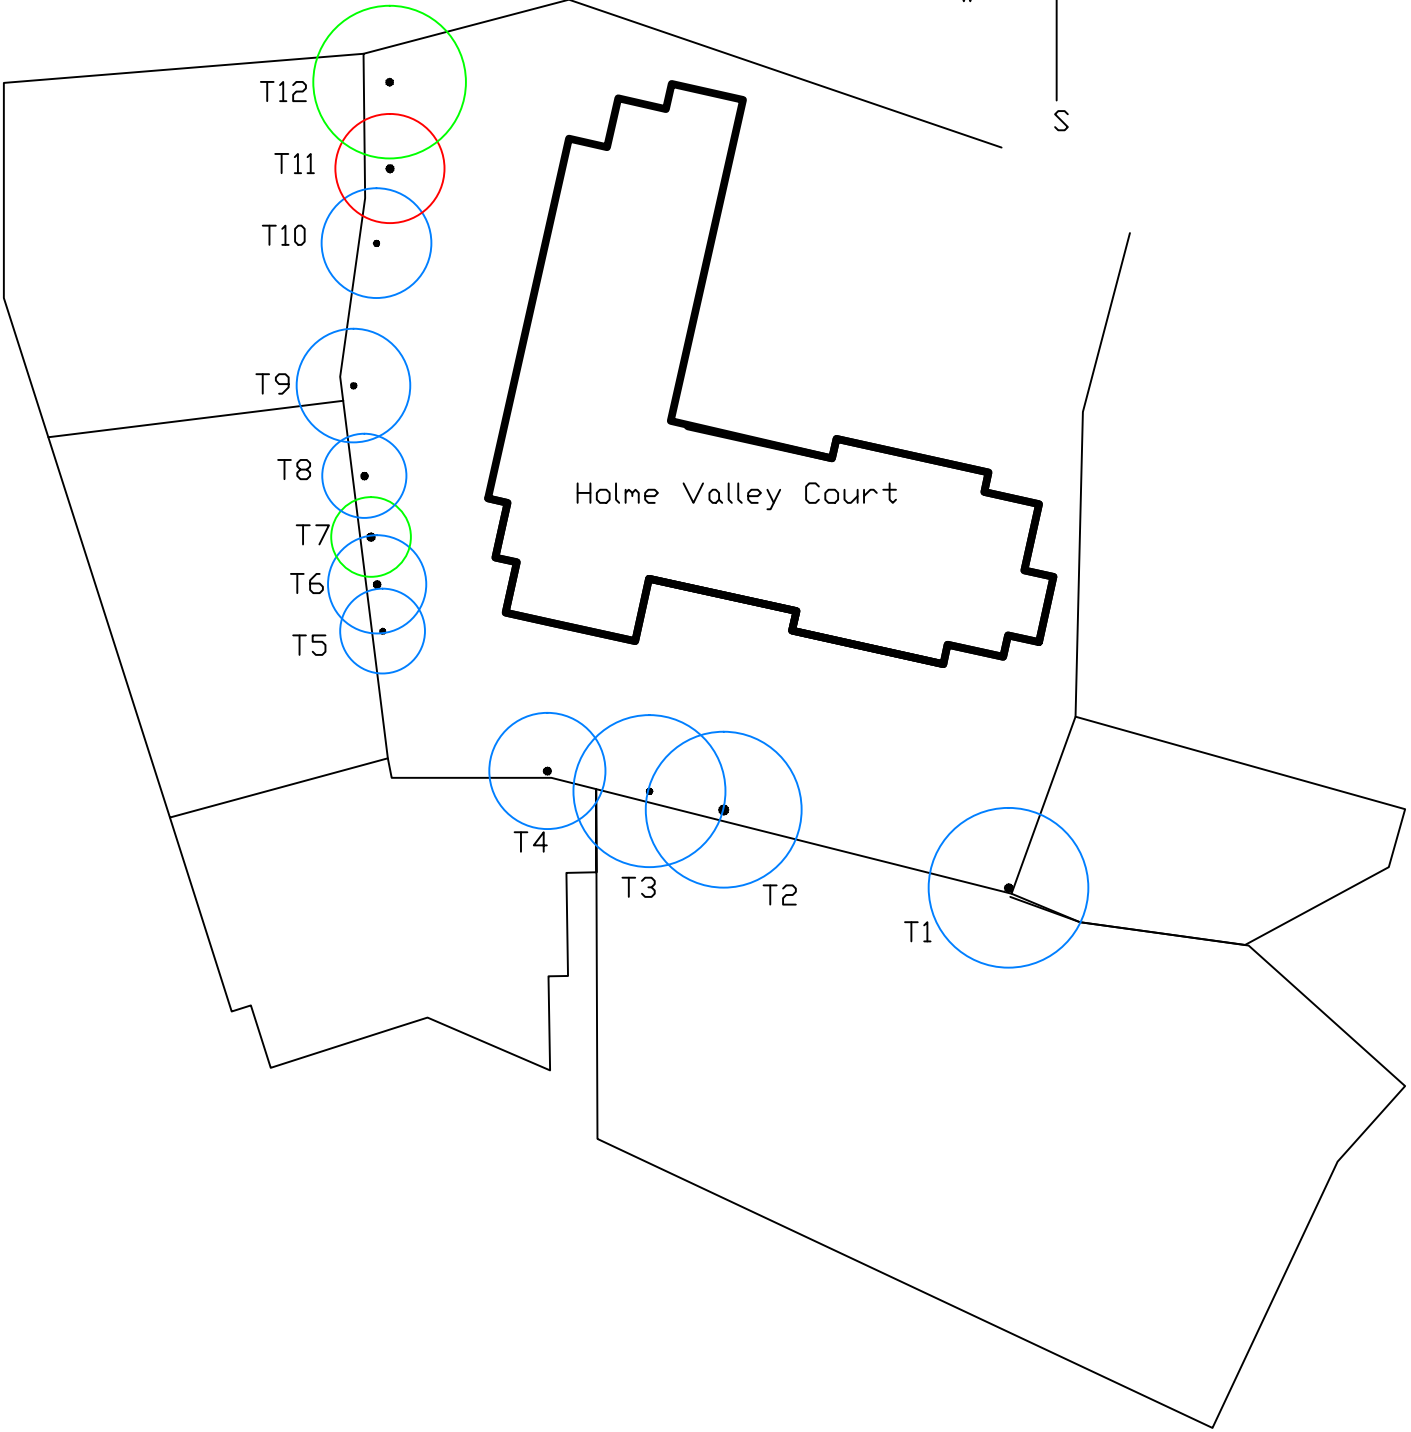
- Key
- Category A tree (No action required)
  - Category B tree (Action required)
  - Category R tree (Tree removal required)
