Our Ref: B22621-JNP-XX-XX-CO-Z-0001/JAW/cl

Date: 22 August 2019

**Re: Unit 24, Flush Mills, Heckmondwike**

Further to your instructions I made a joint inspection on the boundary wall with yourselves on the 08 August 2019. The purpose of my inspection was to assist in the discharging of condition 12, which states: -

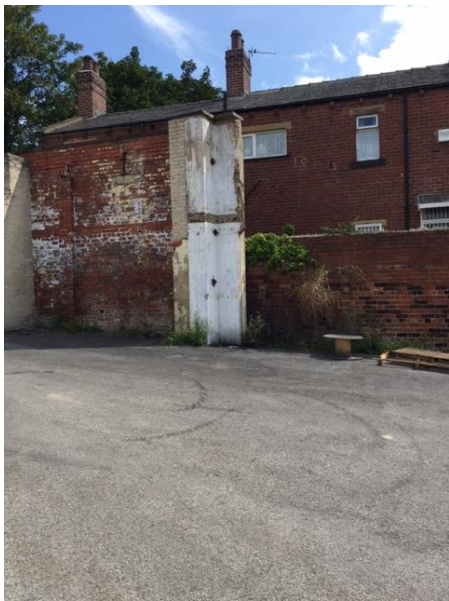
The south boundary wall has two piers which are approximately 5.7m. These piers will have to be reduced in size to allow for a fire exit route between the boundary wall and existing building. The wall is to the rear of numbers 8 and 9 Barbers Square and photographs of the wall are shown on plates 1 to 3 appended. The wall is approximately 3.55m high, where it meets the front corner of the building, see plate 4. The ground in front of the building slopes gently away towards the south and the wall is approximately 4.45m at its highest point. Having discussed the wall with the owner of No.8 Barbers Square, he would be pleased to see the wall reduced by approximately 6 brick courses to allow additional day light to the properties. He has also requested, to improve appearance, that the concrete leading edge to be removed. This is the remains of a previous building. To reducing the height of the wall the coping stones should be re fitted. The pier depths are to be reduced to approximately 500mm to allow for a fire escape route around the building.

Plate 1-External wall

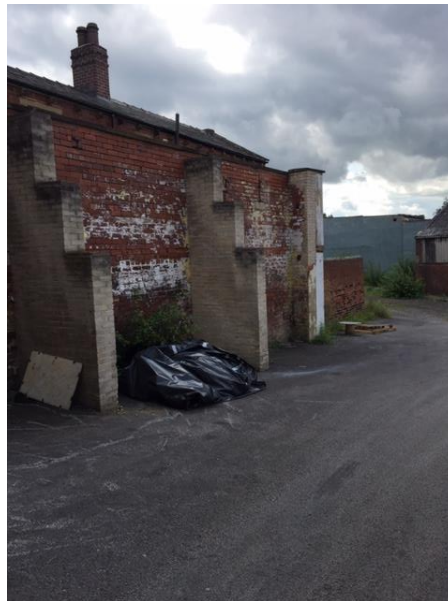
Plate 2-External wall

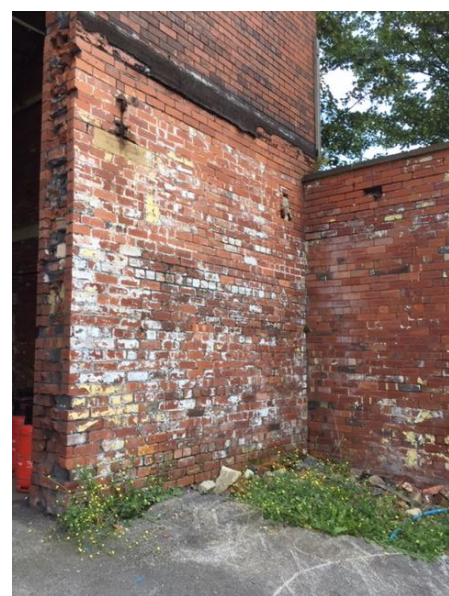
Plate 3-Front corner of the building

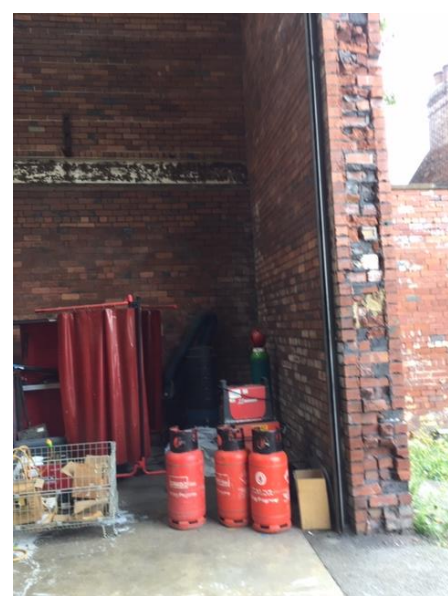
Plate 4-Front corner

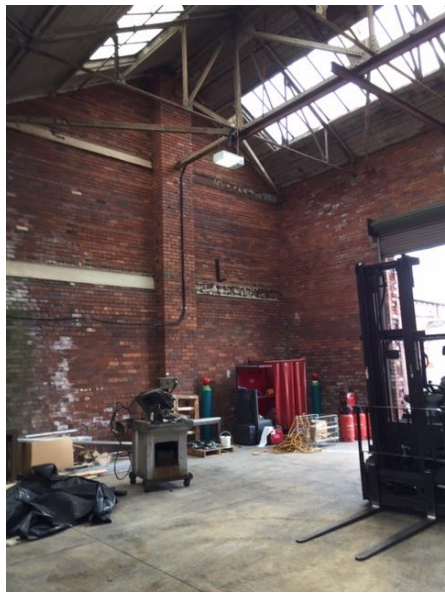
Plate 5-Internal wall towards the front

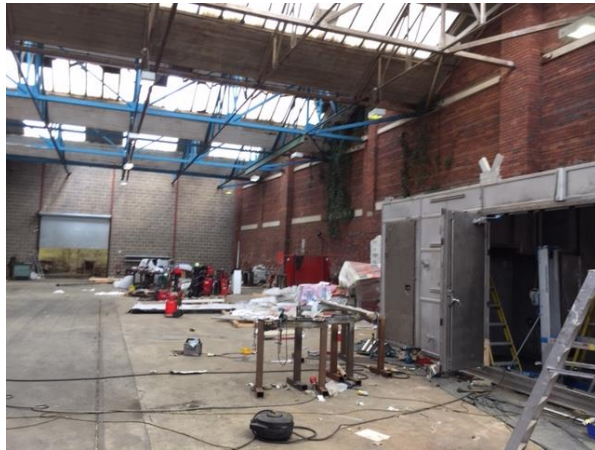
Unit 23 is split into two sections separated by a blockwork internal fire wall shown on plate 6. The southern section of this building is shown on plates 5 to 9 and the northern section is shown on plates 10 and 11. The floor slab internally is at the same along the wall.

Plate 6-Internal wall looking to the back.

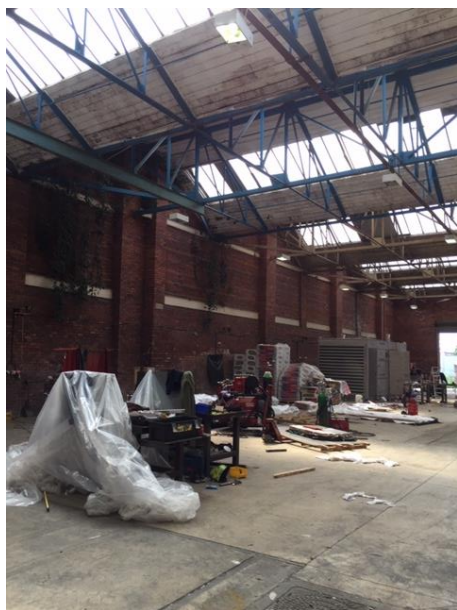
Plate 7-Internal wall looking to the front.

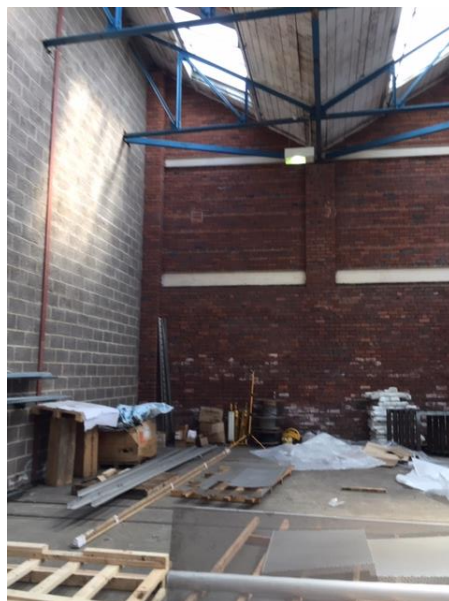
Plate 8-Wall close to blockwork partition

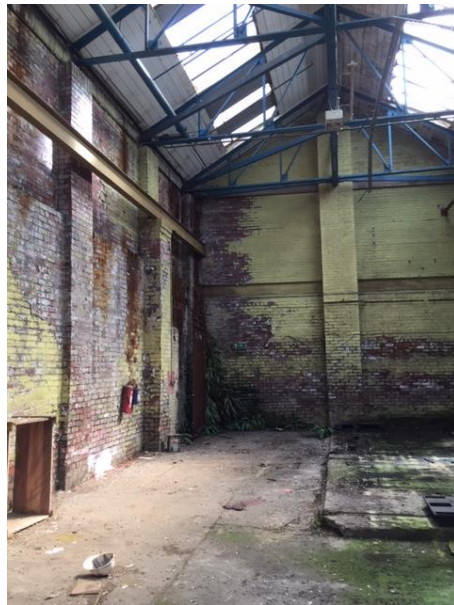
Plate 10-Rear corner

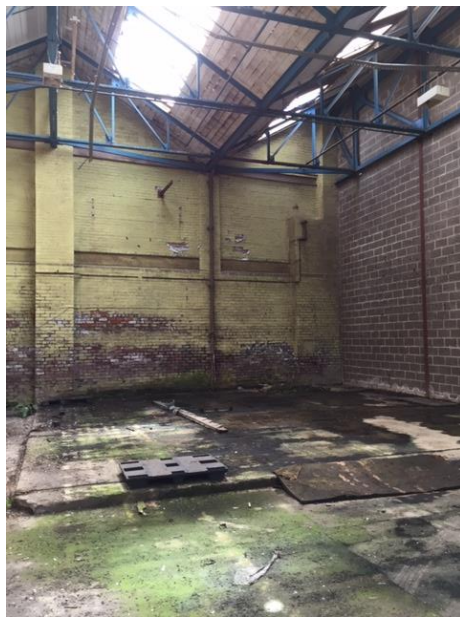
Plate 11- Wall continues to rear of blockwork separating wall

Most of the wall has a relatively clean brick finish and no treatment will be required to this part of the wall. The steel beam should be given further corrosion protection before coping stones are fitted. To the rear two bays (behind the blockwork fire wall) the yellow paint on the wall should be removed. Any areas of repointing should be identified once the brickwork is clean.
