**Project Name:** 19-06-11790 Elmtree Contracts Ltd 5 Ravensdeane  
Huddersfield  
**Project Date:** 19/06/2019  
**Project Standard:** MSCC4 Sewers & Drainage GB (SRM4 Scoring)

### CCTV survey report & recommendations

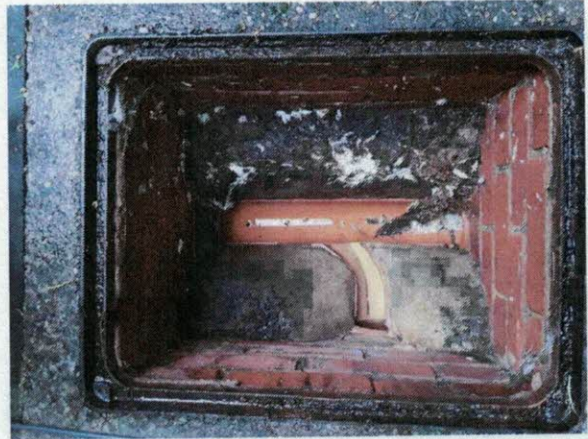
Man hole 1 with roots

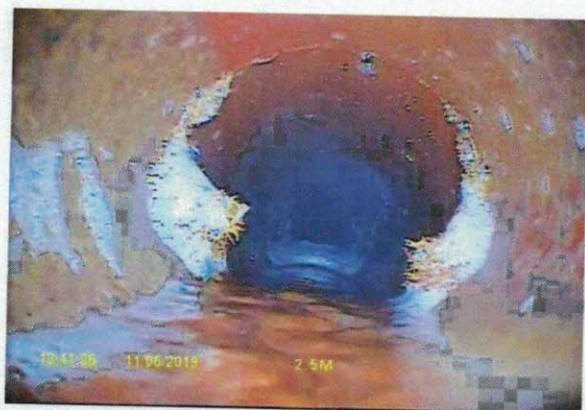
| Section | PLR | Grade | Description |
|---|---|---|---|
| 1 | MH 1X | 3 | Roots, mass at joint, 10% cross-sectional area loss |

, 00:01:19, 2.50 m  
Roots, mass at joint, 10% cross-sectional area loss

Remove roots with Warthog

Insert a 100mm x 600mm localised structural repair sleeve

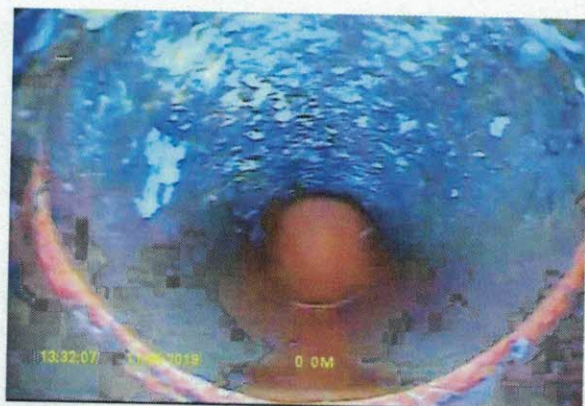
, 00:00:13, 0.01 m  
Joint displaced, medium

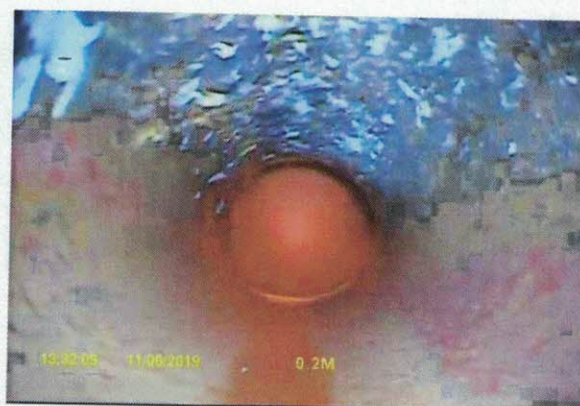
| Section | PLR | Grade | Description |
|---|---|---|---|
| 2 | SVPX | 3 | Attached deposits, fouling from 10 o'clock to 2 o'clock, 10% cross-sectional area loss |

, 00:00:14, 0.20 m  
Attached deposits, fouling from 10 o'clock to 2 o'clock, 10%  
cross-sectional area loss

Remove all attached fouling deposits from pipework with a spinning nozzle

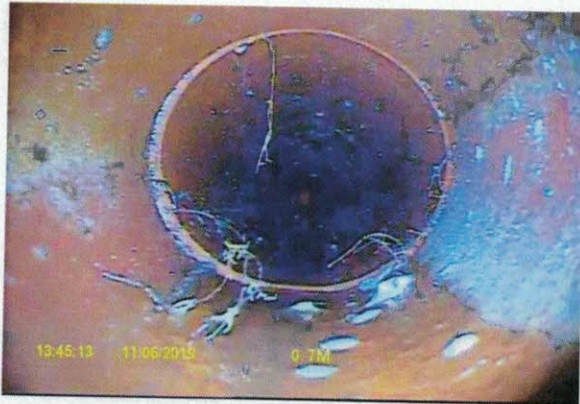
, 00:01:13, 0.70 m  
Roots, tap at joint

Remove all roots from pipework with a spinning nozzle

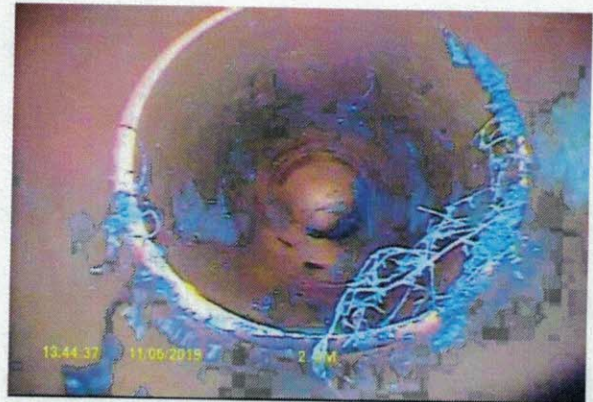
, 00:00:53, 2.40 m  
Roots, tap at joint

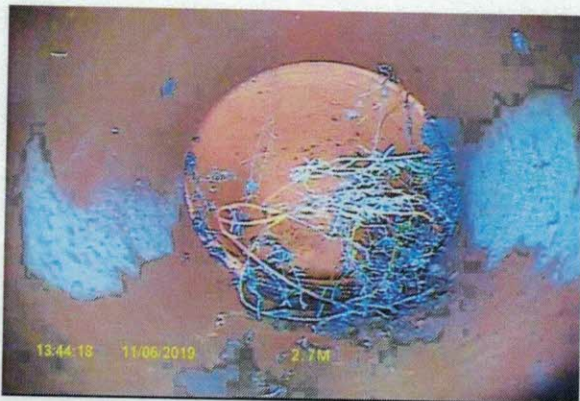
| Section | PLR | Grade | Description |
|---|---|---|---|
| 3 | RWGX | 5 | Roots, mass at joint, 40% cross-sectional area loss |

, 00:00:44, 2.70 m  
Roots, mass at joint, 40% cross-sectional area loss

Reline drain with a 3mm Polyester structural sleeve
