## **Arboricultural Safety and Condition Report**

The Old Vicarage

Date of report: 14<sup>th</sup> October 2019

Reference: OWA0142

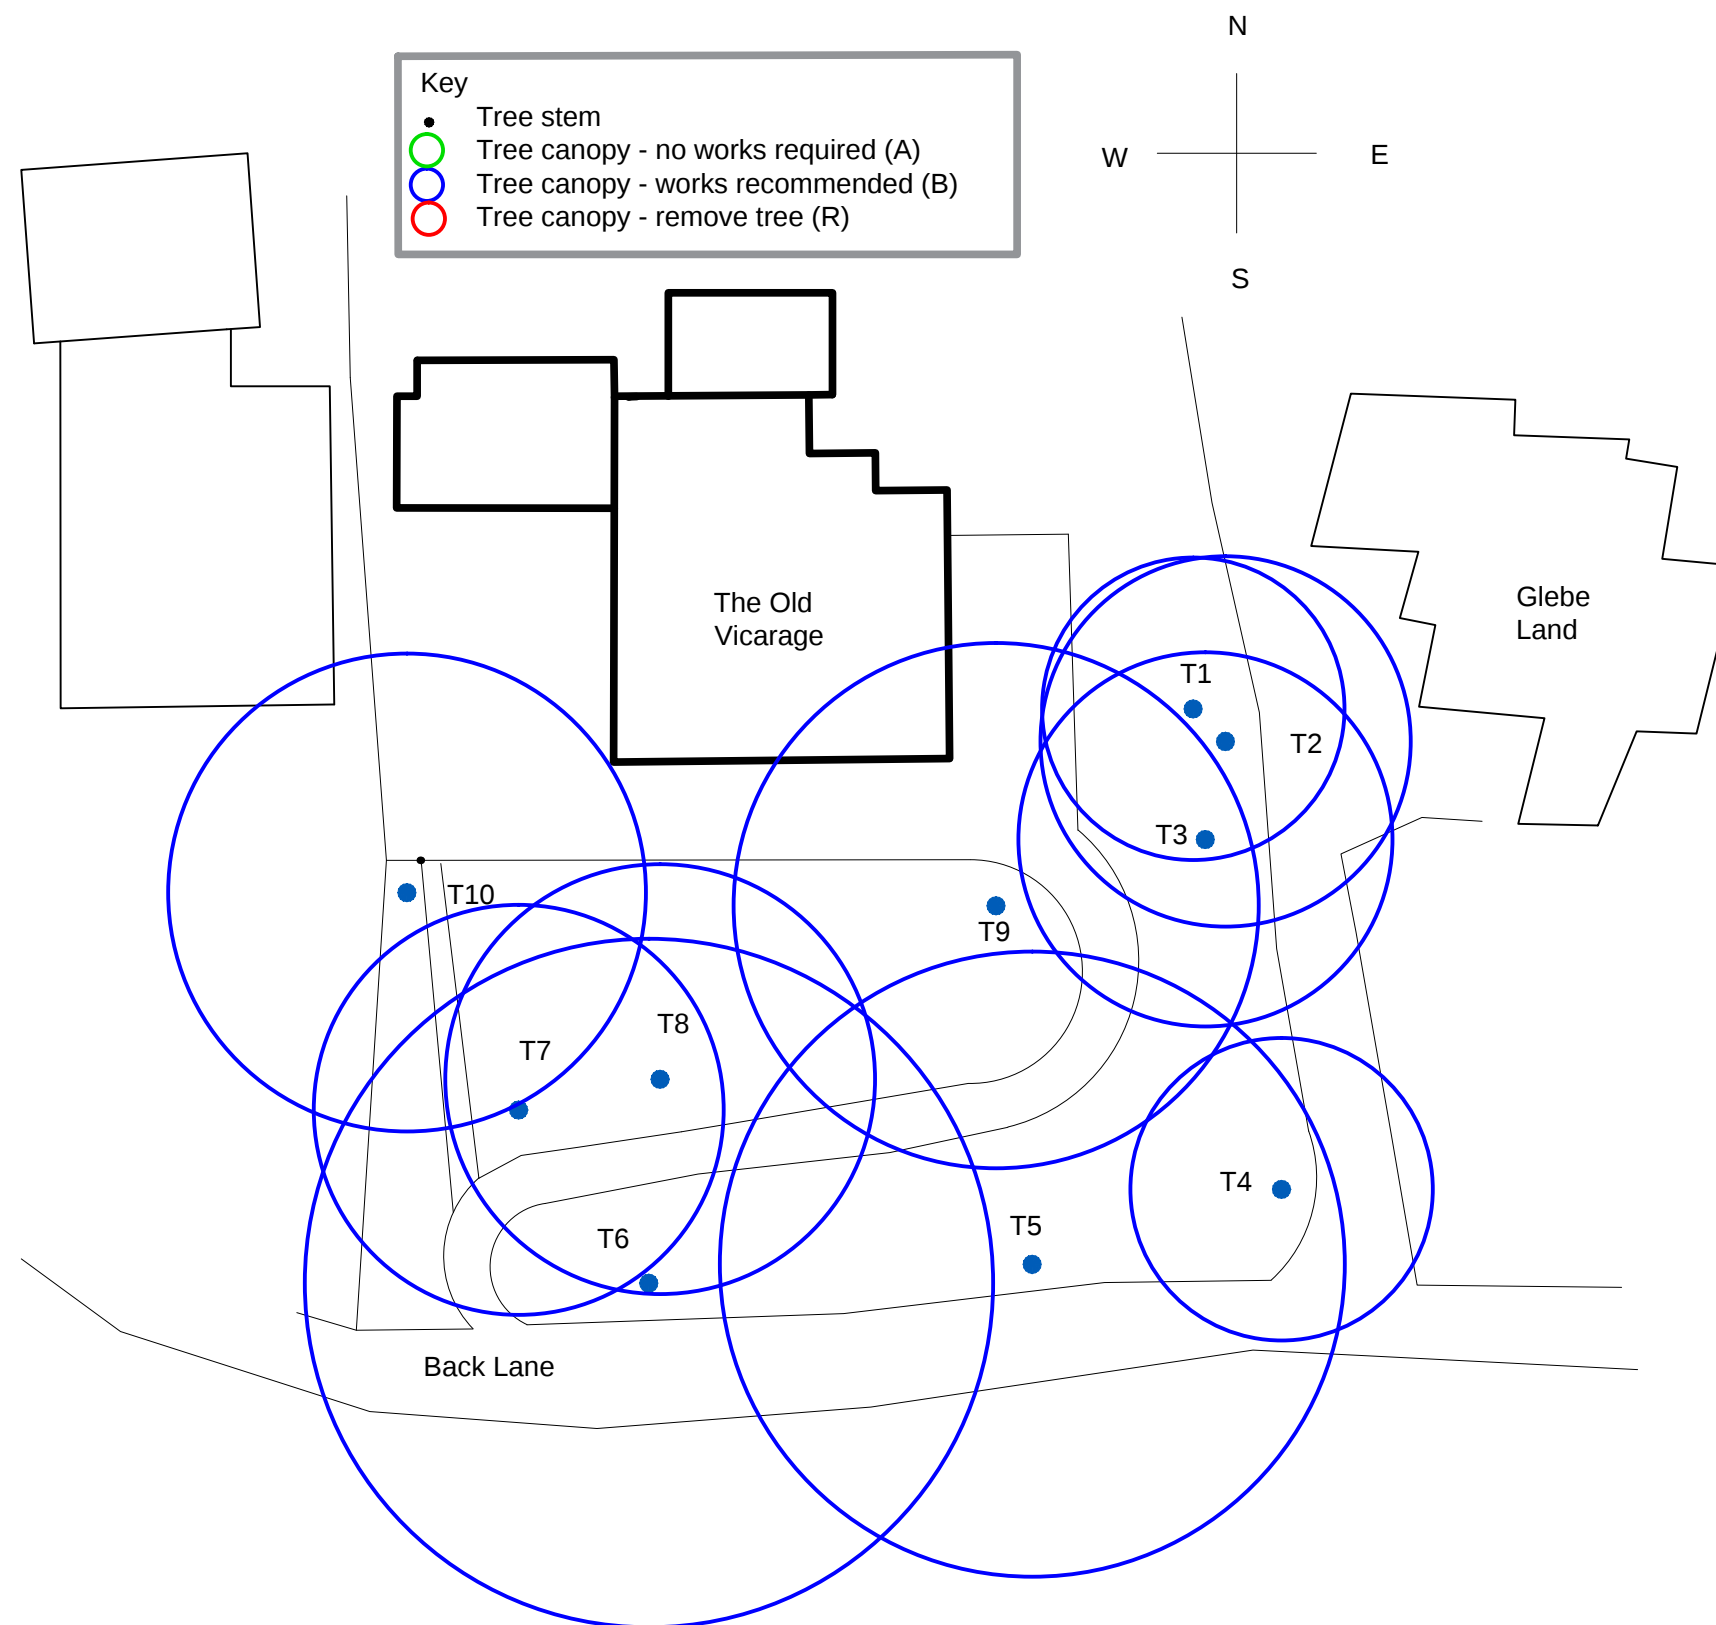
## **Appendix 1 Plan of the site**

The surveyed trees are drawn and numbered on the plan at the back of this report in **Appendix 1**. They are numbered **T1-T10**.
