# Cumberworth Lane, Denby Dale

Road Safety Audit

Stage 1

Project No: 1242

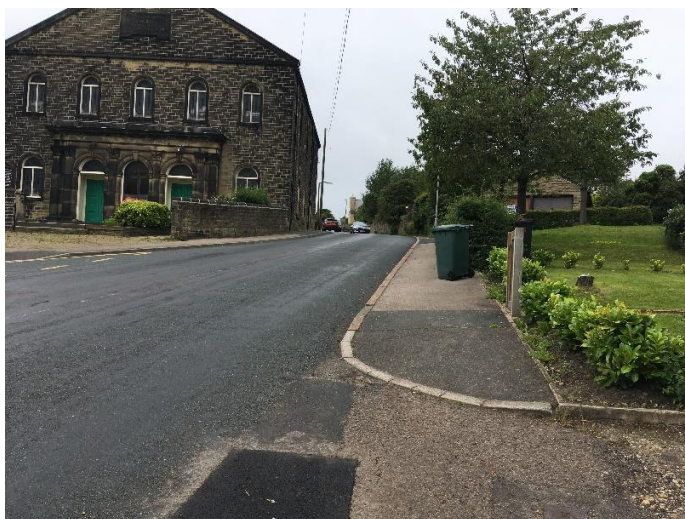
**Detail:** The proposals do not indicate what sightlines will be achieved at the new junction with Cumberworth Lane. It seems that they will be adequate however there is a bus stop and clearway on the south-east side of the new access road. Although this is existing, there will be more traffic using the access and the sightlines will be blocked when a bus is waiting.

*Photo 1 – Cumberworth Lane – looking north-west*

**Recommendation:** Ensure that adequate sightlines can be achieved and that the existing bus stop and clearway do not create a problem for vehicles exiting the new development.

**Design Team Response (1):** The proposed sight lines have been added the latest submission as shown in Appendix C.

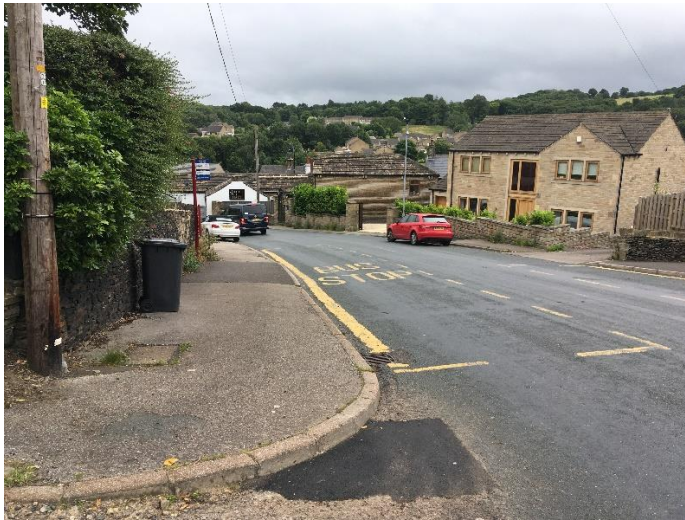
*Photo 2 – Cumberworth Lane – looking south-east*
