# TECHNICAL REPORT ON A SUBSIDENCE CLAIM

Crawford Reference: SU1804442

## SUBSIDENCE CLAIM

DATE 18<sup>th</sup> September 2018

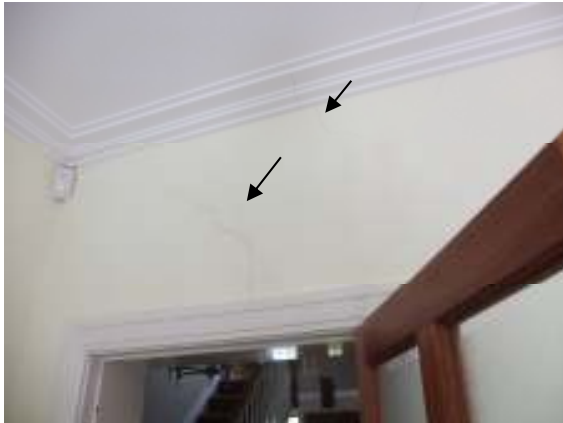
Internal crack above front right internal door to rear left lounge

Separation non-tapered cracking above the front internal door leading to the hallway in the wall and coving. Cracking less than 1mm wide.

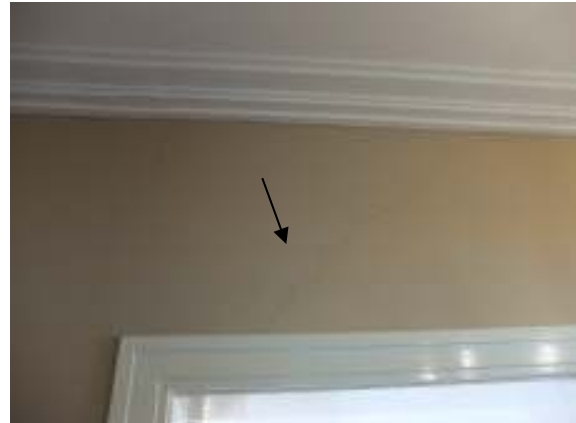
Internal crack above rear facing internal door leading to rear left lounge in front hallway

Non-tapered cracking above the rear facing doors leading to the rear left sitting room and rear right lounge. Cracks extend from left up towards the right and do not exceed 0.5mm width. The crack above the left door leading to the rear left sitting room is mirrored on both sides of the internal supporting wall.

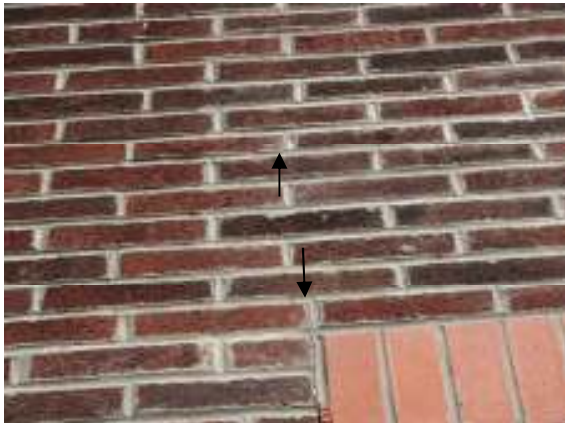
External cracking above right to rear left lounge French doors

Stepped crack rising up from the right of the door lintel extending up towards the right and then returning to extend up towards the left of the property. Cracking is slightly tapered up to 1mm wide.

The pattern and nature of cracking is indicative of thermal movement but we cannot ignore the history of the claim where movement was determined to relate to the seasonal affects to the underlying clay soils from nearby trees.

In respect of the damage affecting the rear elevation to the rear sitting room, masonry expands and contracts with changes in temperature. For example, a 12m long brick wall can expand by as much as 6mm in the first few months after construction. This is classified as irreversible movement and is due to water uptake of clay which has been kiln fired - it is a one off occurrence. In subsequent years, there can be further cyclical and reversible movement which causes minor cracks to develop.

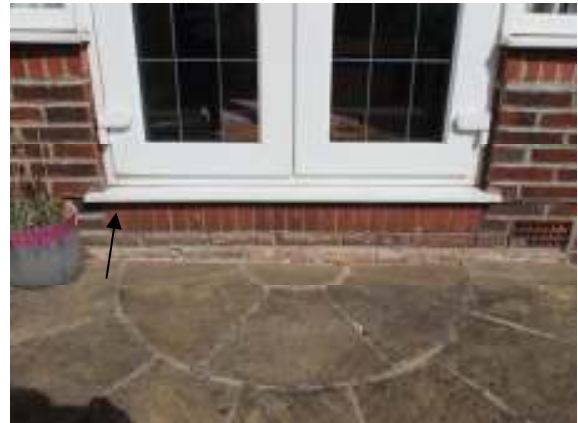
External cracking in loose bricks beneath rear left lounge French doors

Brickwork beneath the rear uPVC French door is cracked to the right hand side with cracking up to 2mm wide.

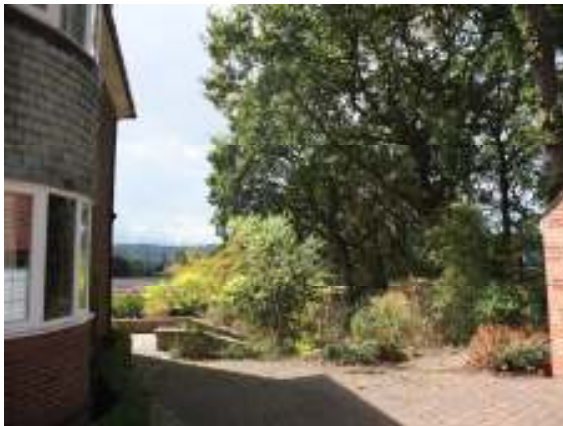
The thermal movement affecting the property to the rear is also considered to be the operating cause of the internal damage around the central hall. The seasonal movement appears to have been picked up during previous monitoring which concluded with an assumption that the damage was due to the influence of nearby trees. However we consider that the Oak trees to the rear right of the property are located at a reasonable distance and are seated at least 3m lower than the level of the property and therefore are not of influence.

Oak trees to rear right of site at lower level

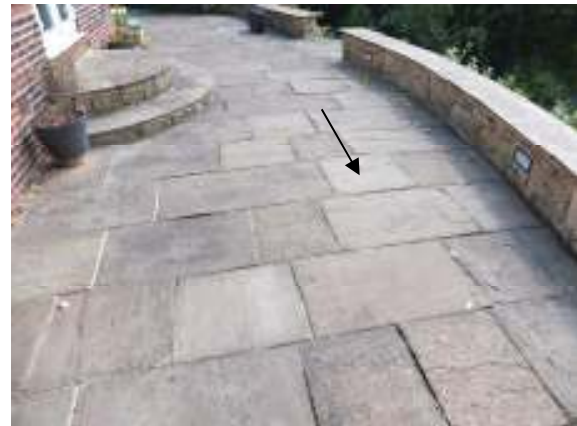
Paving stones drop from level towards the rear small retaining stone wall. Some paving stones are loose.

The movement to the rear raised patio is due to rain water percolation which has resulted in movement of the underlying ground. This is not related to the movement affecting the main property.

External movement to raised patio to rear of property due to rain water percolation

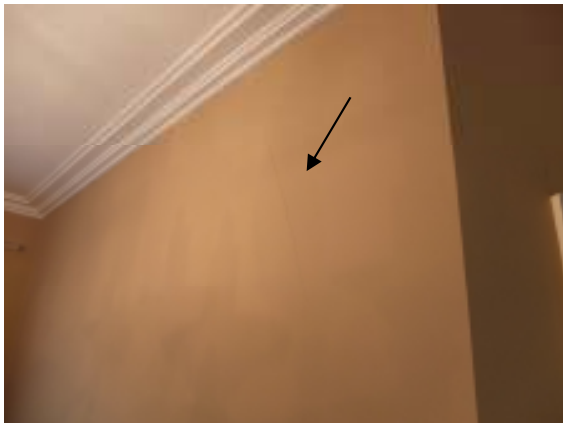
Diagonal non-tapered crack on the left facing wall shared with the front mid-section bathroom. The crack is not mirrored on both sides of the wall is less than 0.5mm wide.

Internal crack to left internal wall on front stairs shared with front bathroom

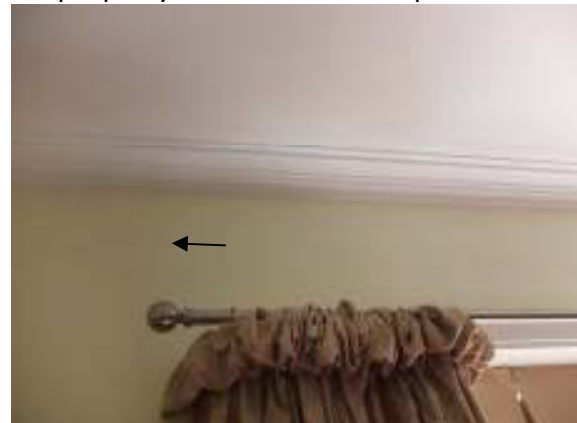
Non-tapered cracking above the right and left to the rear uPVC French doors, along the rear coving and into the ceiling. Cracking less than 0.5mm wide.

Internal cracking above left to rear left lounge French doors

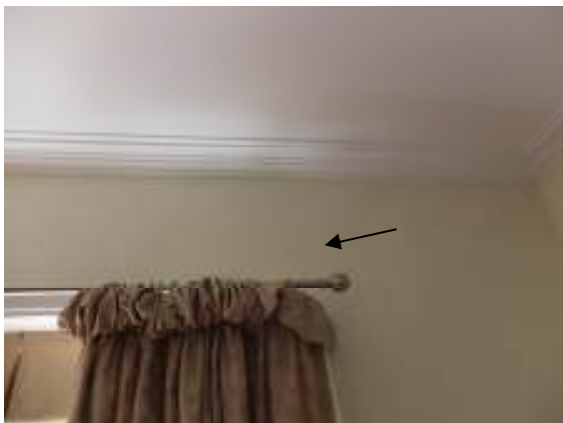
Internal cracking above right to rear left lounge French doors

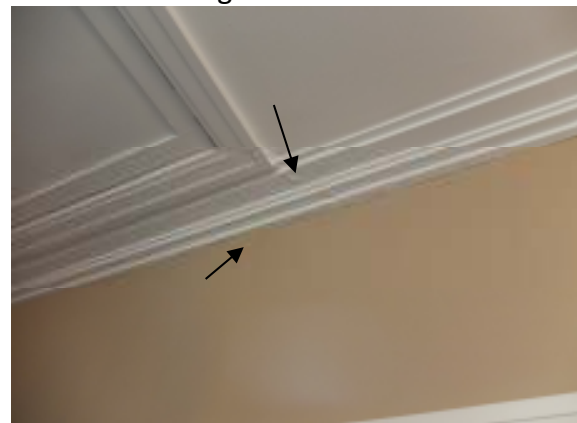
Above the internal door leading to the rear left bedroom there is a further non-tapered crack extending upwards into the coving and timber loft hatch. Crack is less than 0.5mm wide.

Internal cracking to wall and coving adjacent to loft hatch adjacent to internal door leading to rear left bedroom

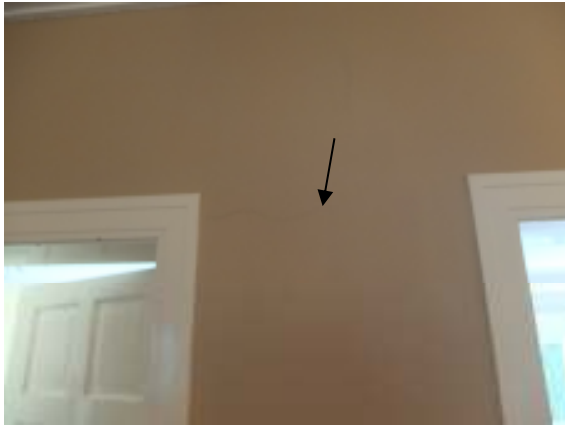
Horizontal non-tapered crack between the door heads to the rear left and rear right bedrooms with the crack less than 0.5mm wide. The plaster has de-bonded causing a small section to protrude slightly away from the vertical face of the internal wall.

Internal horizontal crack between rear left  
and right bedrooms
