# Arboricultural Appraisal Report

## Subsidence Damage Investigation at:

Eldon House, 201 Penistone Road  
Kirkburton  
Huddersfield  
HD8 0PE

| MWA REF: | SUB191031-6030 |

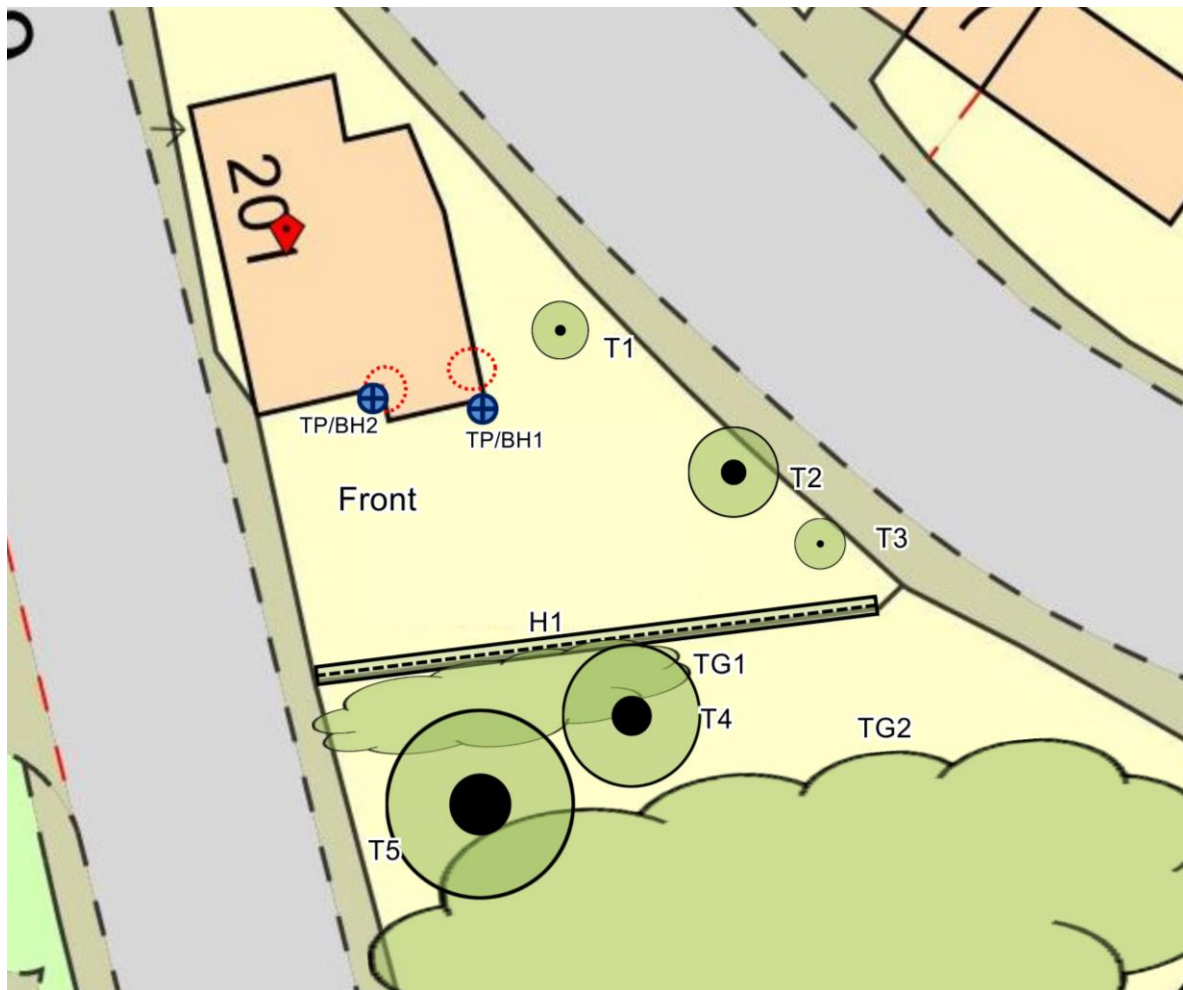
## Site Plan

Approximate areas of damage

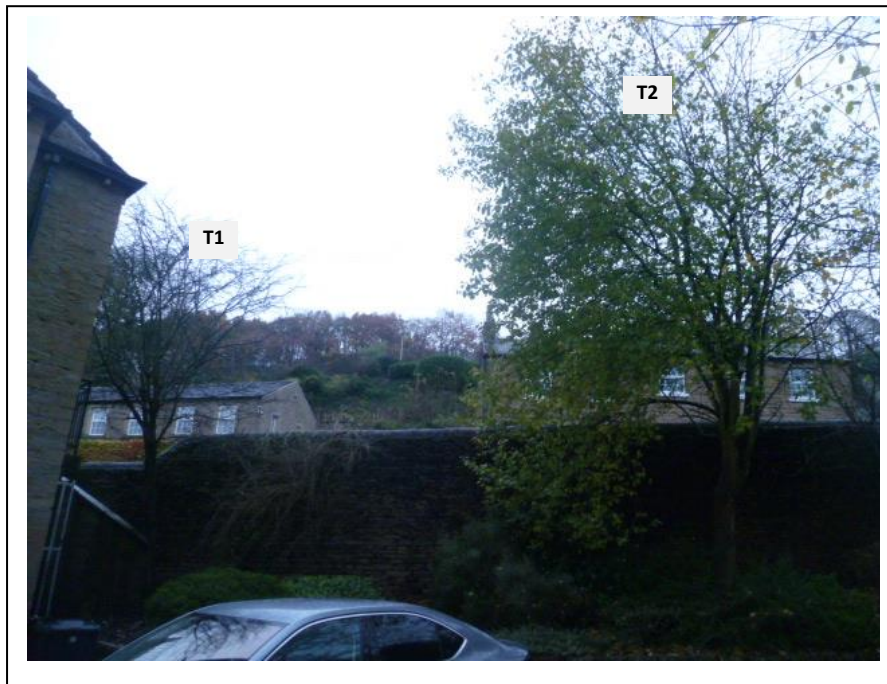
Based on the technical reports currently available, engineering opinion and our own site assessment we conclude the damage is consistent with shrinkage of the clay subsoil related to moisture abstraction by vegetation. Having considered the information currently available, it is our opinion that T1, T2, T4, and TG1 are the principal cause of or are materially contributing to the current subsidence damage. Tree T5 may also be involved although there is no evidence of this.

| Tree No. | Species | Ht (m) | Dia (mm) | Crown Spread (m) | Dist. to building (m) | Age Classification | Ownership |
|---|---|---|---|---|---|---|---|
| T1 | Hawthorn | 5 | 120 Ms | 3 | 2.5 | Younger than Property | Policy Holder |
| T2 | Willow (Goat) | 7 | 300 Ms | 5 | 8 | Younger than Property | Policy Holder |

View of T1 and T2

If an arboricultural solution is to be implemented to mitigate the influence of the implicated trees/vegetation we recommend that T1, T2, T4, and TG1 are removed. Other vegetation recorded presents a potential future risk to building stability and management is therefore recommended.

| Tree No. | Species | Ht (m) | Dia (mm) | Crown Spread (m) | Dist. to building (m) | Age Classification | Ownership |
|---|---|---|---|---|---|---|---|
| Recommendation | | Remove (fell) to near ground level and treat stump to inhibit regrowth. | | | | | |

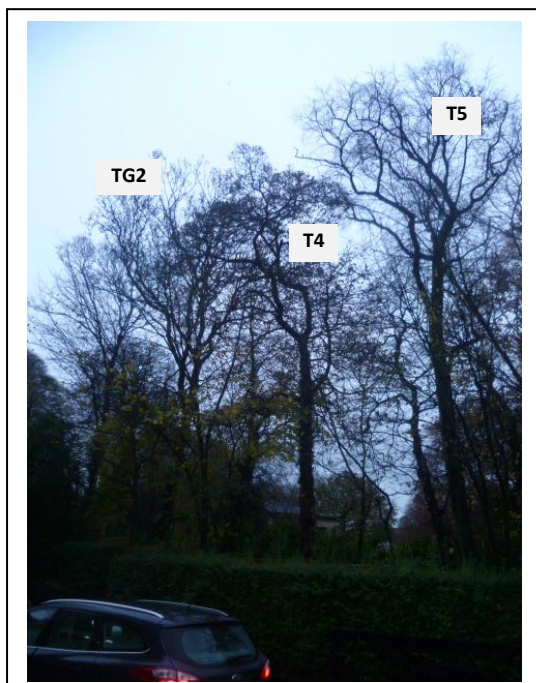
Roots were observed to a depth of 1,500mm bgl in TP/BH2 and recovered samples have been positively identified (using anatomical analysis) as *Acer* (Maple), the origin of which will be T4 and/or TG1 (Sycamores) confirming their influence on the soils below the foundations. Irrespective of the identification of recovered root samples, the roots of T1, T2, T5 and Elms in TG1 may also be present below foundation level in proximity to the area of movement/damage and influencing soil moisture and volumes.

| Tree No. | Species | Ht (m) | Dia (mm) | Crown Spread (m) | Dist. to building (m) | Age Classification | Ownership |
|---|---|---|---|---|---|---|---|
| T4 | Sycamore | 17 * | 550 * | 10 | 16 | Younger than Property | Third Party<br>Kirkburton Hall<br>HD8 OPE |

| Tree No. | Species | Ht (m) | Dia (mm) | Crown Spread (m) | Dist. to building (m) | Age Classification | Ownership |
|---|---|---|---|---|---|---|---|
| T5 | Lime | 24 * | 750 * | 18 | 18 | Younger than Property | Third Party Kirkburton Hall HD8 OPE |
| TG2 | Mixed species group Lime. Sycamore. | 20 * | 650 * | 15 * | 19 | Younger than Property | Third Party Kirkburton Hall HD8 OPE |

View of T4, T5, TG2

| Tree No. | Species | Ht (m) | Dia (mm) | Crown Spread (m) | Dist. to building (m) | Age Classification | Ownership |
|---|---|---|---|---|---|---|---|
| Recommendation | | Remove (fell) to near ground level. Owner to physically remove any regrowth (no chemical treatment due to translocation risk). | | | | | |

| Tree No. | Species | Ht (m) | Dia (mm) | Crown Spread (m) | Dist. to building (m) | Age Classification | Ownership |
|---|---|---|---|---|---|---|---|
| Recommendation | | None at present | | | | | |
| Recommendation | | No works at present. | | | | | |

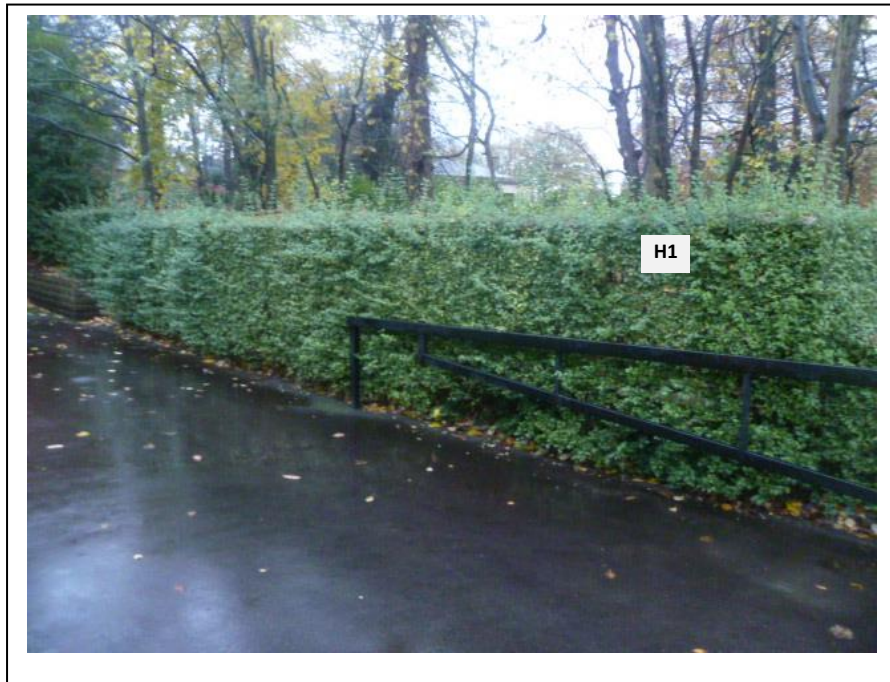
| Tree No. | Species | Ht (m) | Dia (mm) | Crown Spread (m) | Dist. to building (m) | Age Classification | Ownership |
|---|---|---|---|---|---|---|---|
| H1 | Privet | 1.8 | 10 | 1 | 8 | Younger than Property | Policy Holder |

View of H1

| Tree No. | Species | Ht (m) | Dia (mm) | Crown Spread (m) | Dist. to building (m) | Age Classification | Ownership |
|---|---|---|---|---|---|---|---|
| Recommendation | | Maintain broadly at no more than current dimensions by periodic pruning. | | | | | |

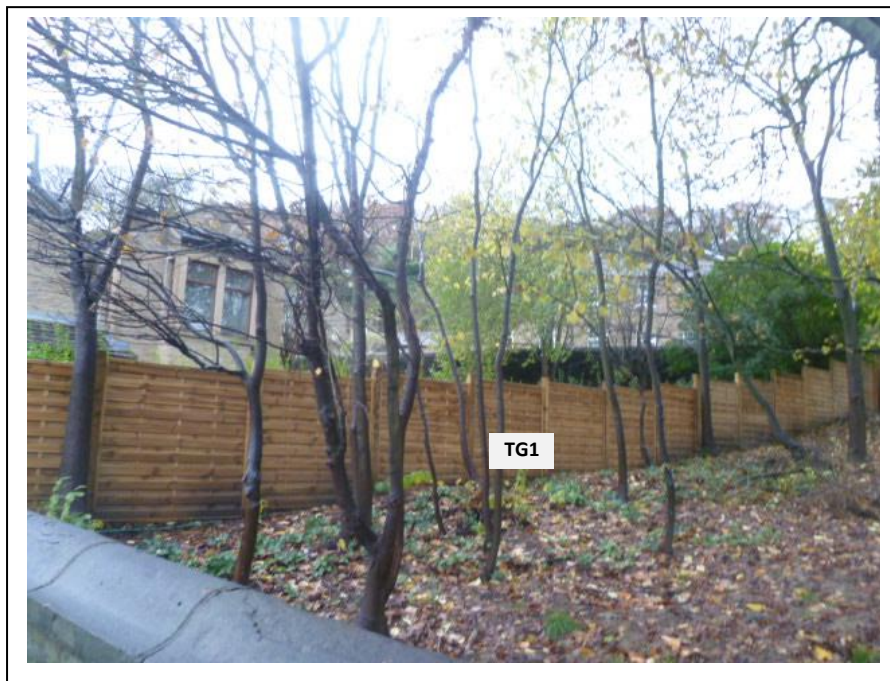
| Tree No. | Species | Ht (m) | Dia (mm) | Crown Spread (m) | Dist. to building (m) | Age Classification | Ownership |
|---|---|---|---|---|---|---|---|
| TG1 | Mixed species group. Elm, Sycamore. | 7 * | 180 Ms * | 5 | 9 | Younger than Property | Third Party<br>Kirkburton Hall<br>HD8 OPE |

View of TG1

| Tree No. | Species | Ht (m) | Dia (mm) | Crown Spread (m) | Dist. to building (m) | Age Classification | Ownership |
|---|---|---|---|---|---|---|---|
| Recommendation | | Remove (fell) to near ground level - approximately 14 stems. Owner to physically remove any regrowth (no chemical treatment due to translocation risk). | | | | | |
