# **MARSH DESIGN LIMITED**

19<sup>th</sup> December 2019  
Our Ref: MDL – 3248

## **Structural Condition Report for Structural Movement 3, Two Gates, Slaithwaite, Huddersfield**

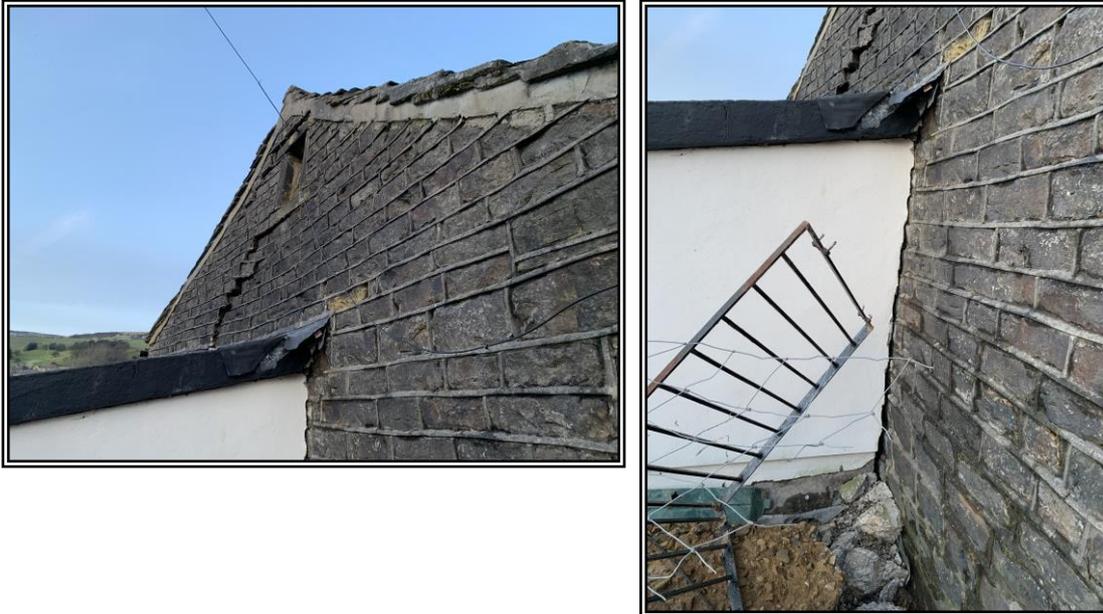
The upper section of the gable elevation was bulging inward with significant cracking also in evidence to this wall.

The extent of this recent structural movement is such that the gable elevation is beyond serviceable repair. Carefully demolition of this wall will be required in a safe manner to prevent collapse of the wall which would severely impair the structural integrity of the remaining walls of property.

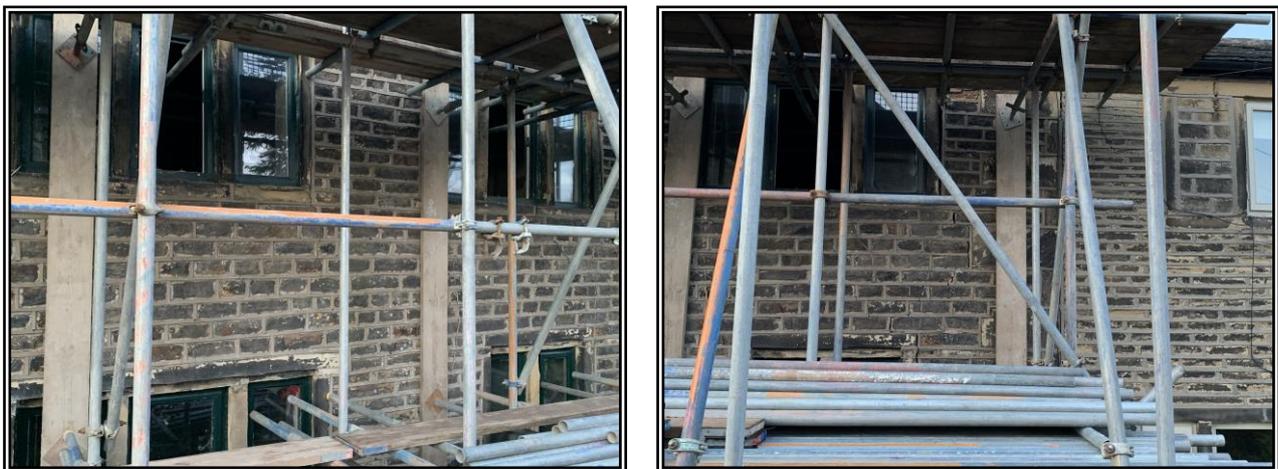
Recent structural movement in the form of cracking and bulging was also noted to the front elevation of the property.

The nature of the vertical cracking suggests that the property has suffered some recent subsidence, and internal inspection confirms that there are no significant foundations to this wall.

Sadly, we can only recommend that the front elevation of the property is carefully demolished and rebuilt off a new more substantial strip foundation.

When removed, all stonework coursings, lintels, mullions and slates, must be numbered and stored safely on pallets, for reinstallation in their original locations when the wall is rebuilt. A lime base mortar should also be used when rebuilding the wall.

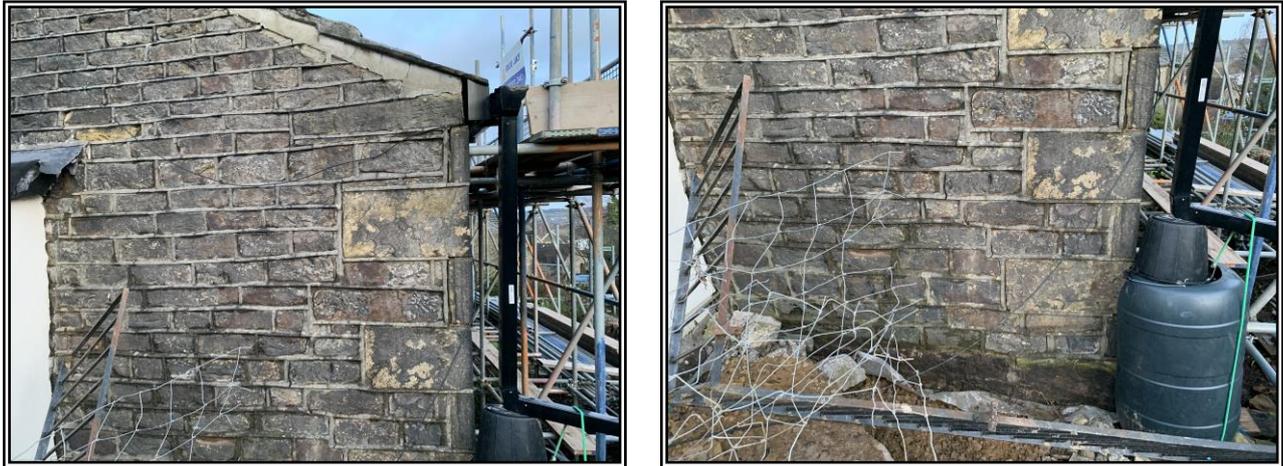
Vertical cracking around the corner quoin stones on the gable elevation also suggests that the front elevation is pulling away from the gable, confirming lateral movement has also occurred. The structural scaffold which has been installed has been effective in arresting any further lateral movement of the wall.

The nature of this sudden recent structural movement is a concern and major structural repairs will be necessary. Traditionally one would suggest underpinning to stabilise the wall against further structural subsidence, however in this instance we cannot recommend this as a course of remedial action.
