## David Watts Associates Ltd

17<sup>th</sup> June 2020

### **Bat Roost Assessment at 1 Sandbeds, Huddersfield, West Yorkshire, HD9 6RD**

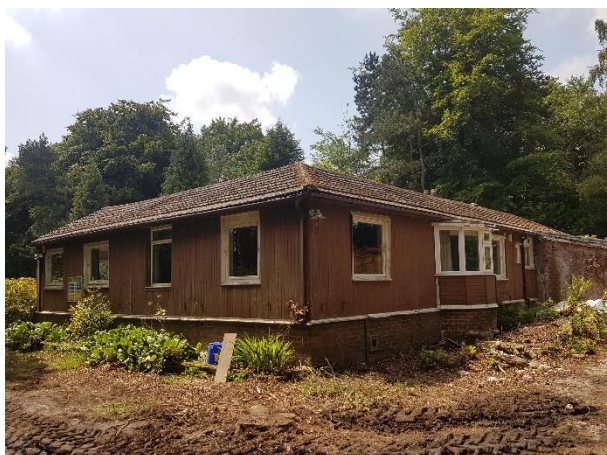
Bungalow, east aspect

Externally, two layers of chicken wire had been placed along the length of the soffit boards and attached to the fascia with nails. The layering of wire significantly prevents any access or egress for bats. Only two small voids ( 4 x 3 cm) in the wire were present on the east-facing aspect of the building, although the gaps were heavily cobwebbed.

No evidence of bat droppings was identified below two voids on the east-facing aspect of the bungalow or throughout the remainder of the building.

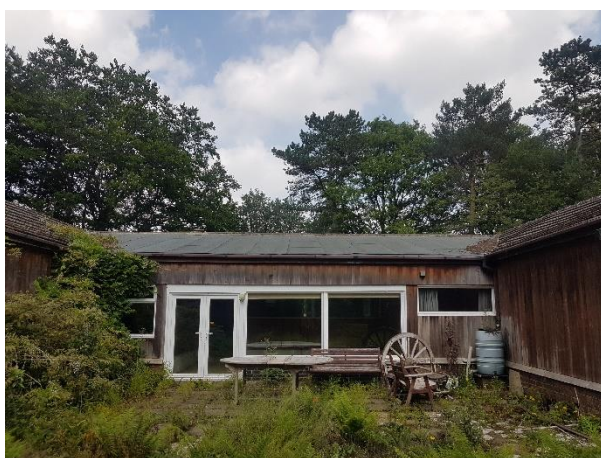
Bungalow, south aspect

Previous surveys completed by JCA identified a small number of missing roof tiles, however, at the time of this more recent assessment, there was significant accumulation of moss throughout the roof tiles, which concealed any previously noted potential gaps. The southern aspect of the roof was covered with roofing felt which was securely fixed to the roof with no obvious gaps.

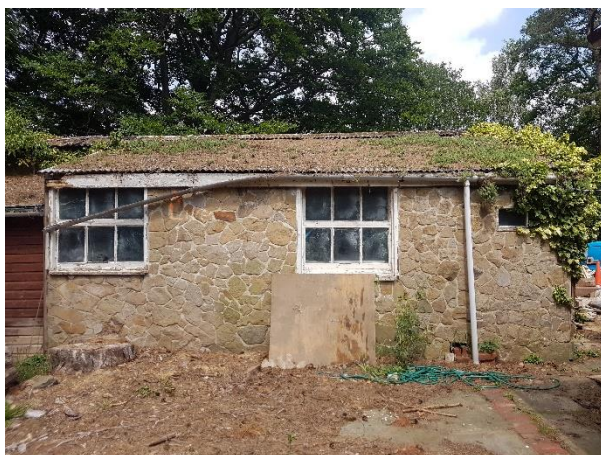
Garage

The garage was built from a combination of bricks, wood and corrugated asbestos, with the overhangs of the roof being concealed with vegetation and cobwebs. There was no evidence of bat droppings internally or externally of the garage.
