**ARBORICULTURAL REPORT
to BS 5837:2012
at
Grove Street
Longwood
Huddersfield
West Yorkshire
HD3 4TS**

Client:
CLO Design Architectural

JCA Ref:
13331/AJB

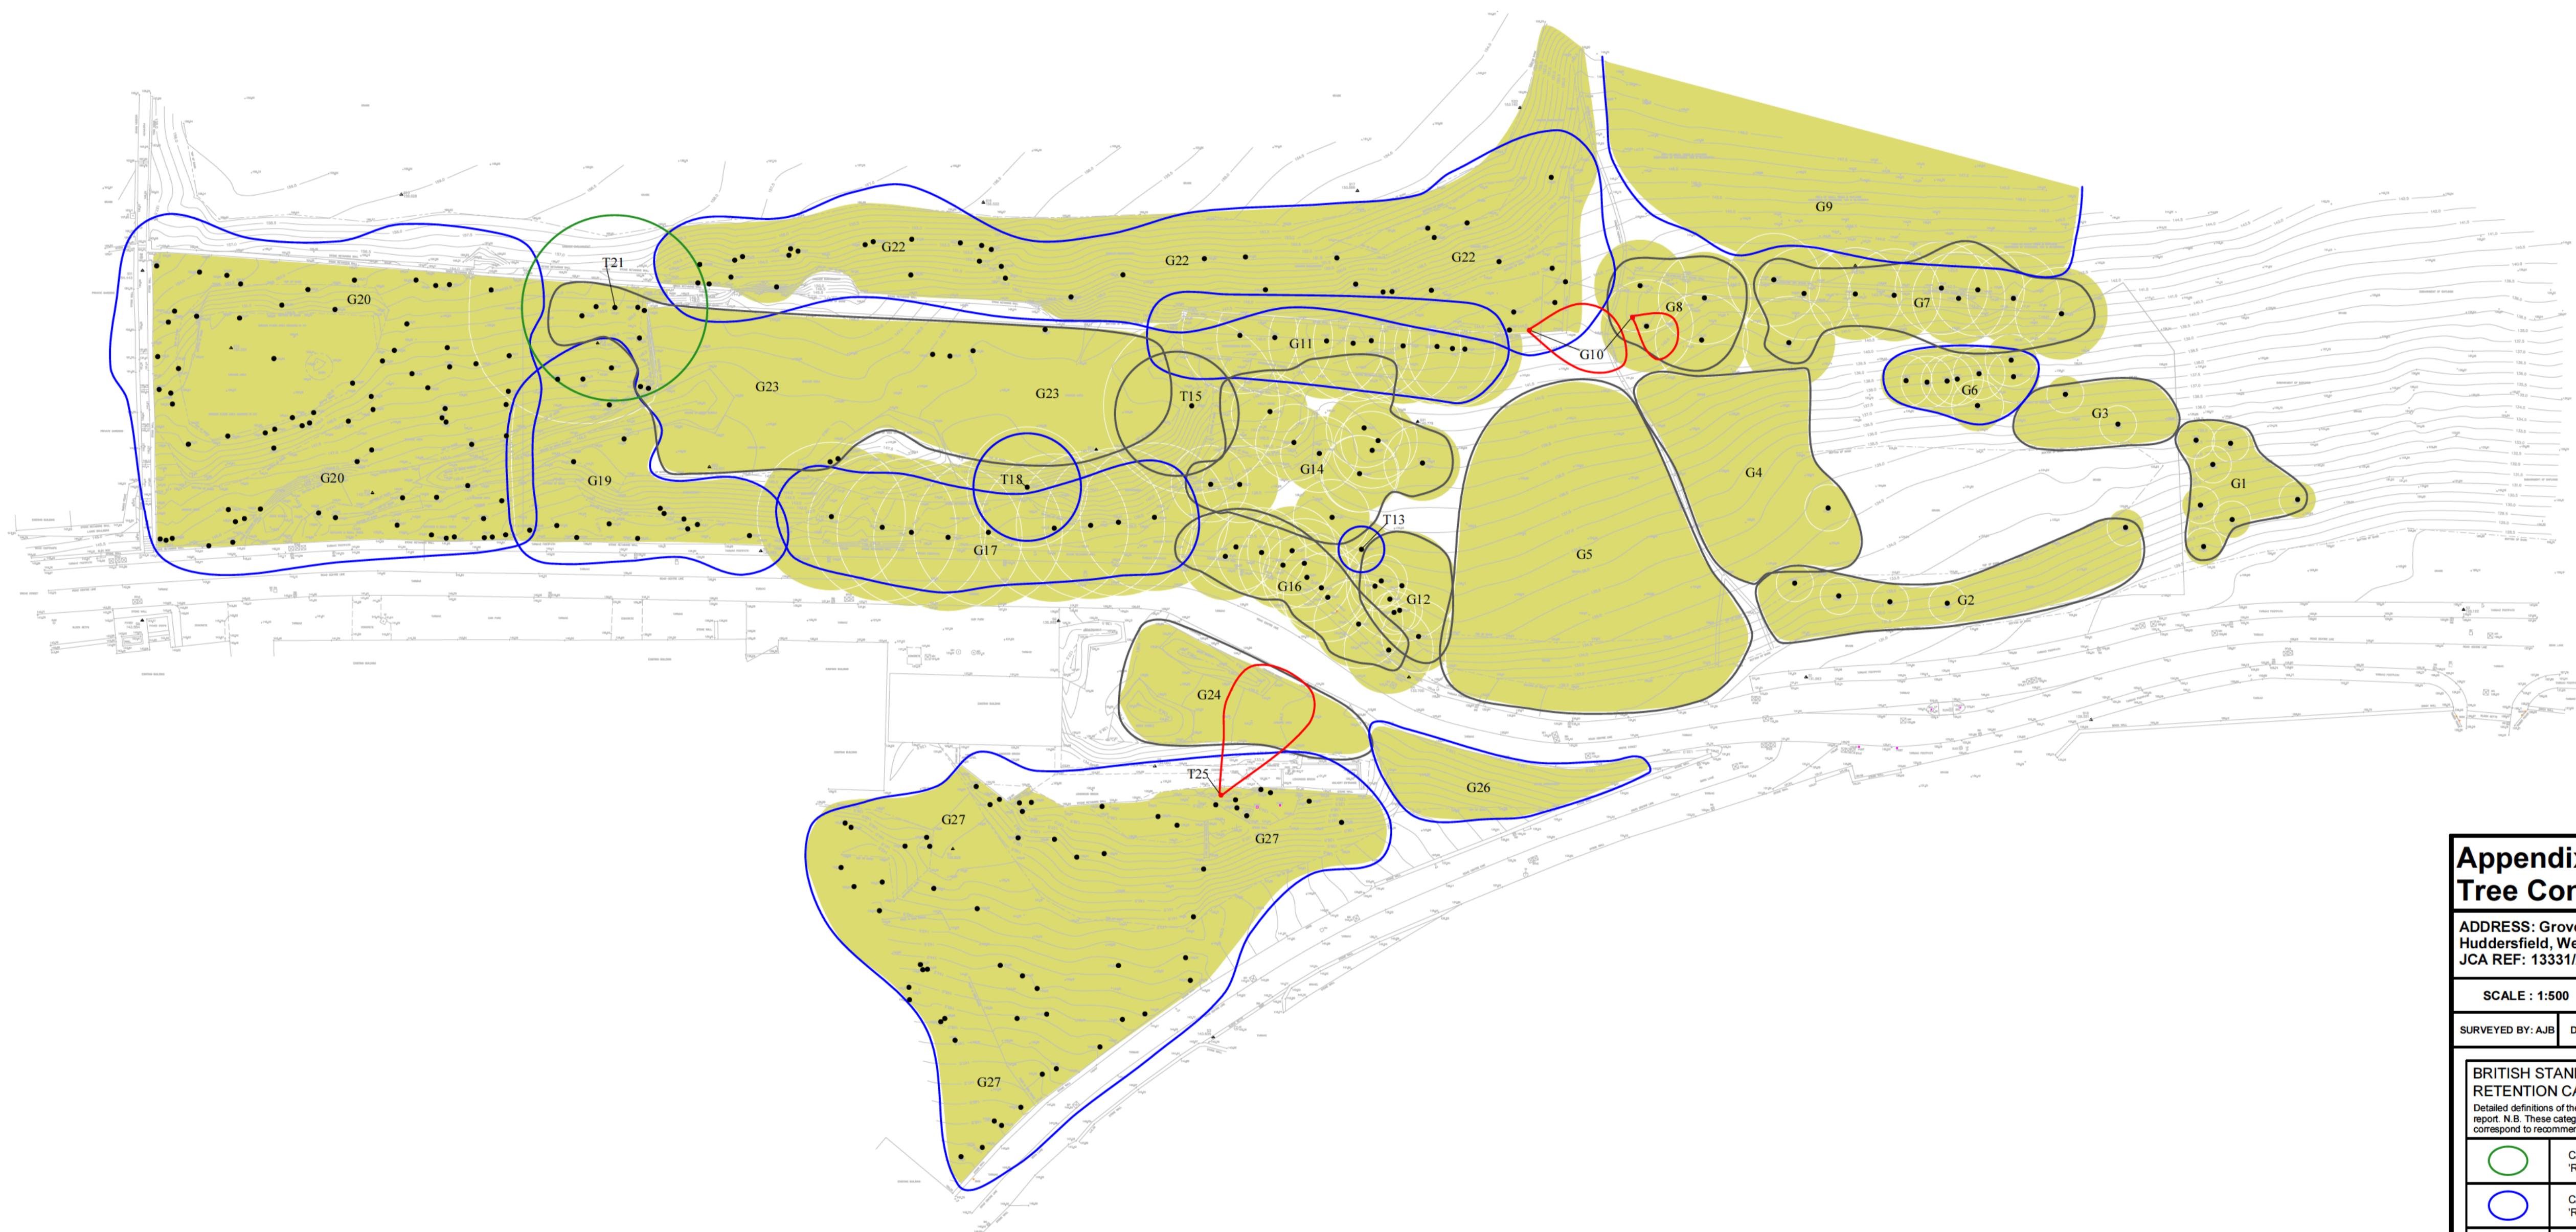
Appendix 6: Tree Constraints Plan

- 5.2.1 **G10** and **T25** were identified as retention category 'U' and require removal as a matter of **low priority** due to the defects detailed at **Appendix 1**.

- 5.4.1 **G12, G14, T15, G16** and **G18** were noted to have structural or physiological defects, as detailed at **Appendix 1**. Although these trees were considered to be in an acceptable condition at the time of the inspection, the defects observed may lead to their early demise or render them unsafe in the future. As such, it is recommended that these trees be monitored (re-inspected and assessed) on a biennial basis to assess if their condition is still acceptable.
