## **STRUCTURAL INSPECTION REPORT**

**REF: MDL – 3584**

Abinger Farm  
Scholes Moor Road  
Scholes  
Huddersfield

We have been instructed to undertake an appraisal of the structural condition of the existing cottage and barn buildings with a view to its future conversion into a habitable dwelling.

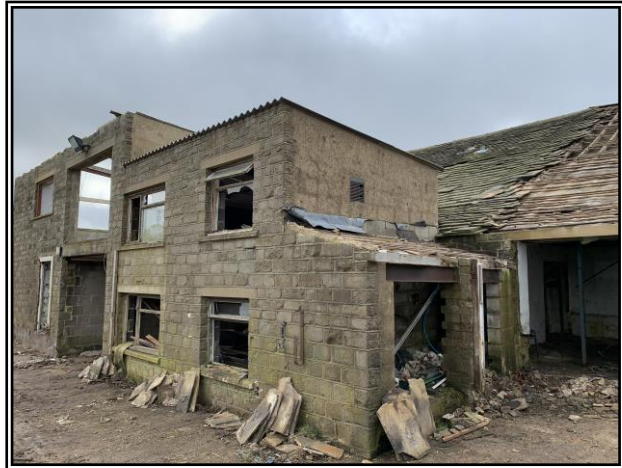
**Photo 1:**  
Front North Elevation.  
Extensions and outbuildings,  
to be demolished.

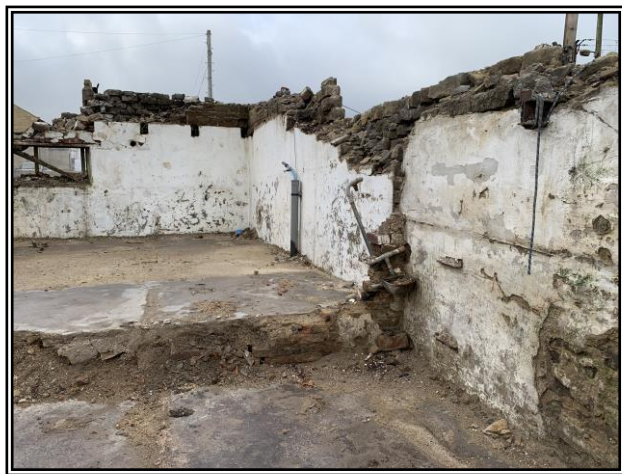
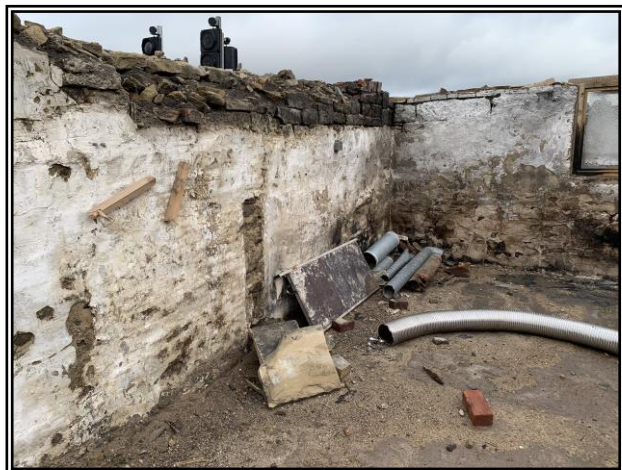
In early 2020, following a lightning strike to the end gable elevation to the West end of the property, the wall became unstable in parts. Due to the proximity of this wall to the adjacent highway it was advised that the wall should be carefully demolished to a safe level to allow rebuilding.

**Photo 5:**  
West gable elevation to barn  
carefully demolished following  
lightning strike.

**Photo 6:**  
West gable elevation to barn  
carefully demolished following  
lightning strike.

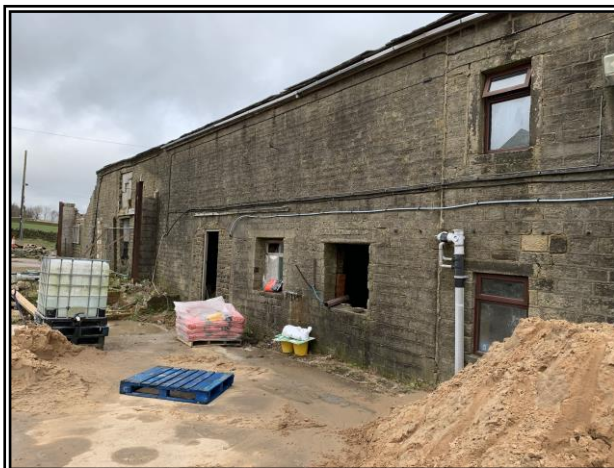
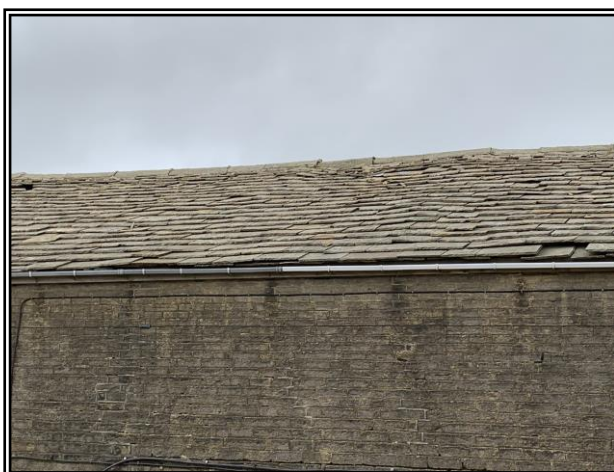
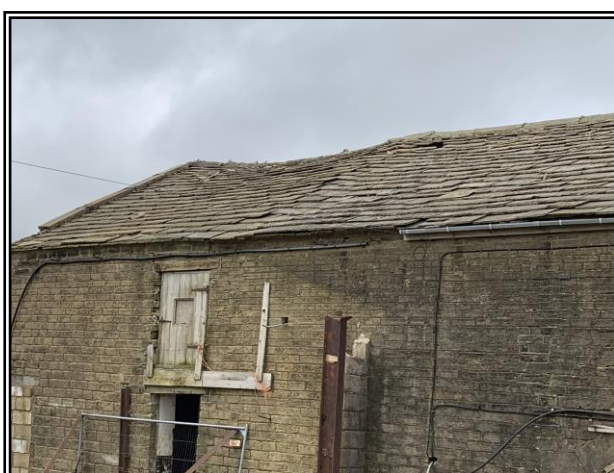
Defects were noted to the roof structure. There was unevenness to the ridge coping stones and there was localised sagging of the stone slate roof covering. This is due to deterioration of the timber rafters and ridge boards with the roof structure.

**Photo 7:**  
Rear South elevations &  
roof structure.

**Photo 8:**  
Rear South elevations &  
roof structure.

**Photo 9:**  
Rear South elevations &  
roof structure.

As part of the renovations works a full overhaul of the roof will be undertaken with the stone slates removed and set aside for reuse. Any defective timbers within the roof can then be easily replaced to strengthen any localised areas of weakness.

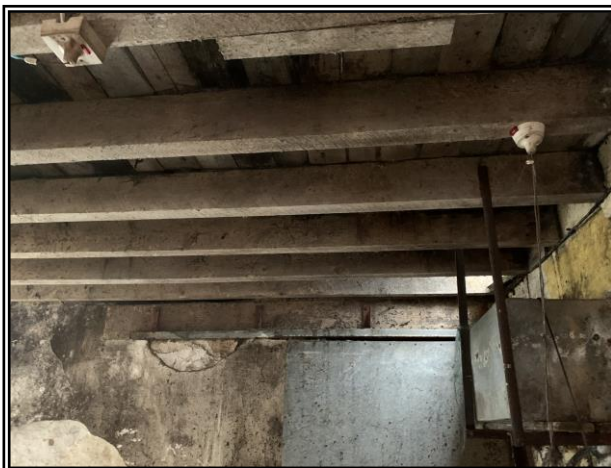
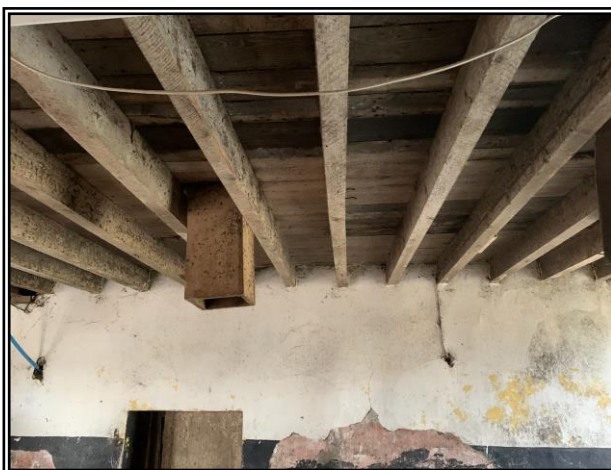
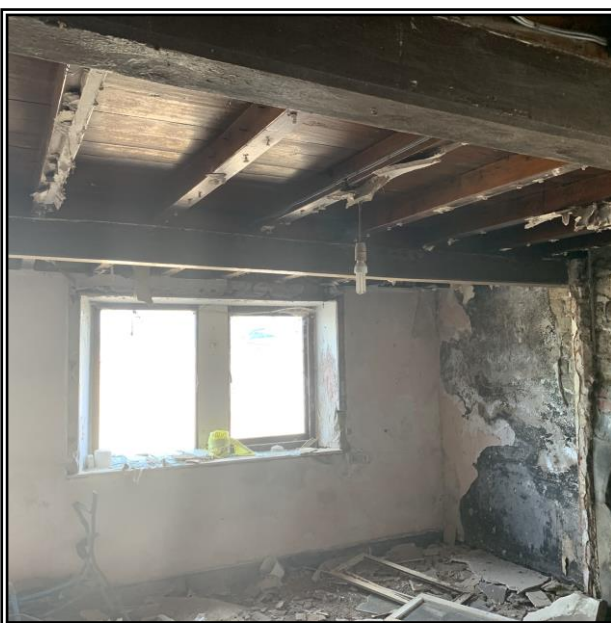
Inspection of the timber floor structures confirmed that there were areas of infestation and decay and replacement of some timbers will be required.

**Photo 13:**  
Timber floors.

**Photo 14:**  
Timber floors.

**Photo 15:**  
Timber floors.
