# Arboricultural Report

## Subsidence Risk Assessment

**Church View  
2 Netherfield Close  
Kirkburton  
Huddersfield  
HD8 0UR**

**20<sup>th</sup> May 2019**

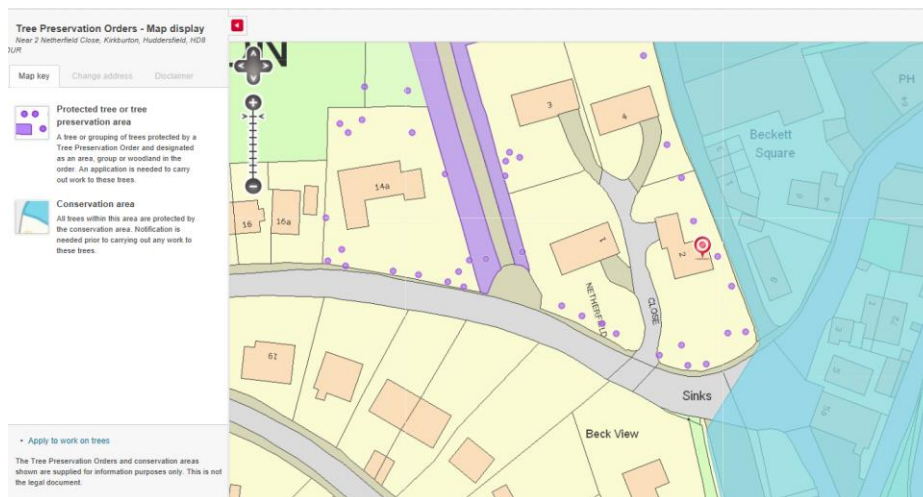
6.1.2. We interpret this to mean that:

- The site does not lie within a Conservation Area.
- There are Tree Preservation Orders affecting trees within the site. We believe trees T1, T2, T3, T4 and T5 (according to our numbering system) to be protected by a TPO. TPO ref numbers: 07/89/t61 (T1), 07/89/t65 (T2), 07/89/t66 (T3), 07/89/t67 (T4), 07/89/t68 (T5). It is unclear whether any of the other trees included within our survey are protected by a TPO as there are some discrepancies between the positions of the trees on the TPO Map and the trees measured on site during our survey.

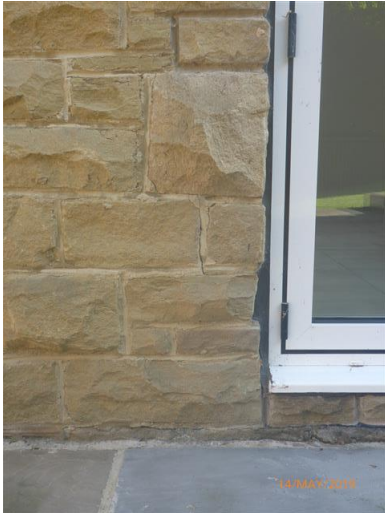
Photo 13.

- 2.5.1. The external masonry was inspected for any signs of movement. A hairline crack was observed to the left-hand side of the patio doors at the rear of the property (see Photograph 13). It is not considered likely to be vegetation related, but due to the installation of the patio doors, or due to initial settlement. No further cracks or signs of movement were observed close to any windows / doors as would normally be expected if subsidence movement had occurred.

- 2.5.2. For the purpose of this report, it is assumed that the crack observed is not due to building movement. However, the origin of the crack should be investigated by a qualified building surveyor.
