Interchange 26 North Brierley Section 38 Works

## Road Safety Audit: Stage 1/2

| Report Reference: | MAL/i26S38RSA2Rev0 |

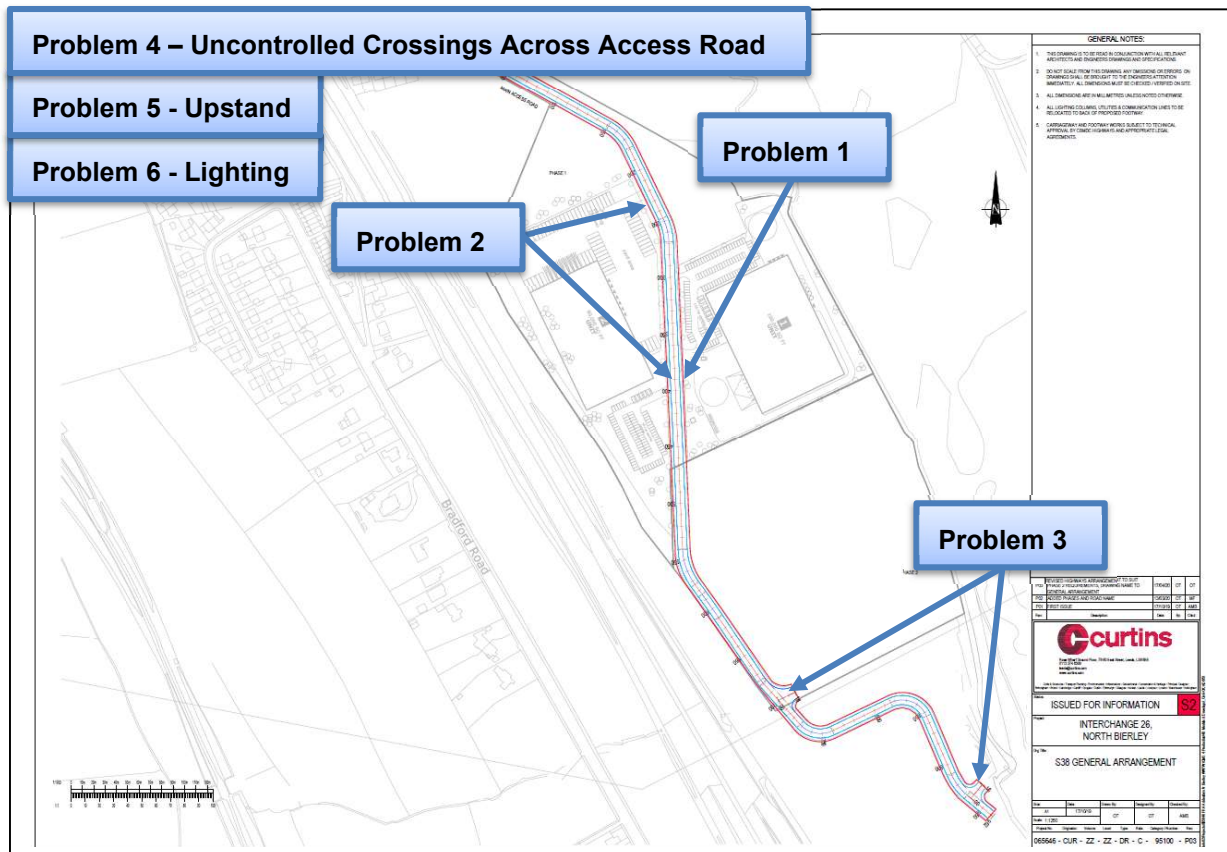
# Appendix 2 – Problem Location Plan

| PROBLEM | | 1 |
|---|---|---|
| Summary: | Vehicles over running footway when turning can increase the risk of NMU collisions. | |
| Tracking has been provided as part of the Road Safety Audit. Drawing 065646 CUR ZZ ZZ DR C 95111 P01 shows that a HGV will over run the footway when manoeuvring in the access to site 1.<br><br>Vehicles over running the footway can increase the risk of NMU collisions. | | |

| PROBLEM | | 2 |
|---|---|---|
| Summary: | Inappropriate NMU facilities can increase the risk of NMU/vehicle collisions. | |
| <p>The standards require a minimum of 1200mm depth of tactile paving across the full width of the crossing for all inline facilities. The drawings do not show this.</p> <p>A lack of suitable uncontrolled crossings can increase the risk of NMU/vehicle collisions.</p> | | |

| PROBLEM | | 3 |
|---|---|---|
| Summary: | A lack of suitable uncontrolled crossings can increase the risk of NMU/vehicle collisions. | |
| <p>The drawings do not show that any new uncontrolled crossings will be provided across the site access associated with future development to the south of Phase 1. The standards require a minimum of 1200mm depth of tactile paving across the full width of the crossing for all inline facilities and 800mm for all other uncontrolled crossings away from junctions.</p> <p>A lack of suitable uncontrolled crossings can increase the risk of NMU/vehicle collisions.</p> | | |

| PROBLEM | | 4 |
|---|---|---|
| Summary: | A lack of suitable uncontrolled crossings can increase the risk of NMU/vehicle collisions. | |
| <p>The drawings do not show that any new uncontrolled crossings will be provided across the main development access road.</p> <p>The Audit Team considered that it would be likely that there would be pedestrian movements across the main development access road.</p> <p>A lack of suitable uncontrolled crossings can increase the risk of NMU/vehicle collisions</p> | | |

| PROBLEM | | 5 |
|---|---|---|
| Summary: | Inappropriate uncontrolled crossings can increase the risk of trips and falls. | |
| <p>The standard details shown on the Section 38 drawings indicate that at uncontrolled crossings an upstand between 0 and 25mm is acceptable. Standards require that upstands at uncontrolled crossings are maximum 6mm.</p> <p>Upstands greater than 6mm at uncontrolled crossings can increase the risk of trips and falls.</p> | | |

| PROBLEM | | 6 |
|---|---|---|
| Summary: | Inappropriate levels of lighting can lead to an increased collision risk. | |
| The drawings provided do not show if street lighting is proposed. The scheme will include a new access arrangements and increase both the night time usage and the number of vehicles/NMUs using the proposed road network once the development is constructed. This may result in the new access roads and NMU crossing points being in shadow leading to possible conflicts during the hours of darkness. | | |

| PROBLEM | | 1 |
|---|---|---|
| Widen the carriageway ensuring that all vehicle turning movements can be safely accommodated within the carriageway. | | |

| PROBLEM | | 2 |
|---|---|---|
| <p>Ensure that appropriate dropped crossing points are provide in accordance with <i>Guidance on the Use of Tactile Paving Surfaces [DfT]</i>.</p> | | |

| PROBLEM | | 3 |
|---|---|---|
| Ensure that appropriate dropped crossing points are provide in accordance with Guidance on the Use of Tactile Paving Surfaces [DfT]. | | |

| PROBLEM | | 4 |
|---|---|---|
| Provide suitable dropped crossings allowing pedestrians to safely cross the development access road from the east to west and visa versa. | | |

| PROBLEM | | 5 |
|---|---|---|
| Ensure that appropriate dropped crossing points are provide in accordance with Guidance on the Use of Tactile Paving Surfaces [DfT]. | | |

| PROBLEM | | 6 |
|---|---|---|
| Ensure that suitable lighting provision is provided. | | |
