Pre-development Arboricultural Report

Date of report: 22nd August 2018 (updated 27th March 2020)

Reference: OWA084 PDR

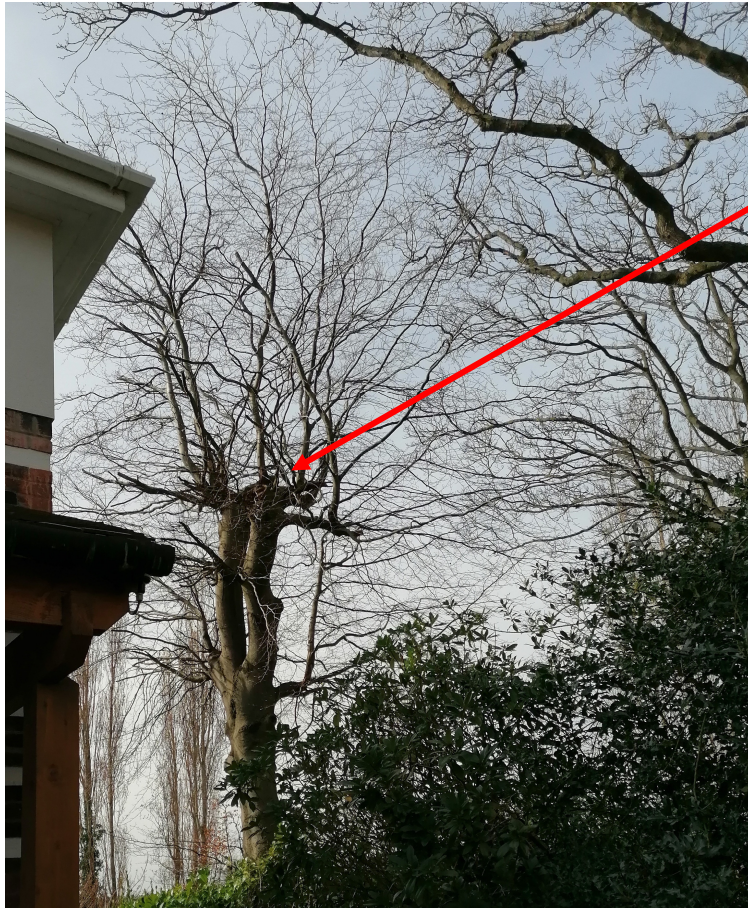
T12 is a Beech tree close to the property, it has large main limbs which were codominant leaders, and these have been significantly reduced in the past (essentially topping the tree). This has led to re-growth, giving a heavy crown when in leaf. It is likely that these new branches have weaker attachments and I recommend that they are not allowed to grow to become too heavy and extended in length. Beech are not good at resisting decay and are also known to readily drop limbs when the structural integrity is insufficient to carry the load. Due to the weight of the wood, this occurs sooner than in other species.

Beech are not very resistant to decay, and topping a mature tree is considered poor practice as it produces large wounds at the top of the tree with no defence for decay fungi and water to enter. As a result, this point of the tree may have the formation of columns of decay.

March 2020 inspection - the structure of the Beech tree could be seen as there were no leaves on the tree. The photo of the tree show 2 limbs which have been topped resulting in long, thin regrowth. This means that there are 2 sections of tree which will be slowly rotting, rather than 1 main stem. The long term future of this tree has been compromised.

Photo of T12 showing the structure and where it has been topped

T12 is a Beech which has been topped. An aerial inspection is recommended to reveal the nature of the wounding at the top of the main stems. There is a strong possibility that decay is present.
