**Lingards Road, Slaithwaite, Kirklees**

**Road Safety Audit Stage 1**

September 2022

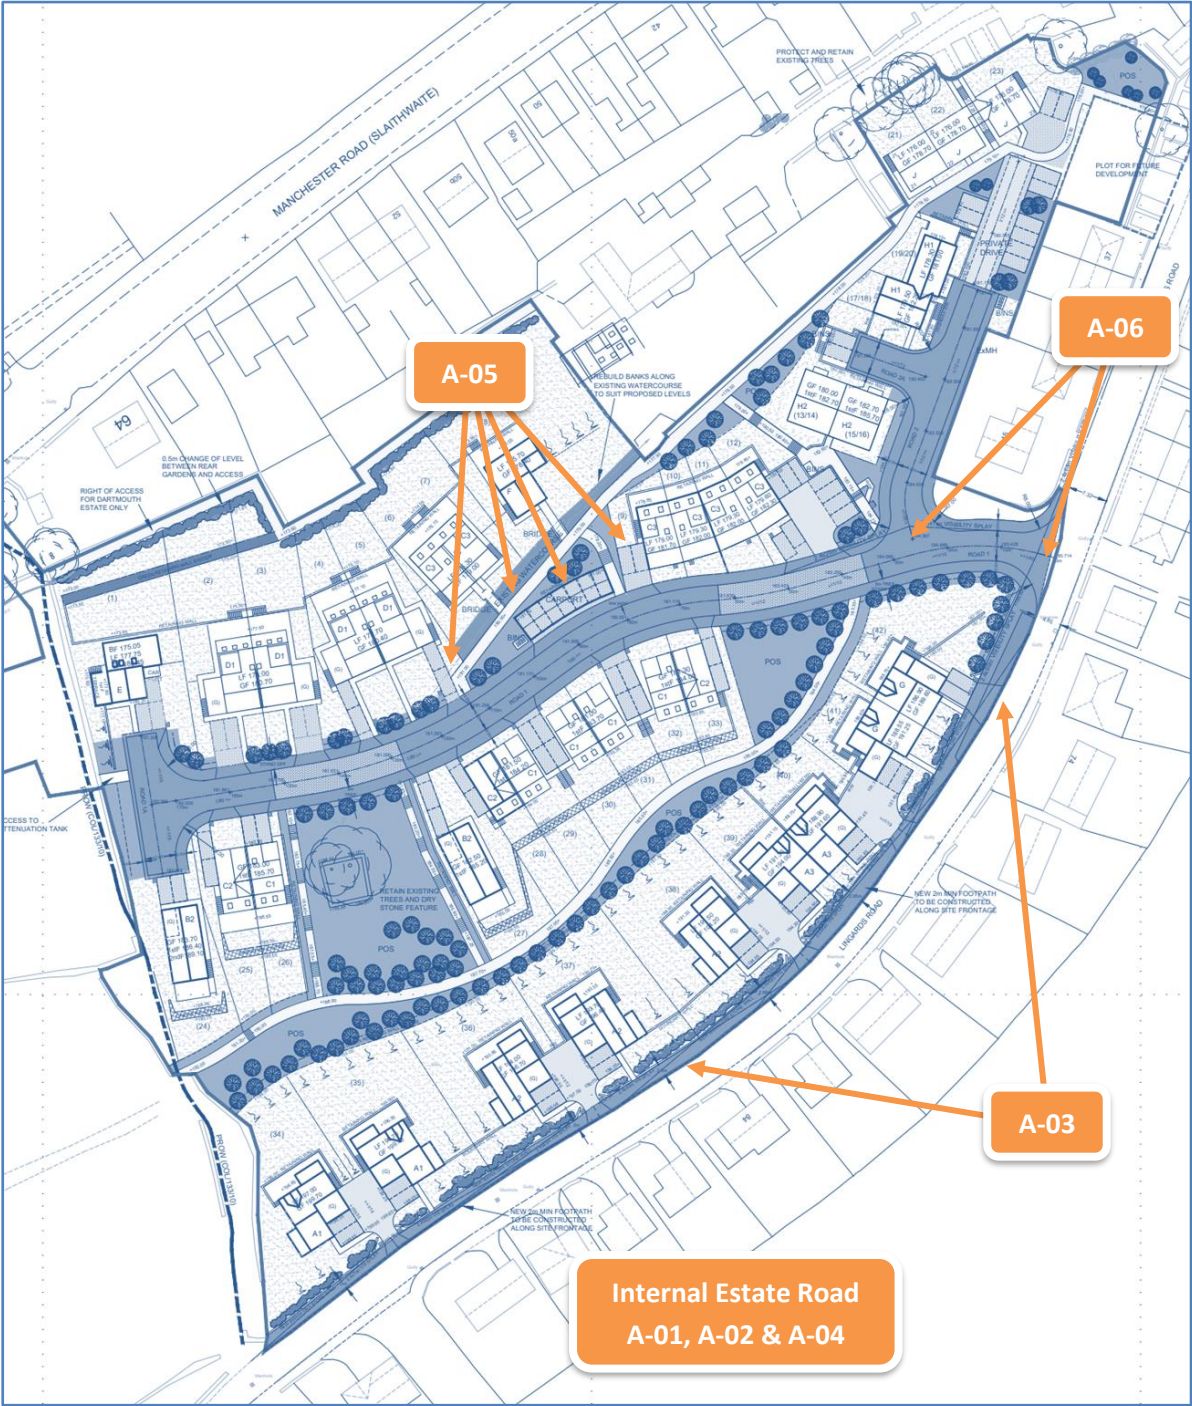
# Problem Location Plan

**Summary:** Visibility – Insufficient forward visibility into side roads and around bends may increase the risk of collisions involving pedestrians.

**Summary:** Drainage – Insufficient surface water drainage may increase the risk of skidding type collisions at the junction, and also slips and falls by pedestrians

**Summary:** Skidding Resistance – Insufficient skidding resistance may increase the risk of loss of control type collisions.

**Summary:** Fences and Restraint System – A lack of protection to the watercourse may increase the risk of falls and errant vehicles entering the water.

**Summary:** Carriageway Markings – Lack of junction priority markings may increase the risk of junction related collisions

It is recommended that forward around the inside of bends and into turning heads is assessed and that the visibility envelope is kept clear of obstructions such as planting, fencing, walls, areas for parking etc, in line with Manual for Streets. i.e. planting when mature should not exceed 600mm from the adjoining carriageway surface with the underside of any tree canopy to be above 2000mm. This is especially an issue on this particular development in terms of the steep gradients which may push the upper envelope of visibility above the 2000mm height.

It is recommended that drainage details are provided at the next stage of road safety audit including locations of gully locations, levels and contours.

It is recommended that a minimum 55 PSV is provided and that inspection chamber covers provide a similar level of skidding resistance to the surrounding carriageway surface.

It is recommended that sufficient measures are in place to reduce the risk of pedestrians falling into the watercourse and also to reduce the risk of errant vehicles entering the watercourse.

It is recommended that junction priority markings (give way markings) are provided.
