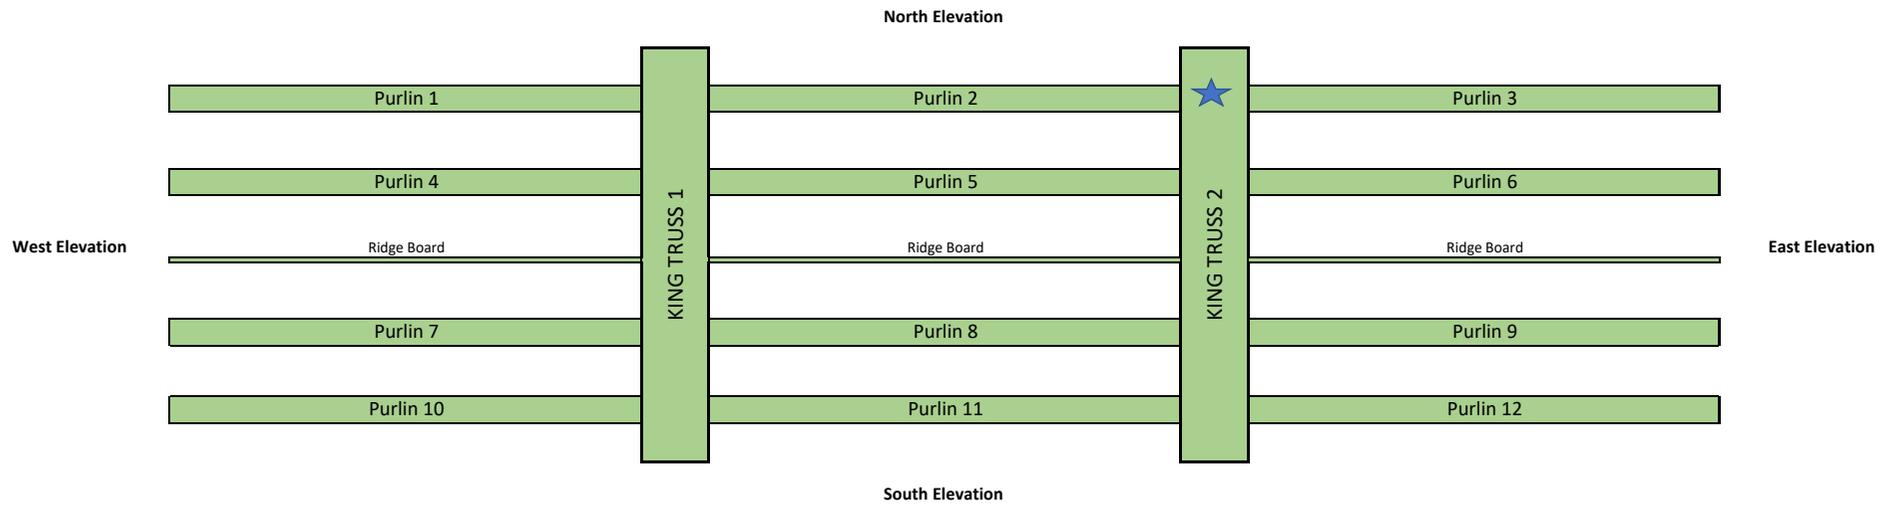
<b><u>Re-Construction</u></b>	
King truss 1	Condition okay. King post and struts in good condition. Full inspection to be carried once on safe ground level. Will be re-used
King truss 2	Condition okay. King post and struts in good condition. Area (marked by "star") braced with steel plate which may need strengthening on tie beam. Full inspection to be carried once on safe ground level. Will be re-used
Purlin 1	Assume existing oak purlin removed during strengthening works. Sawn timber present. Will be replaced with new oak to match existing
Purlin 2	Present however accompanied by new sawn cut timber presume to add structural strength. Full inspection of existing however if defected will be replaced with new oak to match existing
Purlin 3	Present however accompanied by new sawn cut timber presume to add structural strength. Full inspection of existing however if defected will be replaced with new oak to match existing

Purlin 4	Assume existing oak purlin removed during strengthening works. Sawn timber present. Will be replaced with new oak to match existing
Purlin 5	Present however accompanied by new sawn cut timber presume to add structural strength. Full inspection of existing however if defected will be replaced with new oak to match existing
Purlin 6	Present however accompanied by new sawn cut timber presume to add structural strength. Full inspection of existing however if defected will be replaced with new oak to match existing
Purlin 7	Present however accompanied by new sawn cut timber presume to add structural strength. Full inspection of existing however if defected will be replaced with new oak to match existing
Purlin 8	Present however accompanied by new sawn cut timber presume to add structural strength. Full inspection of existing however if defected will be replaced with new oak to match existing

Purlin 9	Assume existing oak purlin removed during strengthening works. Sawn timber present. Will be replaced with new oak to match existing
Purlin 10	Assume existing oak purlin removed during strengthening works. Sawn timber present. Will be replaced with new oak to match existing
Purlin 11	Present however accompanied by new sawn cut timber presume to add structural strength. Full inspection of existing however if defected will be replaced with new oak to match existing
Purlin 12	Assume existing oak purlin removed during strengthening works. Sawn timber present. Will be replaced with new oak to match existing

<b><u>Demolition</u></b>	
1	The roof structure will be careful dismantled and mechanically lifted from the building and stored on site in the barn or garden area (wrapped and protected to keep dry)
2	As the roof has had previous remedial works the rafters will be replaced for new
3	Ridge board will be stored and re-used if possible. If not a replacing (exact size will be introduced)
4	The existing structure will be fully propped with structural scaffolding to protect during the works - this scaffolding is already in place and will be adapted during the works to suit the task
