Mr K Ryall  
3 Two Gates  
Slaithwaite  
HD7 5UG

### Existing Structure

Unfortunately, the existing structure is in incredibly poor condition and has received a number of repairs and alterations over a period of time leaving a lot of the structure in a poor state and un-original.

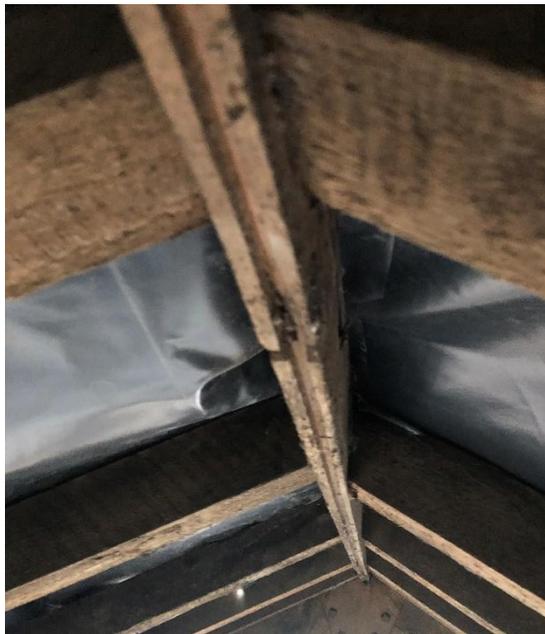
#### 1. Ridge Board

**Ref 1.** Ridge board is not original and has been replaced using an off cut of T&G floorboard. This is also rotting due to an infestation of woodworm

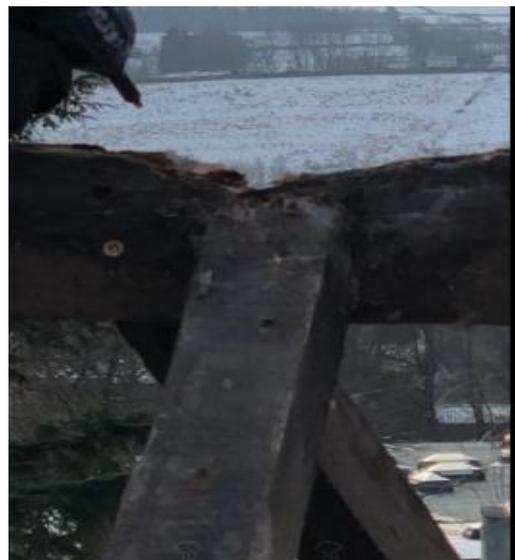
## 2. Common Rafters

Rafters are not original and have been replaced over time with the addition or replacement purlins and the installation of felt. These are in poor condition due to the woodworm infestation (as picture in item 1) and recommend replacing with new during the works.

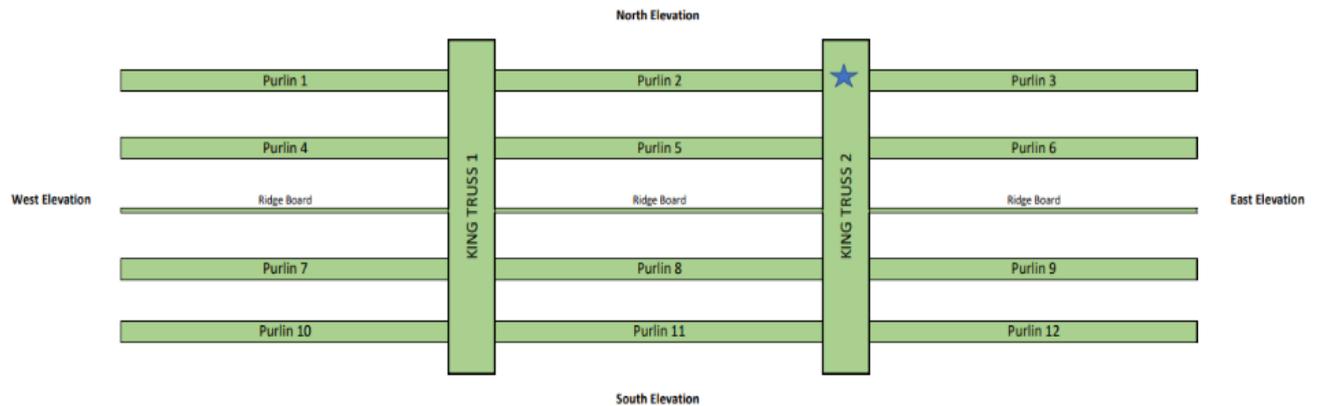
## 3. Purlins

The customer has provided a detail of the existing presence of original materials which we have included within our report FYI.

| Purlin 1 | Assume existing oak purlin removed during strengthening works. Sawn timber present. Will be replaced with new oak to match existing |
| Purlin 2 | Present however accompanied by new sawn cut timber presume to add structural strength. Full inspection of existing however if defected will be replaced with new oak to match existing |
| Purlin 3 | Present however accompanied by new sawn cut timber presume to add structural strength. Full inspection of existing however if defected will be replaced with new oak to match existing |
| Purlin 4 | Assume existing oak purlin removed during strengthening works. Sawn timber present. Will be replaced with new oak to match existing |
| Purlin 5 | Present however accompanied by new sawn cut timber presume to add structural strength. Full inspection of existing however if defected will be replaced with new oak to match existing |
| Purlin 6 | Present however accompanied by new sawn cut timber presume to add structural strength. Full inspection of existing however if defected will be replaced with new oak to match existing |
| Purlin 7 | Present however accompanied by new sawn cut timber presume to add structural strength. Full inspection of existing however if defected will be replaced with new oak to match existing |
| Purlin 8 | Present however accompanied by new sawn cut timber presume to add structural strength. Full inspection of existing however if defected will be replaced with new oak to match existing |
| Purlin 9 | Assume existing oak purlin removed during strengthening works. Sawn timber present. Will be replaced with new oak to match existing |
| Purlin 10 | Assume existing oak purlin removed during strengthening works. Sawn timber present. Will be replaced with new oak to match existing |
| Purlin 11 | Present however accompanied by new sawn cut timber presume to add structural strength. Full inspection of existing however if defected will be replaced with new oak to match existing |
| Purlin 12 | Assume existing oak purlin removed during strengthening works. Sawn timber present. Will be replaced with new oak to match existing |

In addition to the information above where original purlins and completely missing the one that are present are suffering from poor repairs and infestations of woodworm.

Areas where non existing timber is present, we propose to replace with new structurally graded oak such as purlins 1,4,9,10,12.

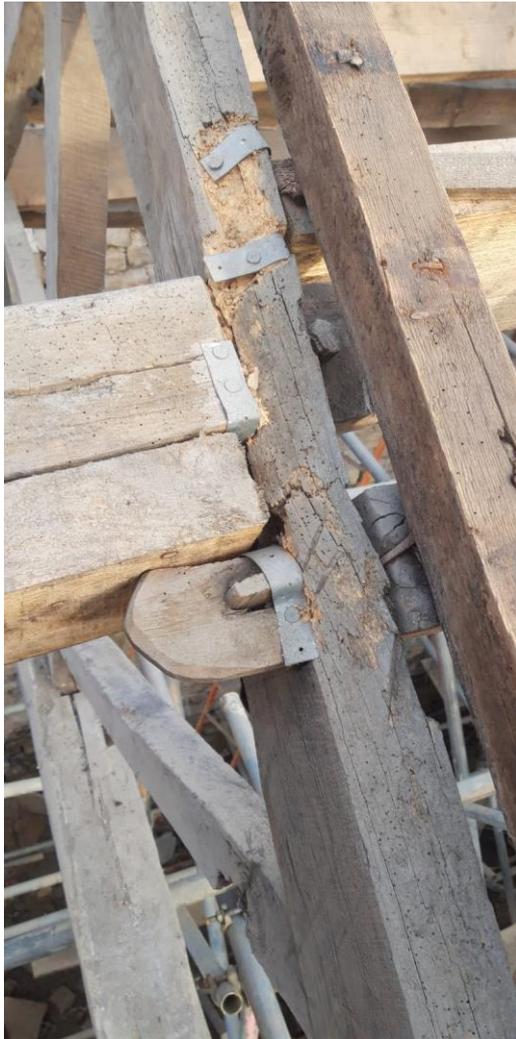
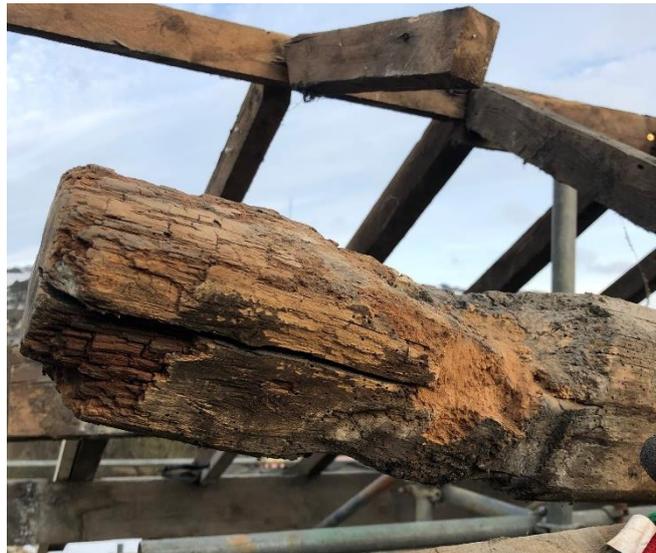
Ref 2. Picture across and below of the poor condition of the roof purlins. Wood worm and brittle damaged ends meaning that these timbers cannot be re-used

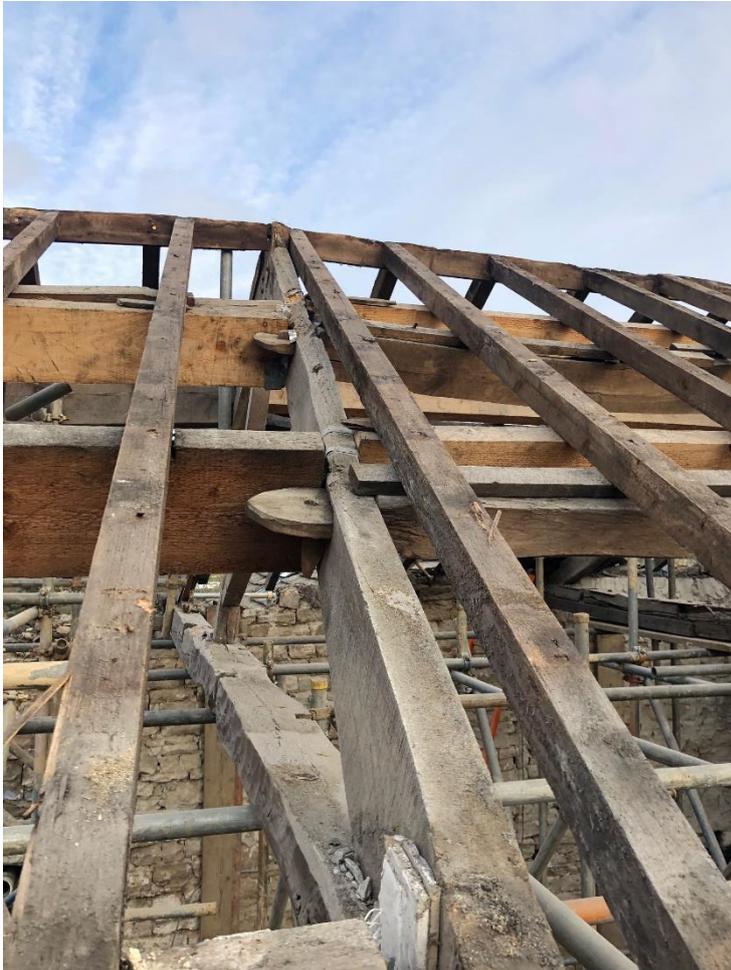
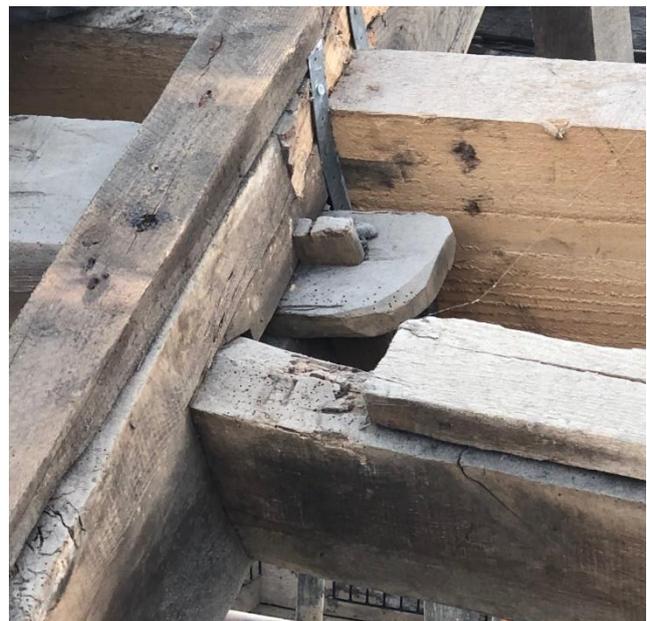
Ref 3. More examples of poor repairs and wood worm infestation. Also additional packers to purlins due to movement which isn't an issue however main points of fixing are damaged

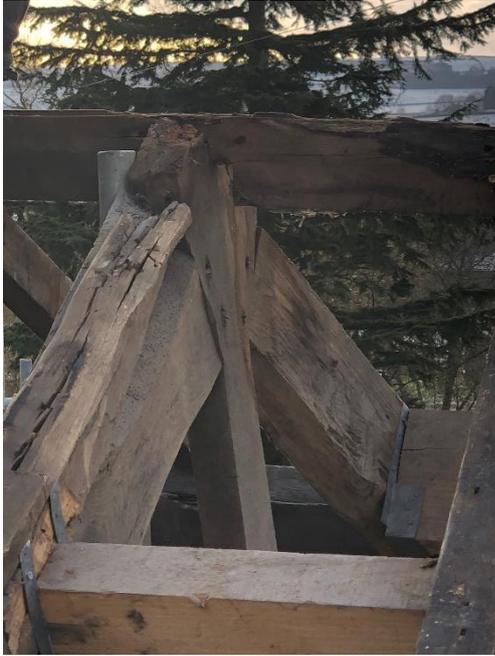
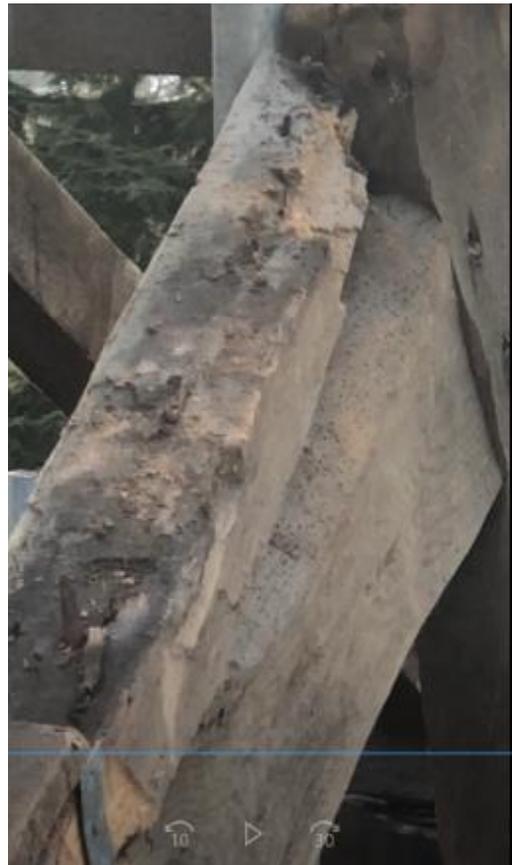
### **3. Principal Rafters**

Show signs of woodworm infestation but generally okay in condition.

Both posts including struts are showing signs or extreme warping (bow type). Otherwise in generally ok condition.

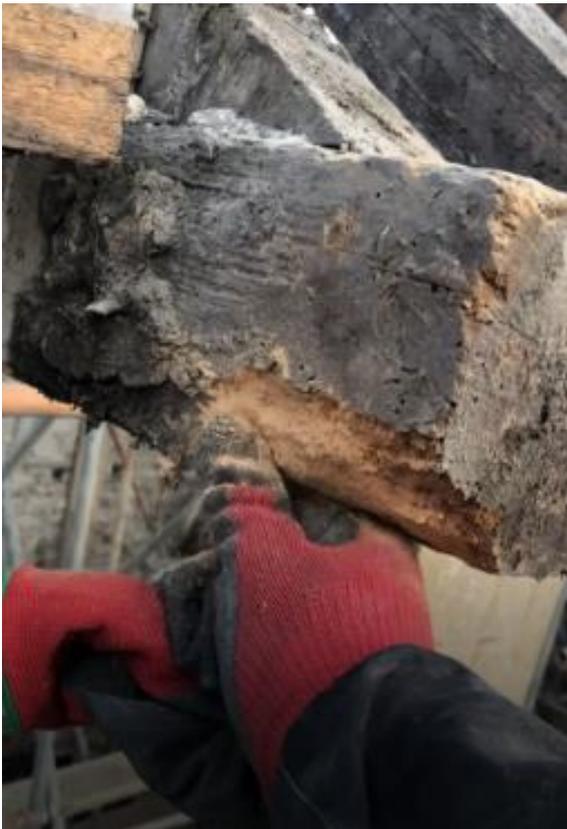
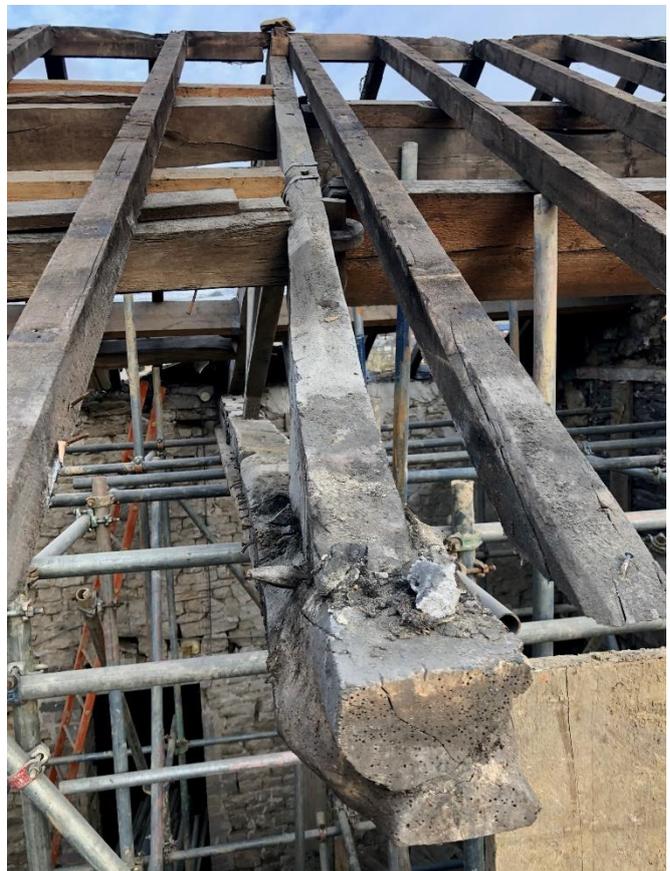
#### **5. Tie Beams**

Ref 4. Tie beams showing signs of woodworm infestation and damage

Where areas of timber are beyond repair which in our opinion is all areas apart from some areas of the king trusses, we would replace with reclaimed oak to match existing. If the tie beams were unable to be reused we would also propose to re-use these as purlins to assist in keeping some original items in the roof. All new/reclaimed timber used would be traditionally jointed.

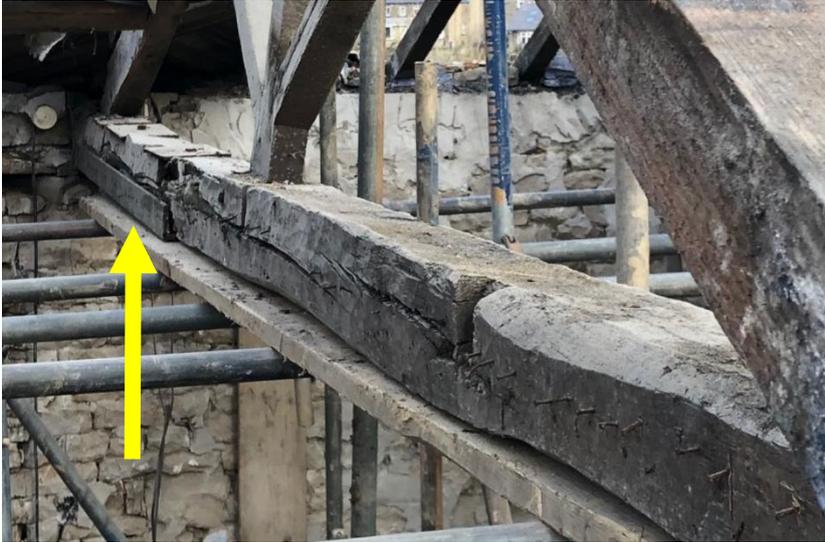
Ref 5. Tie beams showing signs or cracking with previous metal work repair that appears to be defective
