**SAINT JAMES CHURCH  
MELTHAM  
TREE RISK SURVEY REPORT  
FEBRUARY 2020**

| Document Title | Tree Risk Survey Report |
| Document Ref | 8060.003 |

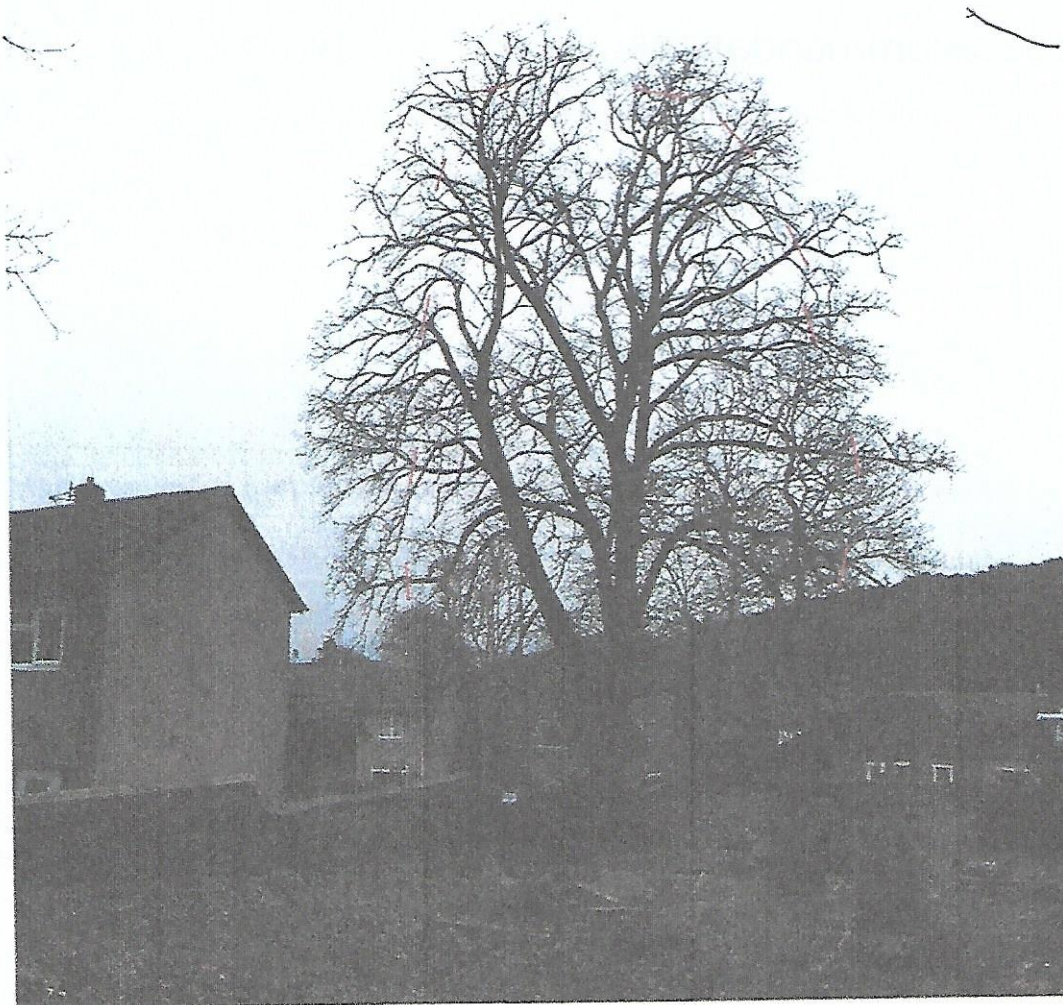
*Figure 1. Indicative extent of crown reduction works to T3.*

| Ref | Species<br>(Common name) | Height<br>(m) | Stem<br>Diameter<br>(mm) | Crown<br>diameter /<br>width<br>(m) | No. of<br>stems /<br>trees<br>(below<br>1.5m) | Lean /<br>canopy<br>bias | Maturity | Condition | Safe Useful<br>Life<br>Expectancy | Comments on form, condition, health and significant defects | Works Recommendations | Primary works<br>objective | Works<br>Priority | TPO | Conservation<br>Area |
|---|---|---|---|---|---|---|---|---|---|---|---|---|---|---|---|
| T3 | Small leaved lime | 20.0 | 800-900 | 17.0 | 1.0 | N | Mature | Good | Medium | Large and notable tree adjacent to residential street. Blurred at c. 2m with acute union and included bark, no apparent natural bruise above union, junction in weakened state, large arising co-dominant stem weighted to north towards residential street, likelihood of failure assessed as medium. Remaining structure appears in good condition, crown in good health with good presence of water buds, some small diameter deadwood over head and numerous small diameter drooping branches too. | Reduce crown by 2.3m all round to reduce loading on over extended limbs and re-balance crown. Crown raise and remove deadwood above pavement / road to north to create minimum 2.1m clearance | Safety | Routine | Y | N |

- 5.4 The extent of works to reduce the crown of T3 are illustrated indicatively within Figure 1. These works are recommended to reshape the crown of T3 whilst reducing the sail area of the tree (the area of a tree's aerial structure, particularly foliage, which intercepts winds) and associated strains from leverage on over extended and end-weighted limbs.
- 5.5 All recommended works should be carried out according to *BS3998 Tree Work - Recommendations*.
