# GEOSHIELD

## Verification Report

GEO1006200/AC/D

Phase 1 Factory Martech UK Ltd

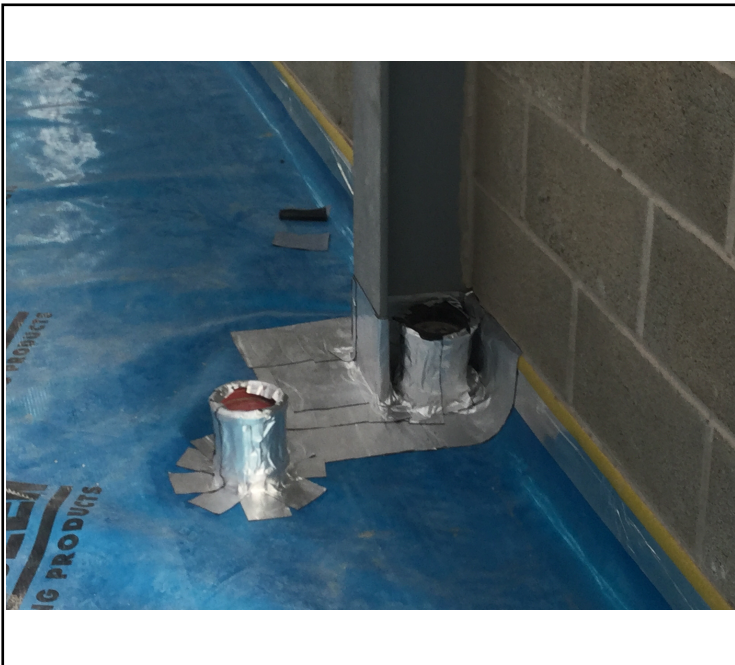
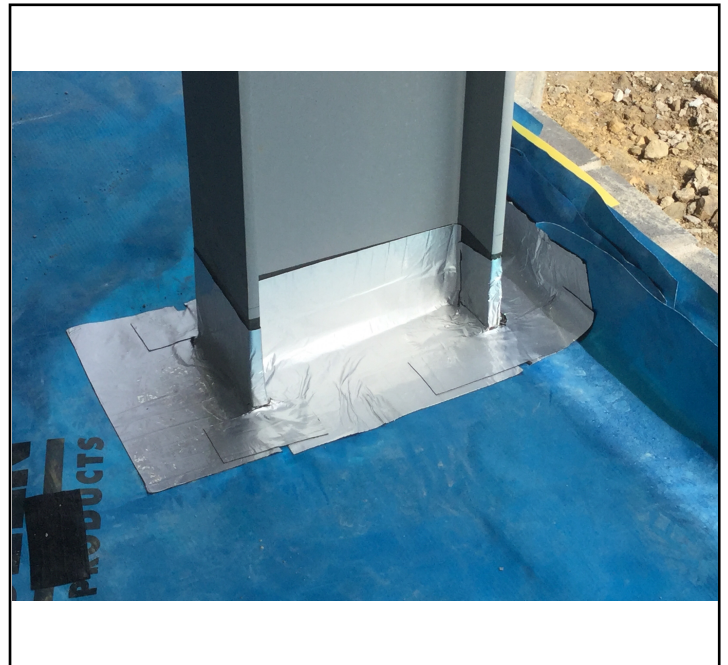
LOCATION/GRID LINE: Perimeter A1 to E1 and 1 to 13

Photo 1 - showing detail to both pipe penetration and Stanchion base.

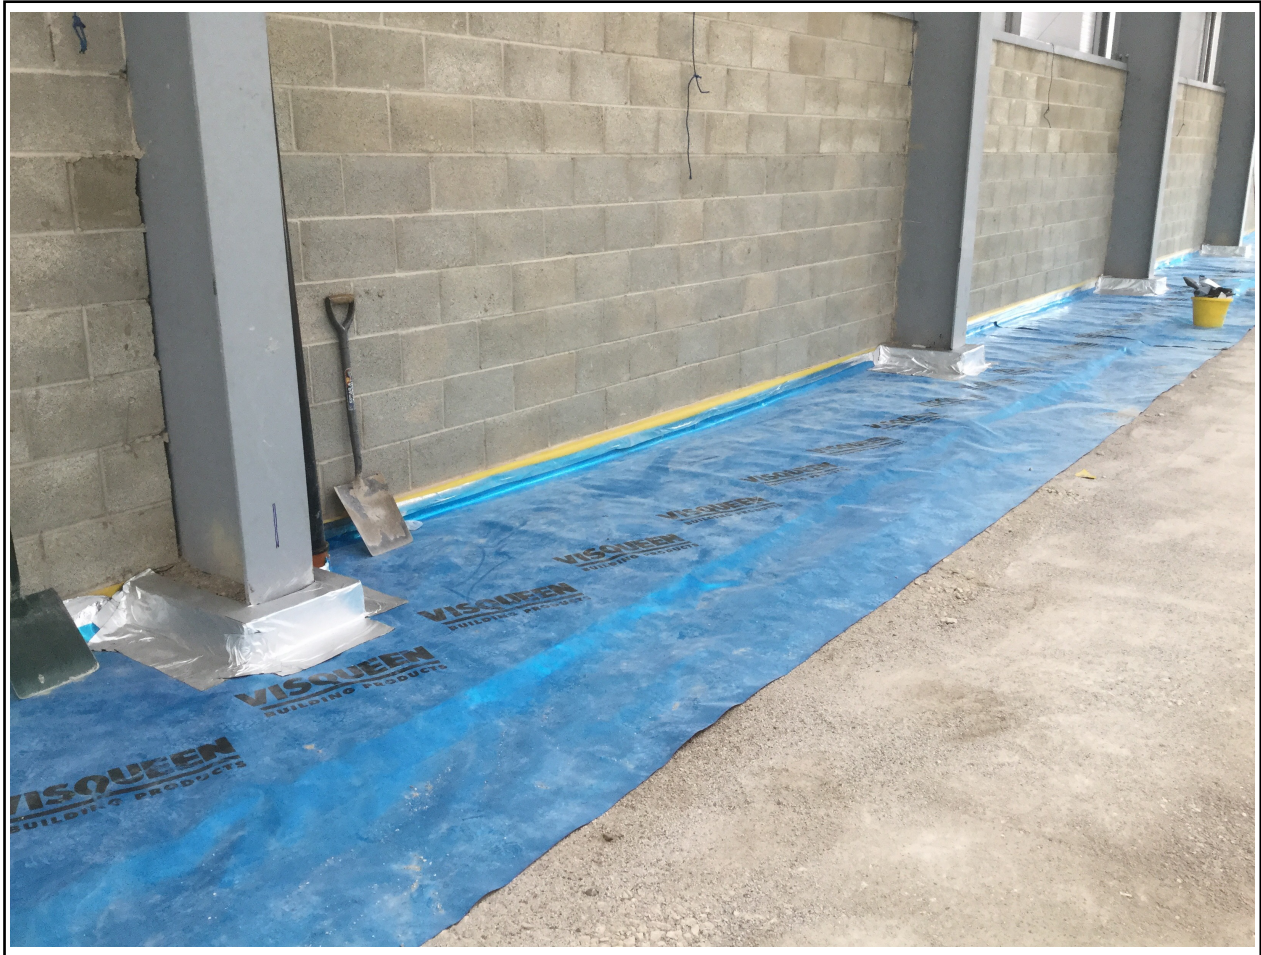
Overview of Stanchion bases following detailing to bases

Stanchions to be completed in TWO stages - Greystones Industrial Flooring to complete to top of Stanchion Blockwork followed by Adamco who will complete onto Stanchion will be primed and detailing Tape heated whilst fixing to blockwork. Blinding was completed to BS8485 and in stages to reduce damage from site Plant and Machinery.

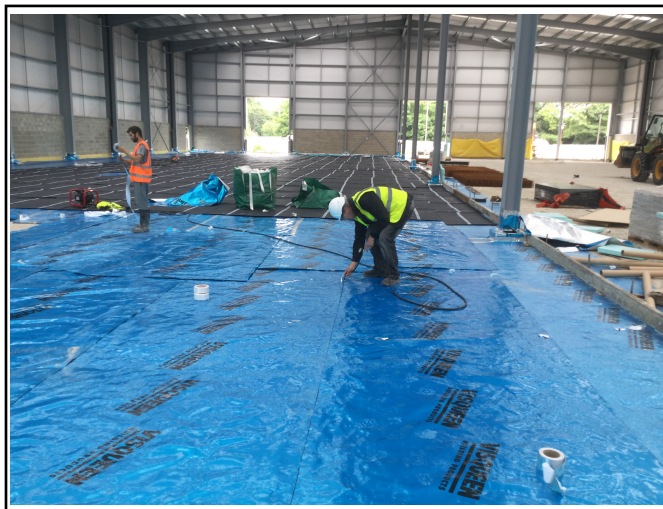
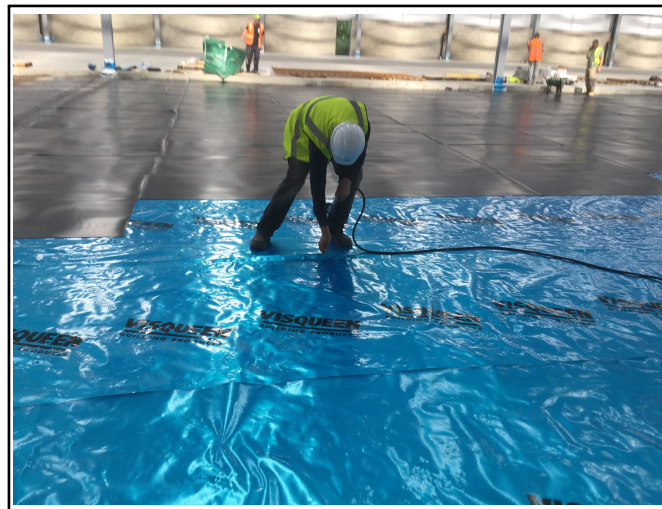
LOCATION/GRID LINE: A to E - 9 to 6

Photos showing Air Lancing being carried out

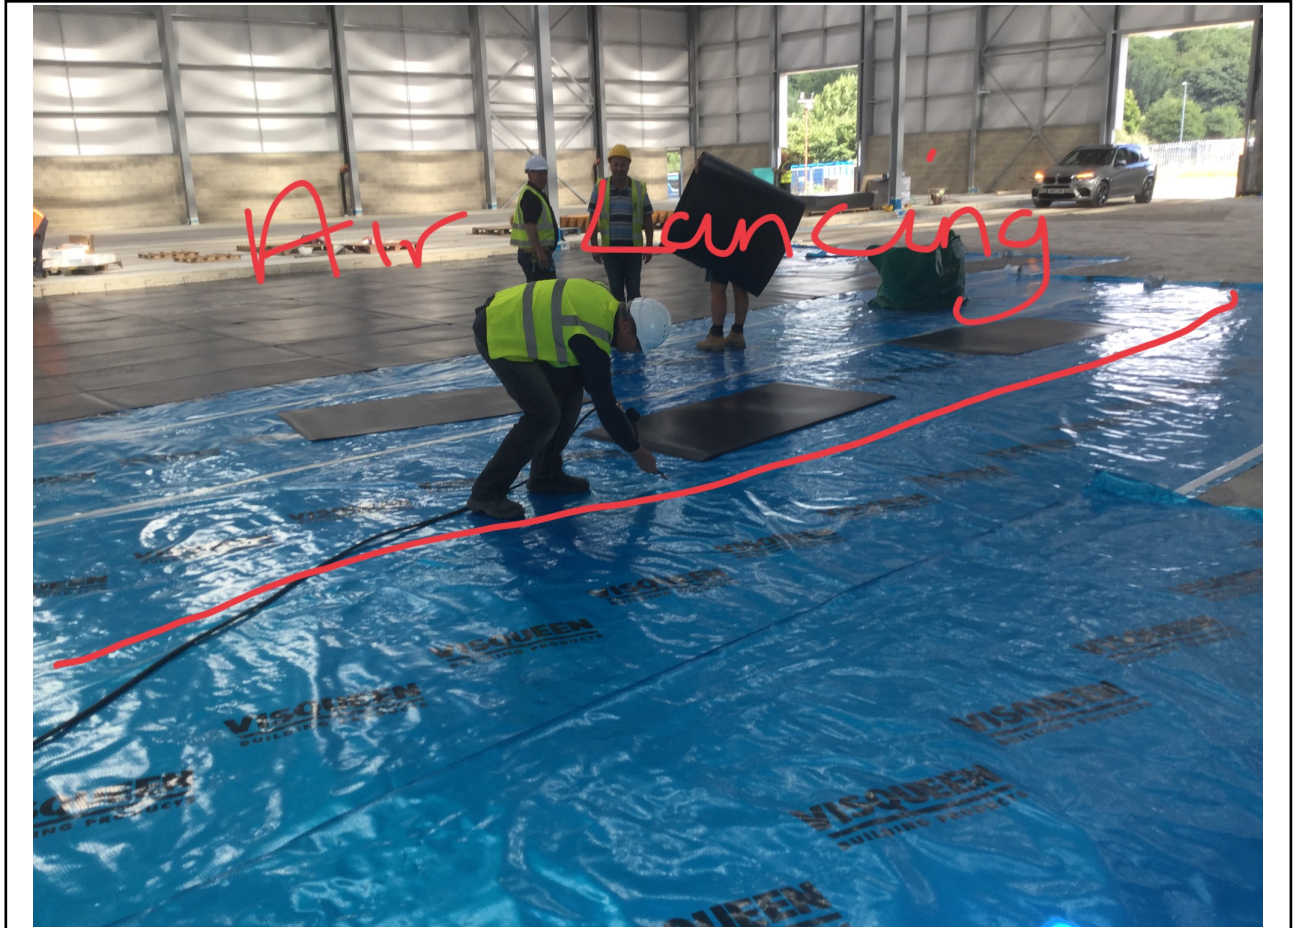
Photo showing Air Lancing being undertaken

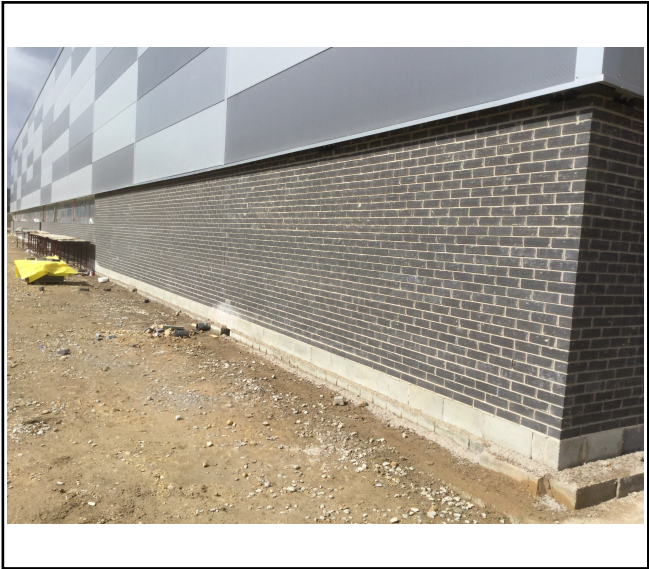
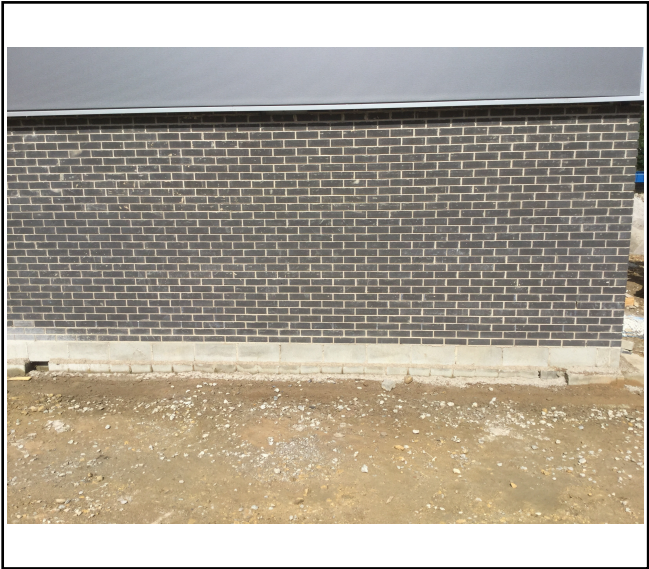
LOCATION/GRID LINE: Grid Reference A 1 to A 6

Photo 1 - Overview of External Brickwork

Photo 2 - Area of Brickeork in need of Air Bricks at DPC and Soffit

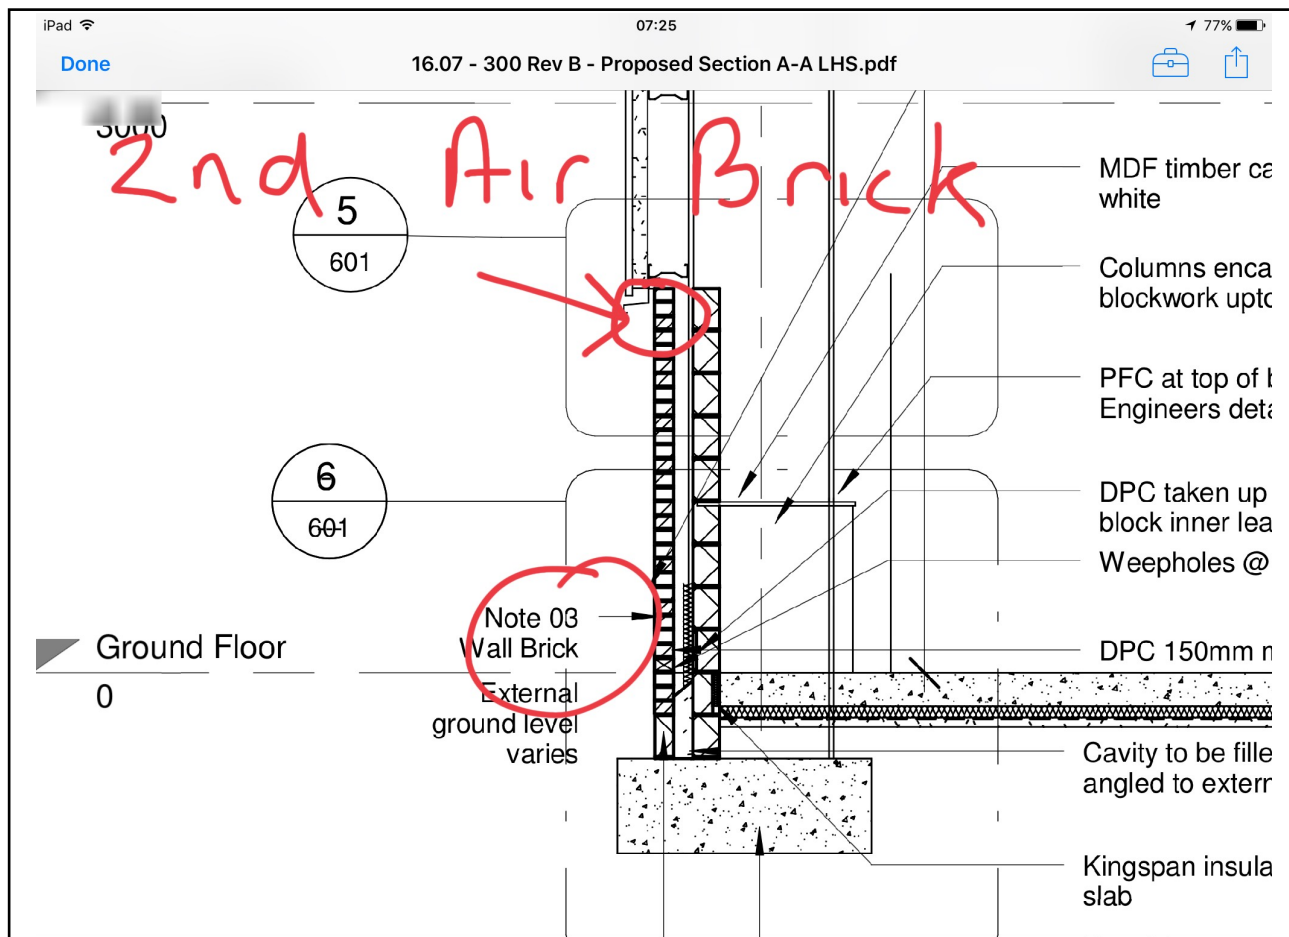
Air Brick positioning including additional one at Soffit level.

This process to be replicated around the building

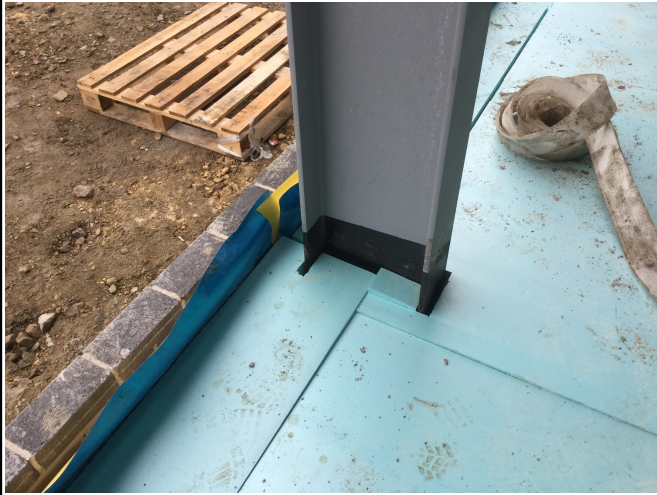
Stanchion prior to Membrane

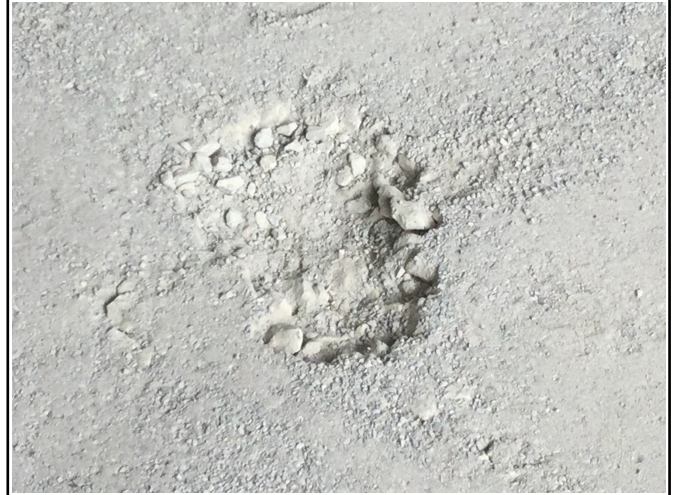
Sand Blinding Repair

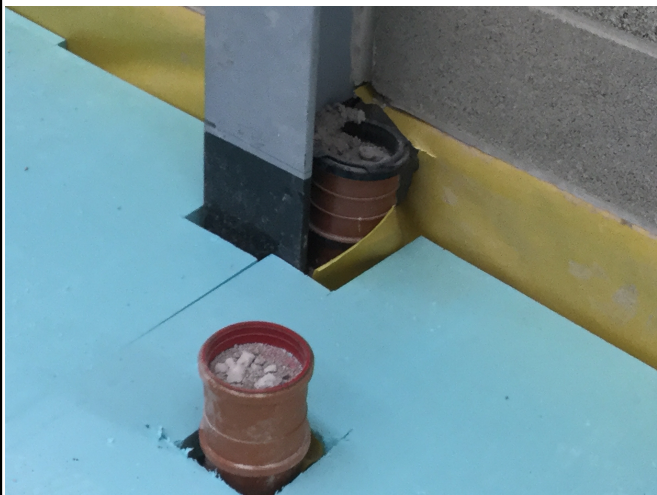
Pipe Penetration

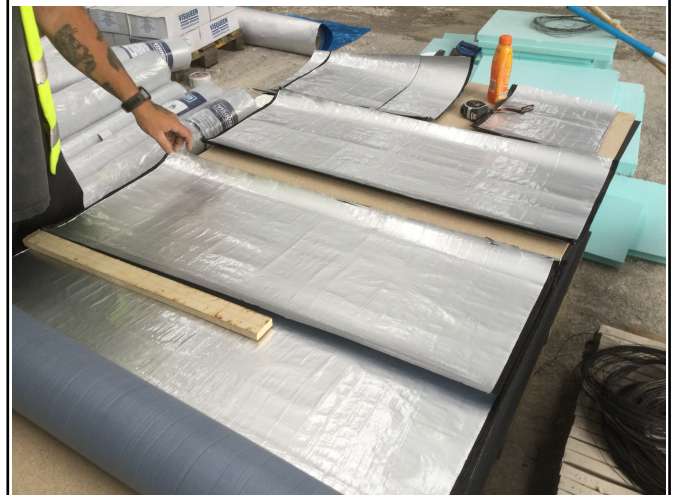
Preparing Detail Tape
