# **ARBORICULTURAL REPORT & Impact Assessment to BS5837:2012 at:**

*Land at:*  
***Northorpe Lane,  
Mirfield,  
West Yorkshire,  
WF14 0QN***

Prepared for:  
***Newett Homes***

Reference: AWA3667

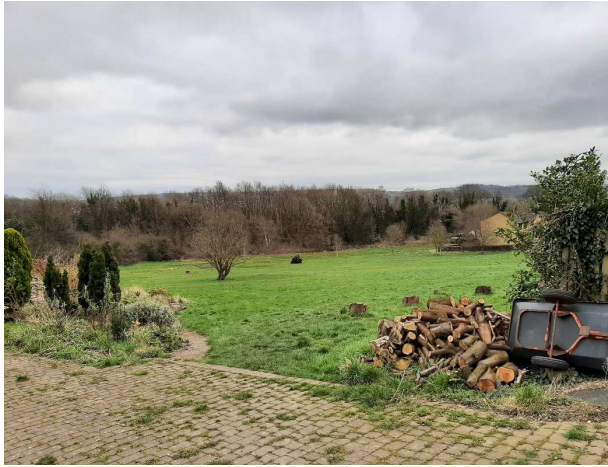
Photo 1: Overview of the site, from the north-west

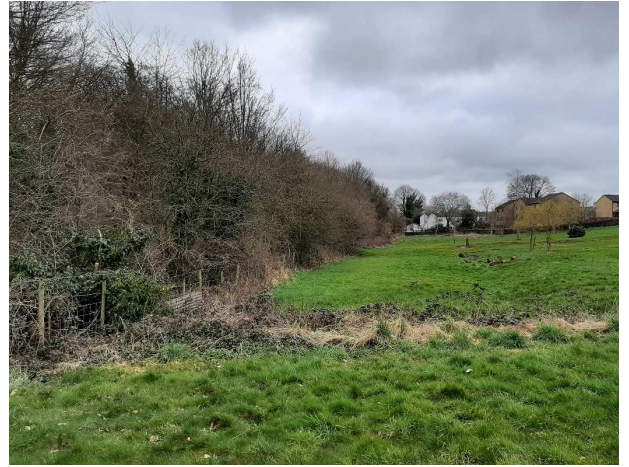
- 3.2.4 Beyond the eastern boundary is steep banking, leading to a disused railway. Situated on the banking is a dense, shelterbelt woodland group G1. G1 is predominantly comprised of semi-mature trees, with occasional inaccessible larger trees toward the top of the banking. Most individual trees within G1 have limited individual value, with smaller trees situated at the boundary being particularly low value. However, collectively the group has moderate amenity value in the wider landscape. At the edge of the woodland is a small ditch, which extends along the eastern boundary.

Photo 2: G1, at the eastern boundary

- 4.2.4 Part of G1 will be removed, to facilitate development. Trees at the western aspect of G1 are growing within the curtilage of the development site, and will be removed to facilitate the erection of new boundary treatments. This will be limited to smaller, lower value understory trees and will not impact the overall landscape value of the woodland group.

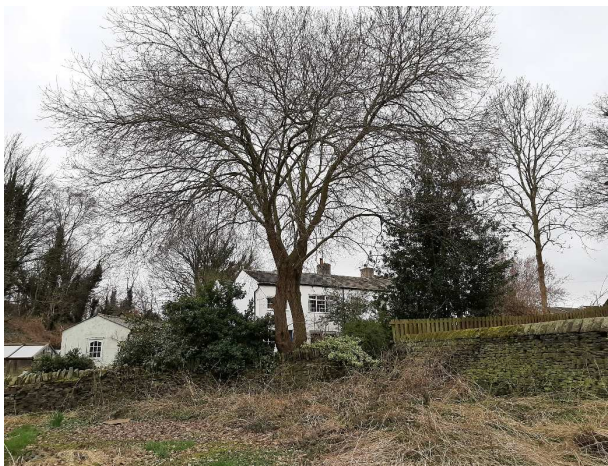
- 3.2.6 Situated close to the southern boundary, in adjacent gardens, are Birch T11, Willow T12 and Rowan T13. Of these trees, T11 and T12 are of more moderate amenity value, with T11 being an ornamental, cultivated Birch and T12 being a large, early-mature tree that will be prominent from neighbouring gardens. Close to T12 there is a prominent root causing minor displacement of the boundary dry-stone wall. While displacement was insignificant at time of survey, future repairs or rebuilding may be required if the wall is displaced further.

Photo 3: Willow T12, at the southern boundary

| Tree ID | Tree Species | | Maturity | Measurements | | | | Crown (m) | | | | | Tree Condition | | | | | | | Value | | Management |
|---|---|---|---|---|---|---|---|---|---|---|---|---|---|---|---|---|---|---|---|---|---|---|
| T12 | Willow | <i>Salix caprea</i> | Early-mature | 15 | 2 | 450, 450 | Yes | 6 | 7 | 7 | 7 | 6.5 | Limited access around base | Twin stemmed at base, Vertical, Old pruning wounds, Epicormic growths, Minor cavity, Minor decay | Overhanging into the site, Minor deadwood | Access prevented detailed inspection. Minor cavity north aspect of north stem. Roots under wall | Good | Fair | 20 to 40 yrs | Moderate | C | No works required |

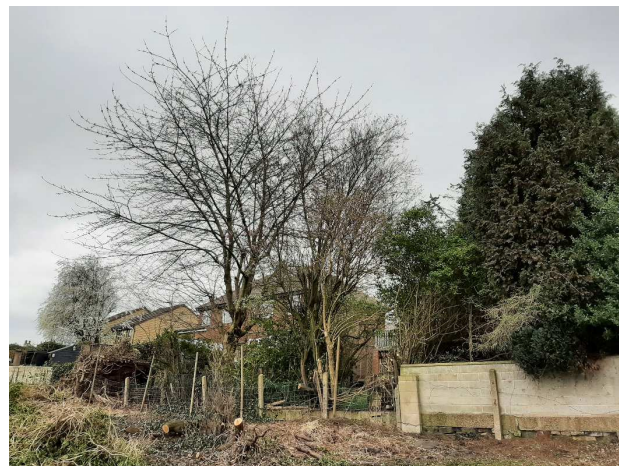
- 3.2.8 At the western boundary of the site, in adjacent gardens, are Cherry T27, Plum T28, groups G29 and G31. These trees and groups have reasonable amenity value as screening for neighbouring properties.

Photo 4: T27, T28 and G29, screening at the western boundary

| Tree ID | Tree Species | | Maturity | Measurements | | | | Crown (m) | | | | | Tree Condition | | | | | | | Value | | Management |
|---|---|---|---|---|---|---|---|---|---|---|---|---|---|---|---|---|---|---|---|---|---|---|
| T27 | Cherry | <i>Prunus avium</i> | Mature | 11 | 1 | 350 | Yes | 3 | 6.5 | 6.5 | 6.5 | 6.5 | No visual defects, Limited access around base | Single stemmed, Vertical, Old pruning wounds, Stubs, Epicormic growths | Overhanging into the site, Stubs, Minor deadwood | Access prevented detailed inspection. Occasional poor pruning but mostly well maintained. Retaining wall at base | Fair | Fair | 20 to 40 yrs | Moderate | C | No works required |
| T28 | Plum | <i>Prunus cerasifera</i> | Semi-mature | 7.5 | 1 | 200 | Yes | 3 | 4.5 | 4.5 | 2 | 3 | No visual defects, Limited access around base | Single stemmed at base, Vertical, Twin stemmed at 2m, Tight union | Suppressed, Overhanging into the site, Stubs | Has previously been heavily pruned, now with full crown | Fair | Fair | 20 to 40 yrs | Low | C | No works required |
| G29 | Cypress, Holly, Privet | <i>Cupressus sp.</i> , <i>Ilex sp.</i> , <i>Ligustrum sp.</i> | Semi-mature | 7.5 | 10+ | 100 avg | Yes | 2.5 | See Plan | | | | Access prevented detailed inspection. Mixed tree and shrub group at bottom of adjacent garden. On opposite side of retaining wall, with a minor crack but no visible roots | | | | Good | Fair | 20 to 40 yrs | Low | C | No works required |

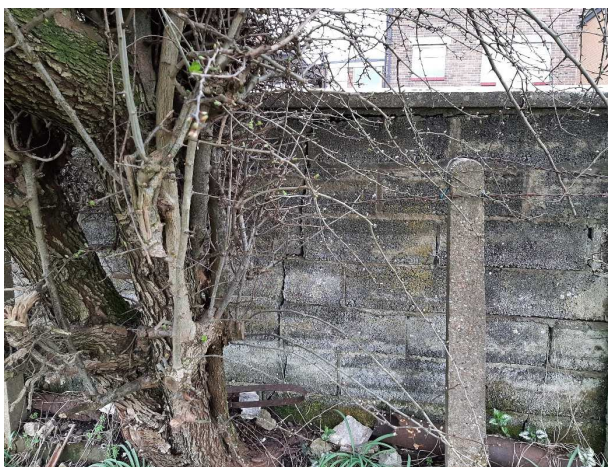
- 3.2.9 Situated at the base of the retaining wall at the western boundary is Hawthorn T30. There is a prominent crack in the wall immediately adjacent to the T30, most likely caused by the trees continued growth.

Photo 5: Prominent crack behind T30

- 3.2.12 T8, T9, T14 and T15 are dead, and T30 is causing significant damage to a boundary wall. These trees should be felled regardless of any new development (as detailed in Appendix 4).

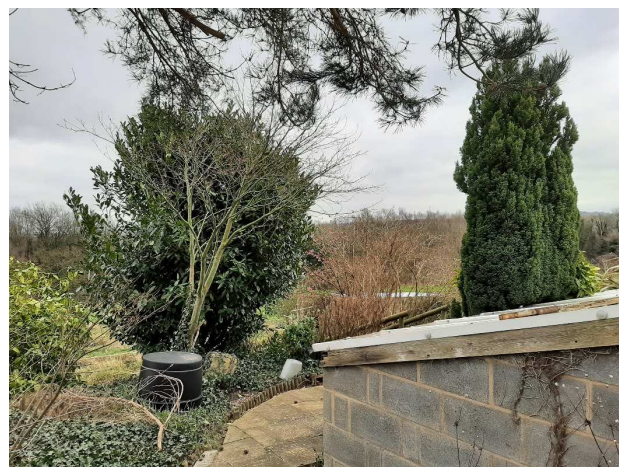
Photo 6: Small garden trees T38, T39 and T40

| | Tree Species | | | Measurements | | | | Crown (m) | | | | Tree Condition | | | | | | | | Value | | Management |
|---|---|---|---|---|---|---|---|---|---|---|---|---|---|---|---|---|---|---|---|---|---|---|
| T38 | Cypress | <i>Cupressus sp.</i> | Young | 4 | 10+ | 40 | Yes | 0.5 | 0.5 | 0.5 | 0.5 | 0.5 | No visual defects | Multiple stemmed at base, Vertical, Tight union with partially included bark | Normal | Situated in paving | Good | Fair | 20 to 40 yrs | Low | C | Removal required to facilitate development |

| Tree ID | Tree Species | | Maturity | Measurements | | | | Crown (m) | | | | | Tree Condition | | | | | | | Value | | Management |
|---|---|---|---|---|---|---|---|---|---|---|---|---|---|---|---|---|---|---|---|---|---|---|
| T40 | Maple | <i>Acer sp.</i> | Semi-mature | 4 | 2 | 80, 60 | No | 2.5 | 2 | 1.5 | 2 | 2 | Limited access around base | Twin stemmed at base, Slight lean west, Ivy covered, Tight union with partially included bark, Bark damage | Normal | Bark damage on underside of branches, in west crown aspect | Fair | Fair | 20 to 40 yrs | Low | C | Removal required to facilitate development |

- 4.2.2 The trees that require removal are T10, T16, T17, T18, T19, T20, T21, T22, T23, T24, T25, T26, T32, T34, T35, G36, G37, T38, T39, T40, T41, T42, G43 and T44.
