## Proposed Housing Development Northorpe Lane, Mirfield

### Road Safety Audit: Stage 1 S278 and S38

| Report Dated: | 30 June 2021 |
| Report Reference: | MAL/NLMRSA1Rev1 |

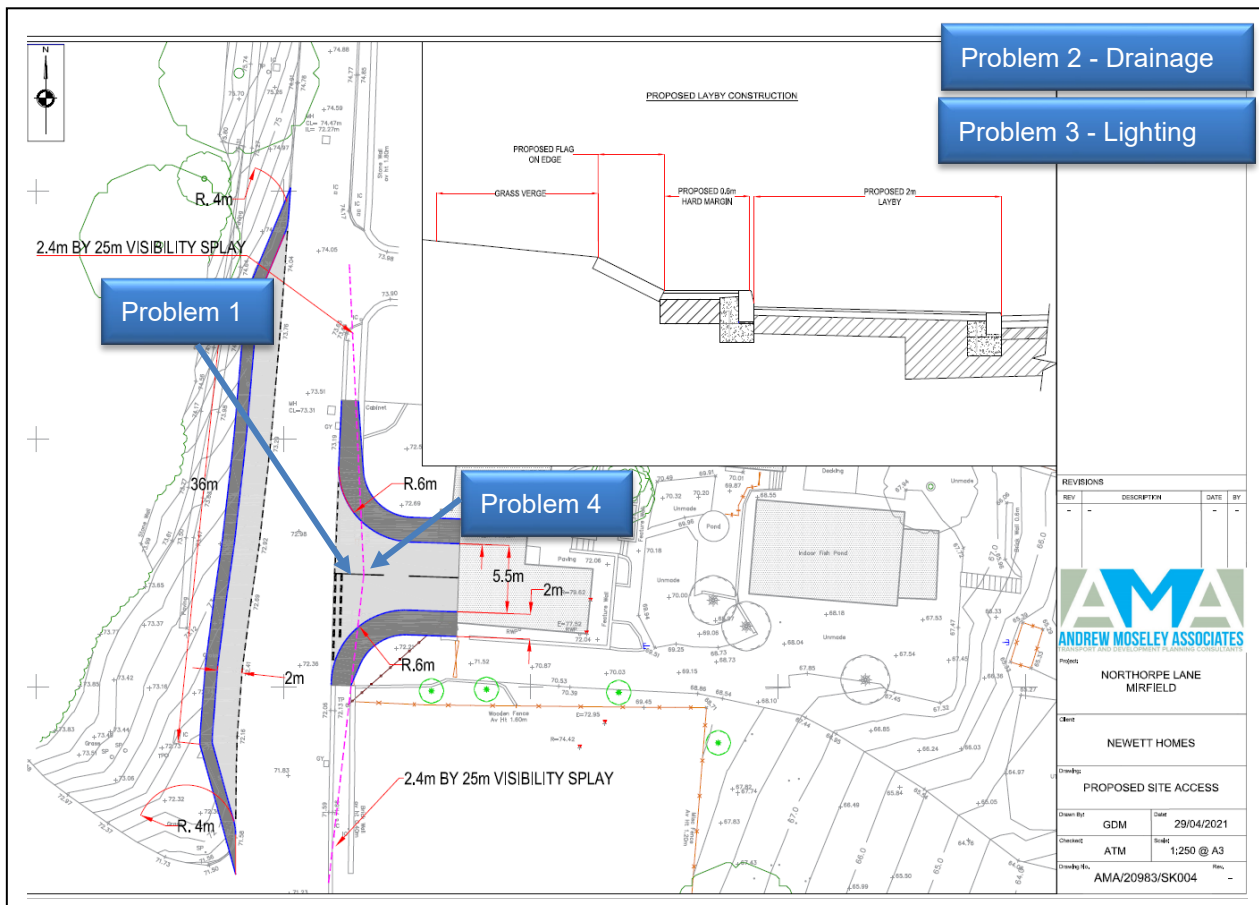
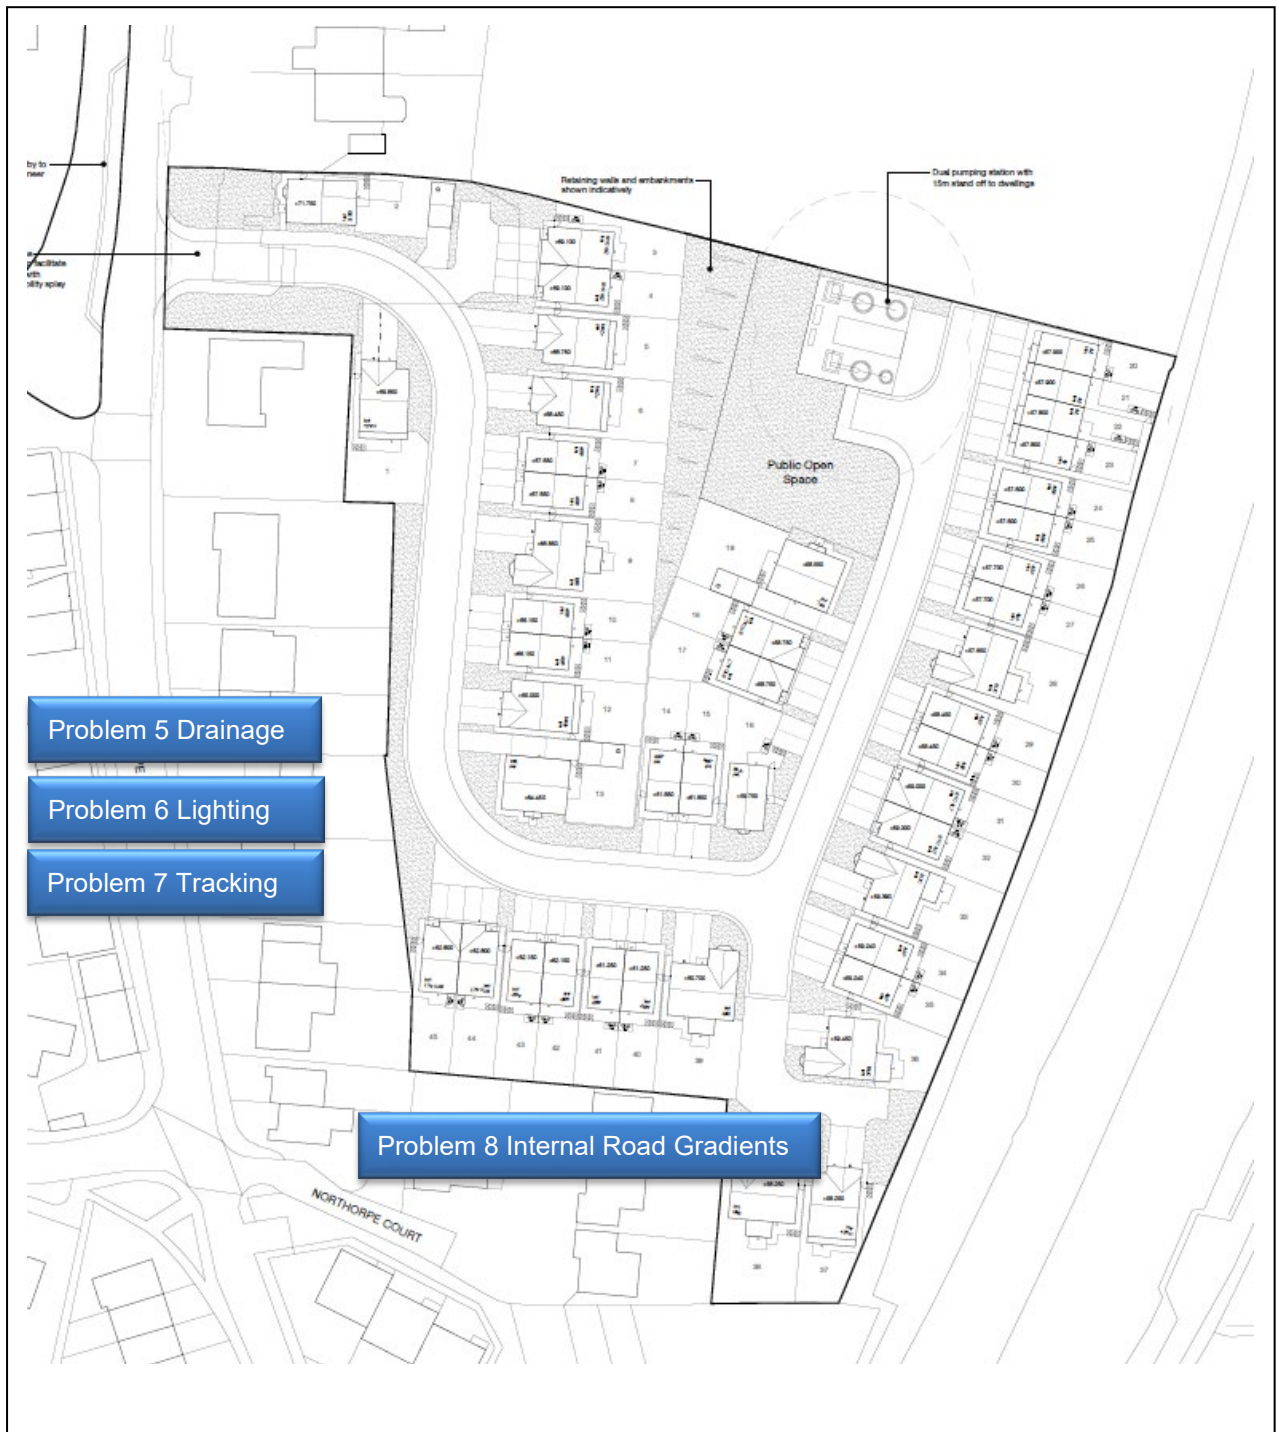
# Appendix 2 – Problem Location Plan

| PROBLEM | | 1 |
|---|---|---|
| Summary: | A lack of suitable uncontrolled crossings will increase both the risk of pedestrian trips and falls as well as pedestrian-vehicle collisions. | |
| <p>The drawings provided do not show any crossing facilities across the new site access onto Northorpe Lane. There is an existing footway along the eastern side of Northorpe Lane that the new access will bisect.</p> <p>A lack of suitable uncontrolled crossings will increase both the risk of pedestrian trips and falls as well as pedestrian-vehicle collisions.</p> | | |

| PROBLEM | | 2 |
|---|---|---|
| Summary: | Inappropriate drainage may lead to ponding water resulting in loss of control type collisions. | |
| A new priority-controlled access and parking bay will be constructed as part of the development. Ponding water can result in an increased risk of loss of control type collisions and at certain times of year standing water will freeze resulting in ice, vehicles manoeuvring in the turning could lose control resulting in an increased risk of collisions as well as pedestrians slipping and falling. | | |

| PROBLEM | | 3 |
|---|---|---|
| Summary: | Inappropriate levels of lighting can lead to an increased collision risk. | |
| <p>The drawing provided does not clearly show if alterations to the existing street lighting is proposed. The scheme will include a new access junction and changes to include a parking bay. The development will increase both the night-time usage and the number of vehicles/NMUs using the proposed road network once constructed.</p> <p>This may result in the new access junction and parking bays being in shadow leading to possible conflicts during the hours of darkness.</p> | | |

| PROBLEM | | 4 |
|---|---|---|
| Summary: | Details of vehicle tracked movements are not provided on the drawings. Inappropriate carriageway widths and turning radii can result in increased vehicle collisions as well as pedestrian-vehicle collisions. | |
| Details of the swept paths of vehicles, are not provided on the drawings. Inappropriate carriageway widths and junction radii can result in vehicles failing to safely negotiate the new junction arrangement increasing the risk of both vehicle and pedestrian-vehicle collisions. | | |

| PROBLEM | | 5 |
|---|---|---|
| Summary: | Inappropriate drainage may lead to ponding water resulting in loss of control type collisions. | |
| A new internal road layout will be constructed as part of the development. Ponding water can result in an increased risk of loss of control type collisions and at certain times of year standing water will freeze resulting in ice, vehicles manoeuvring could | | |

| lose control resulting in an increased risk of collisions as well as pedestrians slipping and falling. |

| PROBLEM | | 6 |
|---|---|---|
| Summary: | Inappropriate levels of lighting can lead to an increased collision risk. | |
| <p>The drawing provided does show any street lighting. The scheme will include new access roads and junctions. The development will increase both the night-time usage and the number of vehicles/NMUs using the proposed road network once constructed.</p> <p>This may result in the new access roads being in shadow leading to possible conflicts during the hours of darkness.</p> | | |

| PROBLEM | | 7 |
|---|---|---|
| Summary: | Details of vehicle tracked movements are not provided on the drawings. Inappropriate carriageway widths and turning radii can result in increased vehicle collisions as well as pedestrian-vehicle collisions. | |
| Details of the swept paths of vehicles are not provided on the drawings. Inappropriate carriageway widths and junction radii can result in vehicles failing to safely negotiate the new road layout increasing the risk of both vehicle and pedestrian-vehicle collisions. | | |

| Summary: | Excessive gradients can increase the risk of loss of control type collisions. |
| <p>Details of carriageway cross sections and long sections are not currently available. The Audit Team noted that the site is on a steep hillside with cross site height difference between Northorpe Lane and the furthest extents of the site of up to 25m.</p> <p>These differences in height can result in steep access roads that during poor weather can increase the risk of drivers losing control.</p> | |

| PROBLEM | | 1 |
|---|---|---|
| Ensure that appropriate tactile paving layouts and dropped crossing points are provide in accordance with Guidance on the Use of Tactile Paving Surfaces [DfT]. | | |

| PROBLEM | | 2 |
|---|---|---|
| Provide appropriate drainage at all locations where changes to the road layout is proposed. | | |

| PROBLEM | | 3 |
|---|---|---|
| Ensure that suitable lighting provision is provided | | |

| PROBLEM | | 4 |
|---|---|---|
| Provide swept path movements the new site access. | | |

| Provide appropriate drainage at all locations where new road layout is proposed. |

| PROBLEM | | 6 |
|---|---|---|
| Ensure that suitable lighting provision is provided. | | |

| PROBLEM | | 7 |
|---|---|---|
| Provide swept path movements on the internal road network. | | |

| At Stage 2 RSA provide details of gradients of all internal roads. | |
