## IVY LODGE, 75 CROWLEES ROAD, MIRFIELD

Having committed substantial investment in the property and adjacent coach house, the owner has growing concerns as to the stability and overall appearance of the projecting gable to Ivy Lodge and seeks advice on the extent of repair / rebuilding which could be undertaken to secure the long term future of the house.

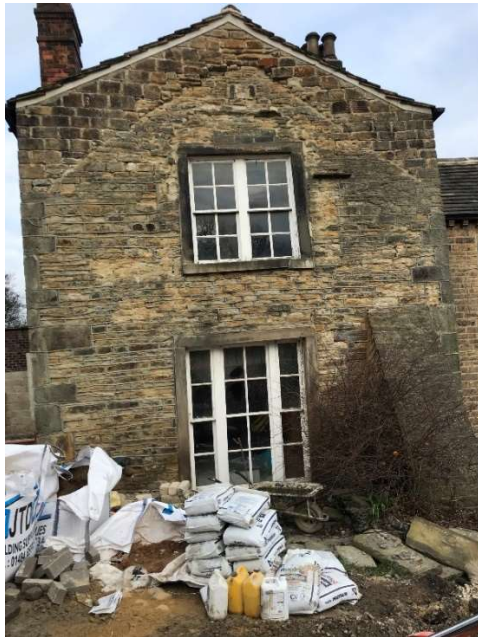
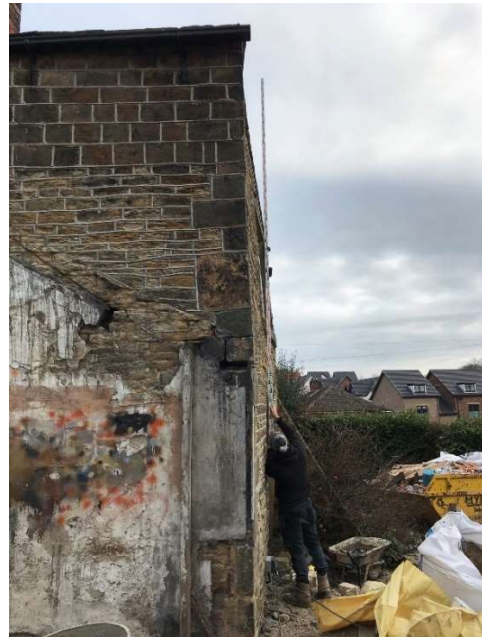
Photographs below show the condition of the walls and the deviation of vertical alignment

The aim would be to re-use the existing quoins and window surrounds in their exact position, although some elements would need replacing, (in particular the fractured first floor window sill), which would be undertaken in sawn stone to match. The existing stone is crumbling and considered unsuitable for re-use and it would be the intention to rebuild in second hand stone in diminishing coursing to match the other parts of Ivy Lodge.

The windows would be replaced in identical style to the existing in painted timber with 4mm clear single glazing

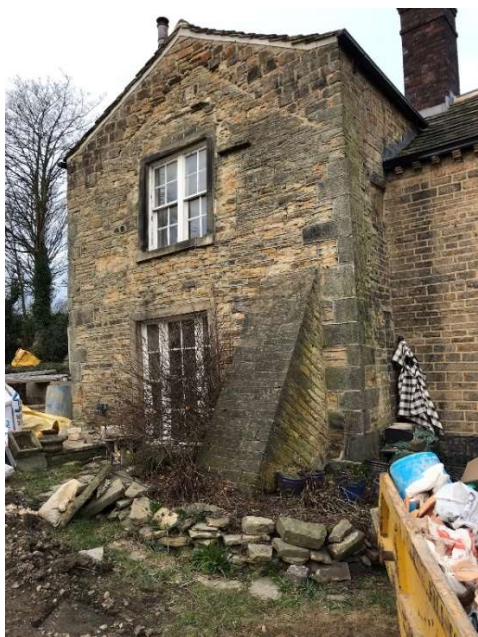
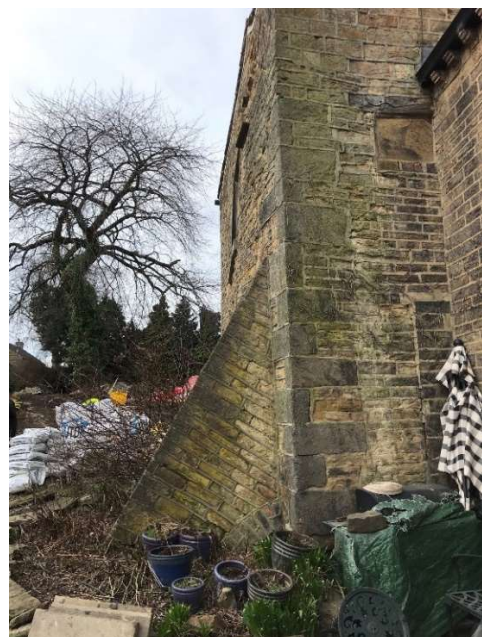
Photographs below show the buttress

This is also seen as an opportunity to remove the incongruous stone buttress, which is clearly an addition to the original structure, added presumably in an attempt to prevent further movement and/or collapse.
