**Ivy Lodge  
Mirfield, W. Yorks**

**Updated Structural Report  
on Gable Wall**

**August 2021**

**Ref: T2360**

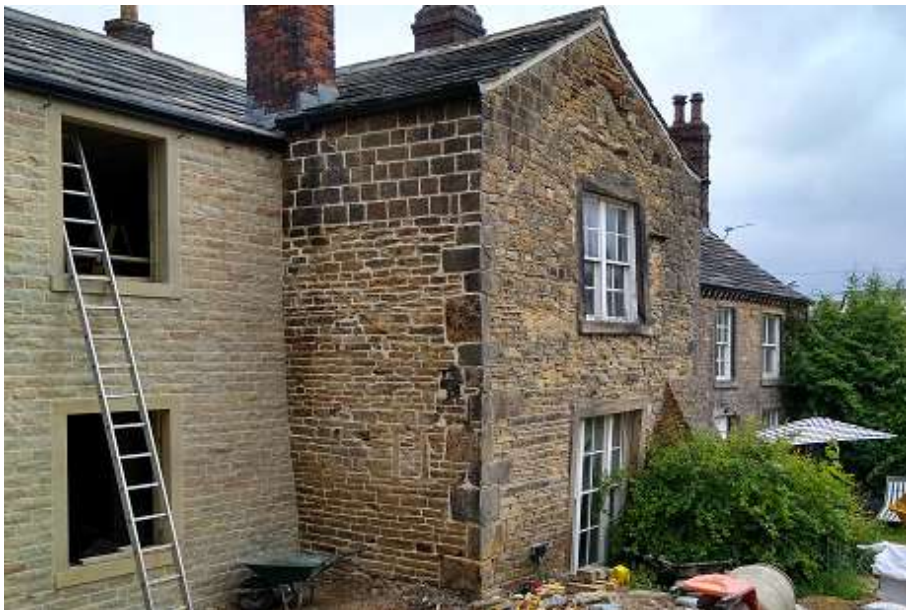
- 2.3 Although it has not been noted in the listing, there is a carved stone that has been used as a quoin stone in the SW corner of the west wing. The stone is likely much older than C17th date for the west wing, and could be a C12th gravestone (Photograph 1).

Photograph 1. Location of carved stone on SW corner

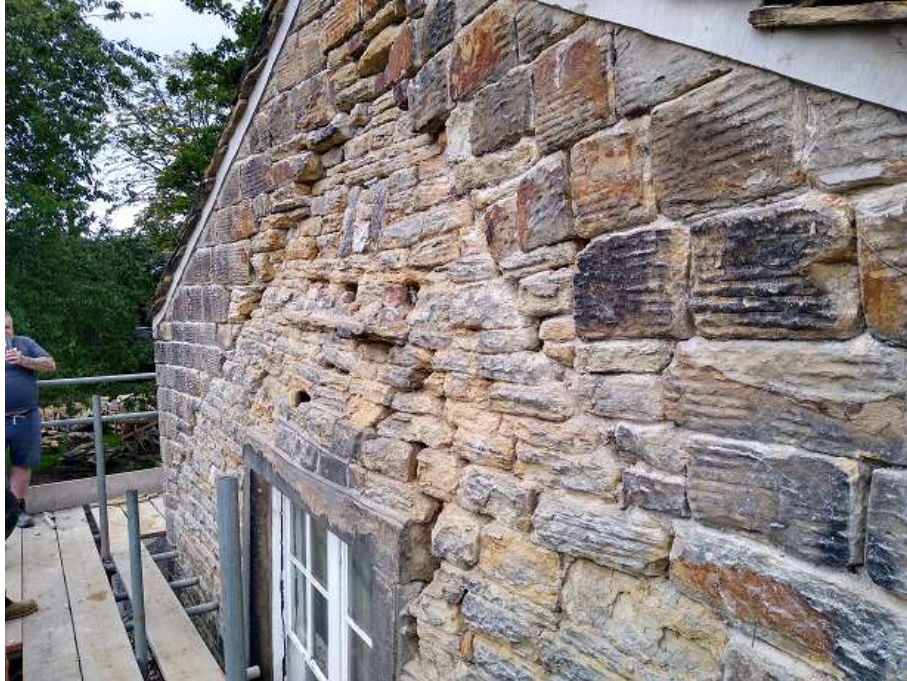
Photograph 2. Area of severely perished stonework

- 3.5 The side walls had also bowed outwards, with outwards movement at eaves level, and bowing on the west side wall.
- 3.6 The squared rubble stonework above the first floor window was in very poor condition, with many of the stones almost completely perished (Photographs 2 and 3). This triangular area of masonry had also been built over to raise the level of the roof, and the upper stonework of larger blocks did not align with the lower masonry.

- 3.8 The relatively recent ribbon pointing in a cement mortar also appears to have accelerated the decay to the stones. Damage to the older squared rubble masonry was even more significant than initially anticipated.
- 3.9 S&CC understand that the poor condition of the stonework, along with the bowing in the wall had made installation of the recommended sock anchor into the front gable impractical at eaves level.

- 4.2 The very poor condition of the masonry above the first floor window will necessitate the reconstruction of a significant portion of the gable wall.

- 5.3 It is recommended that the gable wall is carefully taken down, and rebuilt. There are several different options for the rebuild that should be explored:

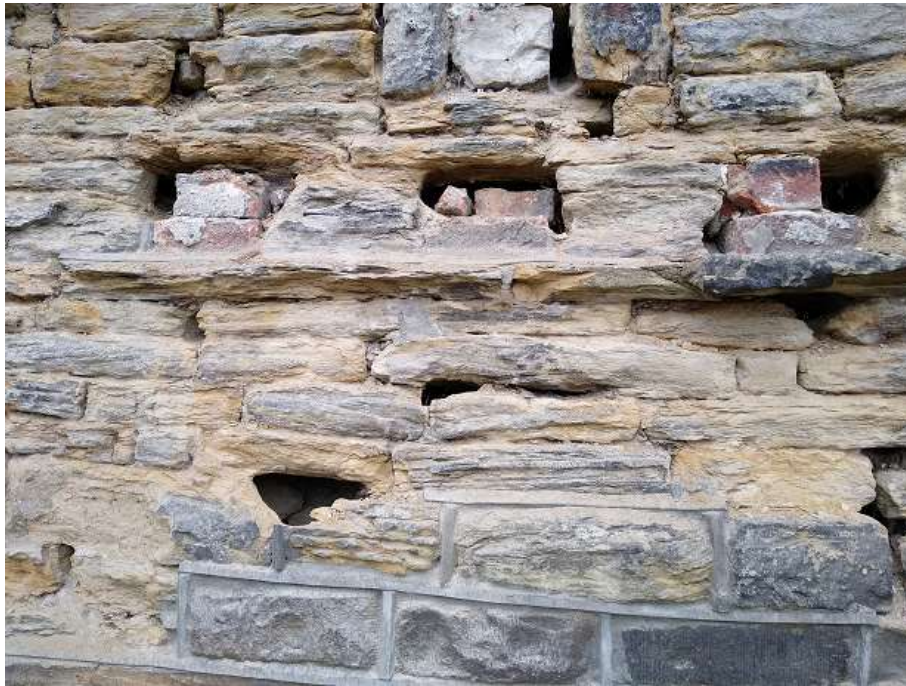
- 3.7 The bowing to the wall also meant that squared rubble masonry above the first floor window was on an incline. Water appears to have been penetrating the outer leaf of the masonry through old doveholes and failed stones (Photograph 3),

accelerating decay of the stones.

Photograph 3. Close-up of perished stones around doveholes

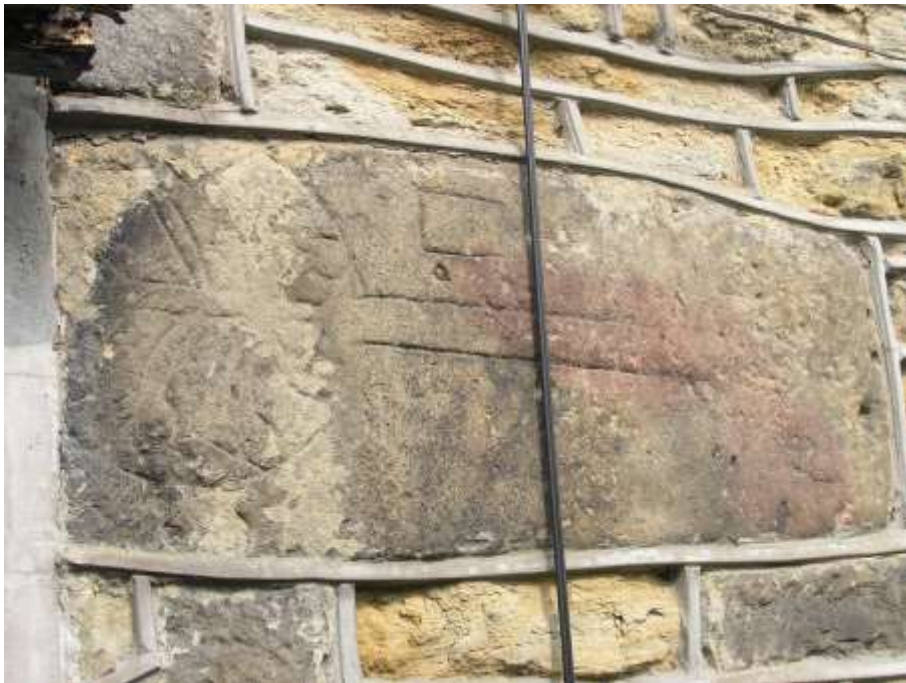
- 4.5 The west wing gable is the part of oldest section of the house. Previous historic changes, including the insertion of the larger windows through the squared rubble walls, and the raising of the wall level, have significantly weakened the wall.
- 4.6 There is an anomaly in the Listing. Although Ivy Lodge is noted as C17<sup>th</sup> or C18<sup>th</sup> in date, a stone used as a quoin and embedded in SW corner of the wall appears to be much older, perhaps C12<sup>th</sup>. Particular care will be needed to ensure this stone is not damaged in the rebuilding.

Photograph 4. Close-up of carved quoin at SW corner

- 5.4 As discussed in paragraph 4.6, whichever option is taken; particular care should be taken with the carved quoin on the SW corner, so that it is preserved and replaced in its original position. A mason experienced in working with historic fabric should carry out the conservation of this stone.
- 5.5 Once the gable wall has been taken down, the foundations should be investigated to check they are in good condition, and suitable for the new wall.
- 5.6 Both options will require the internal floors and roof to be temporarily propped, and
