ARBORICULTURAL REPORT & Impact Assessment to **BS5837:2012 at:**

***Woodhead Road,
Birstall,
Batley,
WF17 9TD***

Date: *March 2021*

Reference: *AWA3591*

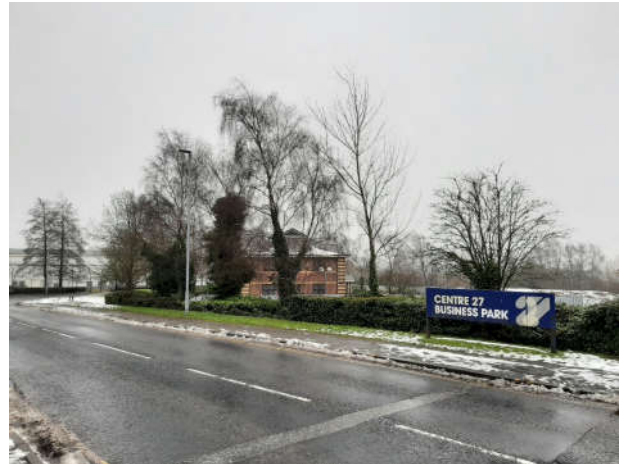
- 3.2.5 At the northern boundary of the site, close to the road, are trees T1 to T9, T26 and T27. These trees are situated in banking, and in dense understory

that prevented detailed inspection. Individually the trees have limited value, but have collective value as a screen between the road and the site.

Photo 2: Trees at the northern boundary of the site, situated in dense shrub beds

4.2.7 T1, T2, T3, T4, T5, T6, T7, T8, T9, T24 and T26, and G25, are individually lower value trees, but collectively provide of canopy cover and screening at the northern boundary. Collectively, this will result in a moderate arboricultural impact.

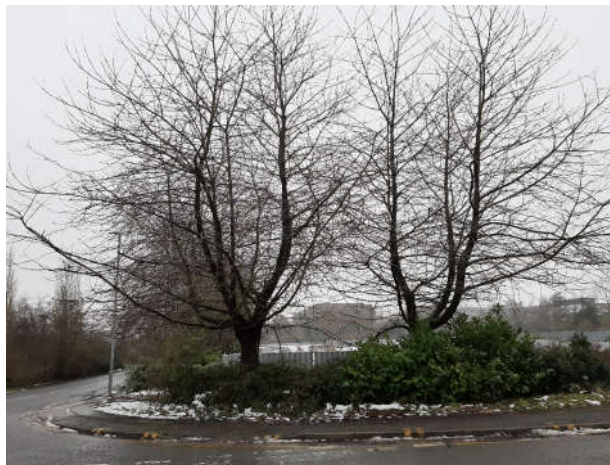
- 3.2.6 In the north-east corner of the site are Birch T14 and Cherry T15 and T16. These trees are currently in reasonable condition and have moderate amenity value, however T15 had some minor dieback and dead wood in the crown which may indicate slightly more limited long-term prospects.

Photo 3: T15 and T16, two of the mature trees on site

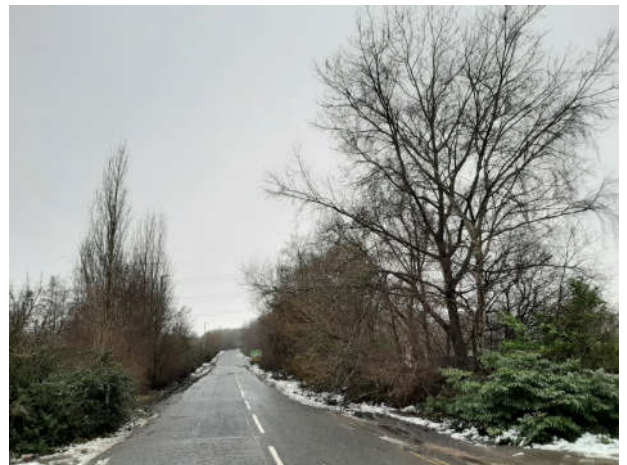
- 3.2.8 Poplar T19, situated within G17, has a prominent hanging branch at its eastern aspect that should be removed regardless of any new development (as detailed in Appendix 4)

Photo 4: G17, at the eastern boundary of the site

4.2.9 The north-western aspect of G17 will be removed, to the boundary line. The collective screening value of G17 will not be significantly impacted by this work.

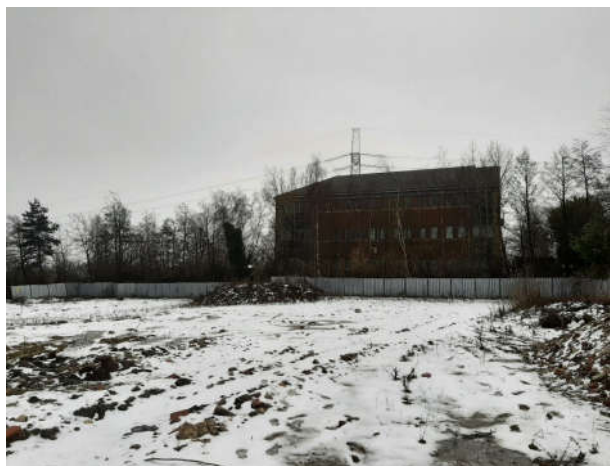
- 3.2.7 At the east, south and west boundaries of the site are large, shelterbelt groups of trees G17, G23 and G25, which contain occasional larger trees T18 to T22, and T26. G23 is a large, dense group of predominantly semi-mature Birch, Alder and Pine that has moderate value as a screen between the site and buildings to the south-west. G17 and G25 have more limited collective screening value. There are occasional failed stems and branches within these groups, including a prominent, low hazard beam failure at the eastern aspect of G17. Trees in groups, including individually numbered trees, have limited individual value, but do contribute to the more moderate collective screening value of the groups.

Photo 5: G23 at the southern boundary, screening the site from adjacent office buildings

4.2.10 The north-western extent of G23 will be removed entirely, while the eastern aspect will be removed to the boundary line. While this will impact the screening value from the road and car park to the north-west, G23 will still effectively screen the building to the west.

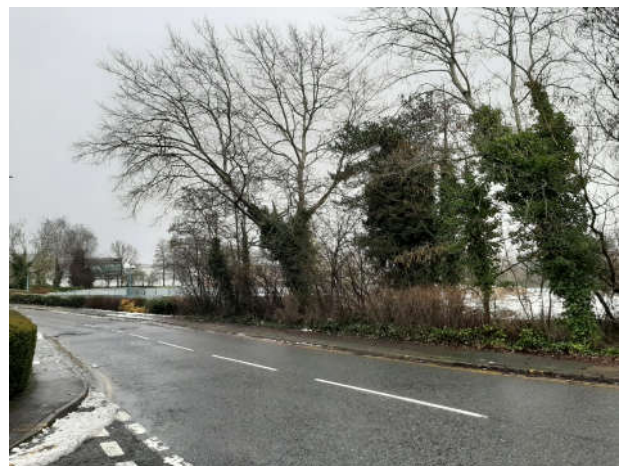
Photo 6: G25 and T26, at the western boundary of the site
