## STRUCTURAL INSPECTION REPORT

Original Farmhouse, Yew Tree Farm,  
Farnley Tyas  
For John Radcliffe and Sons

Date 05/11/2021  
Ref **4011/SIR002**

### **STRUCTURAL INSPECTION REPORT – ORIGINAL FARMHOUSE (BUILDING 6)**

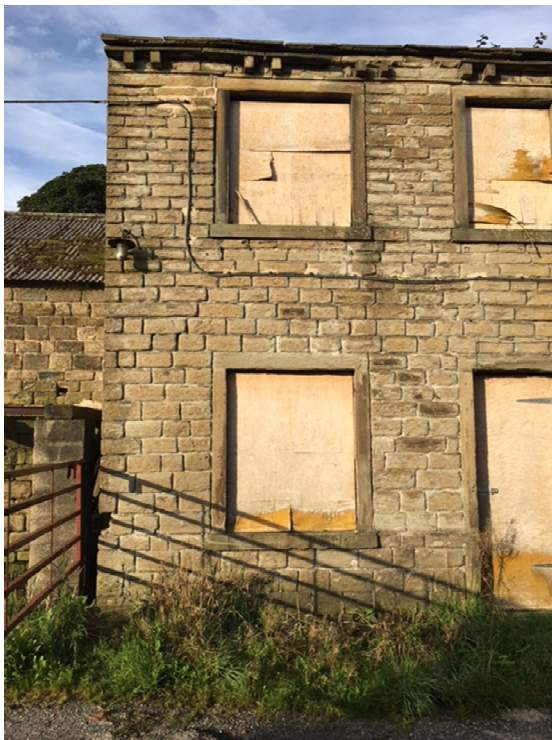
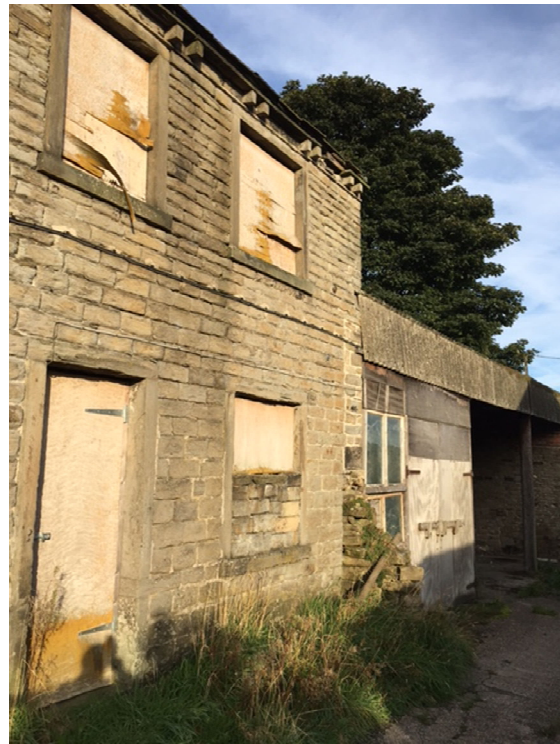
External walls exhibit widespread damp penetration with associated loss of mortar joints and deterioration of masonry facings (particularly at eaves level). Localised settlement cracking suggests foundation issues at the south-eastern corner of the building.

Along the full length of the rear elevation self-seeded tree have been allowed to establish and mature with potential consequences for the integrity of existing foundations which are likely to be shallow and susceptible to the shrinkage potential of underlying natural strata.

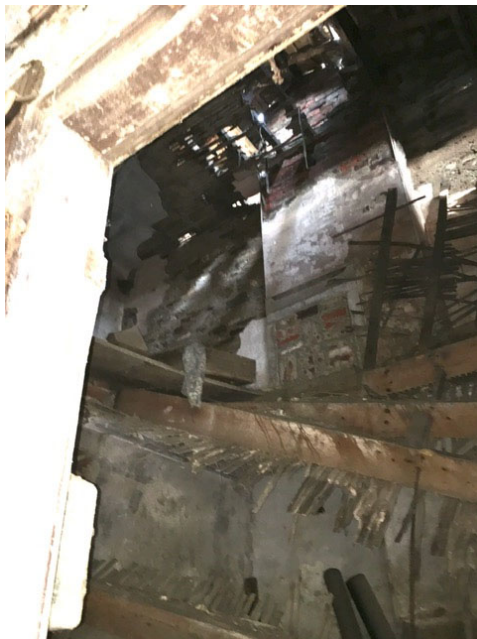
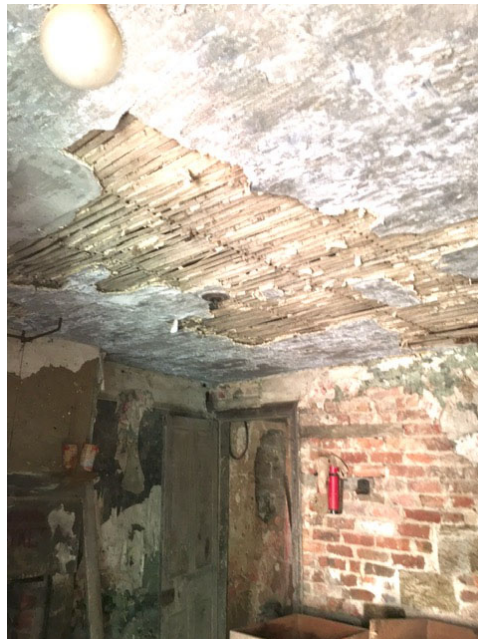
Safe internal inspection of the building is not possible. However, a partial inspection revealed a section of completely collapsed first floor construction and evidence of widespread structural deterioration due to water penetration.

The collapse of the first floor has removed essential lateral restraint to external wall constructions and has significantly impacted on the overall integrity of the building structure.

**Collapsed first floor and ceiling structures**

The collapse of the first floor and the associated loss of lateral restraint to the external walls render the building unsafe and consequently it should be secured against entry immediately.

The controlled demolition of the building is therefore recommended under a contract which should include all necessary CDM measures.
