## STRUCTURAL INSPECTION REPORT

Milking Shed, Yew Tree Farm, Farnley Tyas  
For John Radcliffe and Sons

Date 05/11/2021

Ref **4011/SIR001**

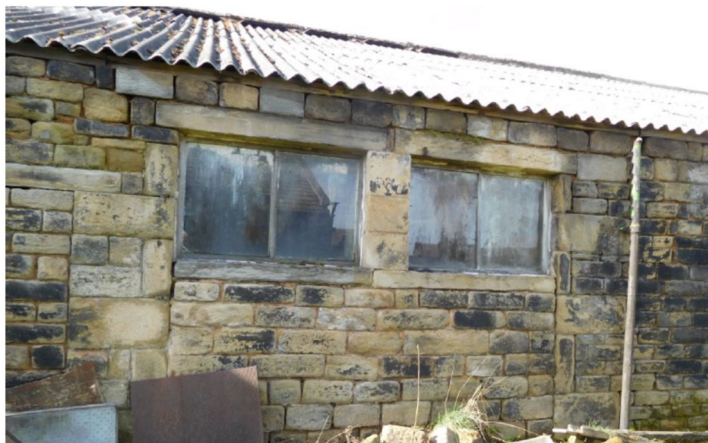
The eastern elevation of the building has the benefit of a separating wall and a return in the external wall on plan, both of which add lateral stability. Consequently, the lateral restraint provided by the roof has undoubtedly diminished over time, lateral movement of this wall is less evident and is more within acceptable limits.

That said, mortar joints have been significantly eroded. Widespread damp penetration is evident (particularly at roof level) and localised settlement cracking suggests foundation issues.

Photo of elevation 3

Whilst it may not be necessary to rebuild all external walls, considerable work will be necessary to bring the structure up to suitable standards for residential development. Overall stability will also be a concern in the construction condition when the roof structure is removed and replaced.

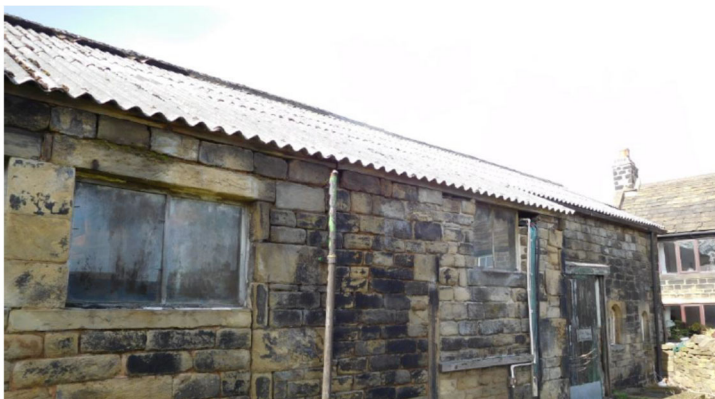
Photo of elevation 3

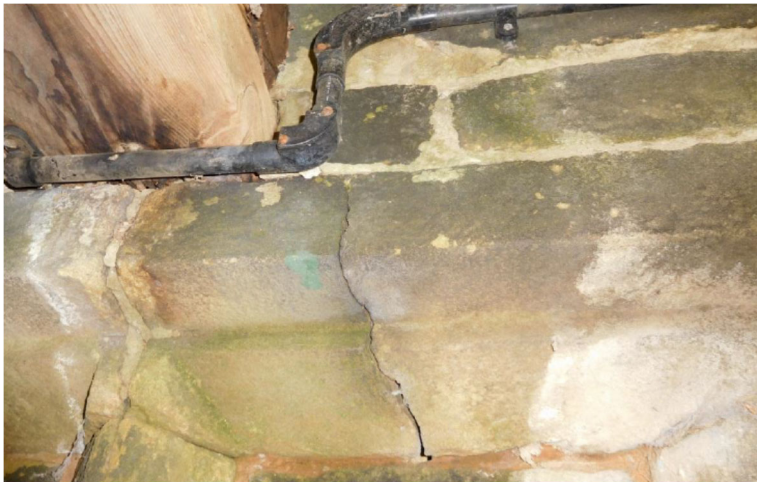
Failed external wall lintel

- The repair/replacement of failed lintels (as shown below).

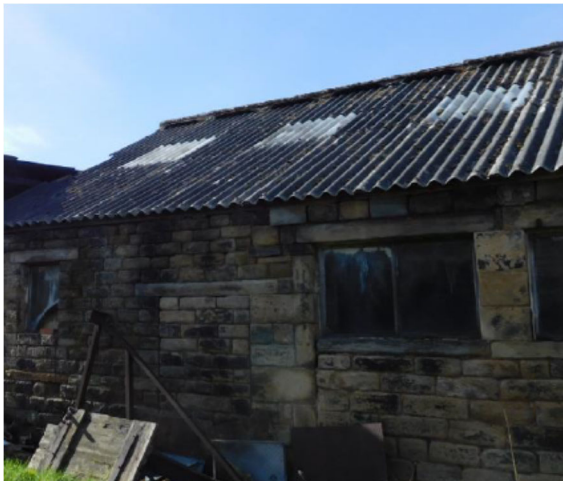
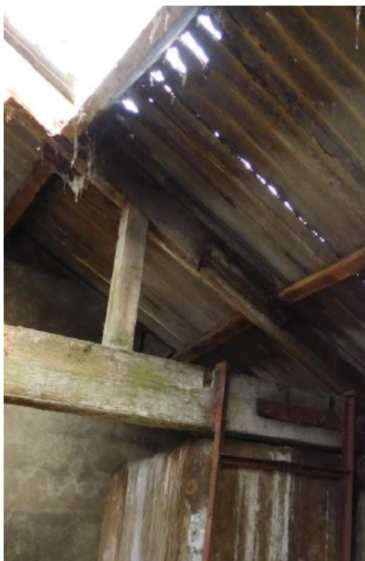
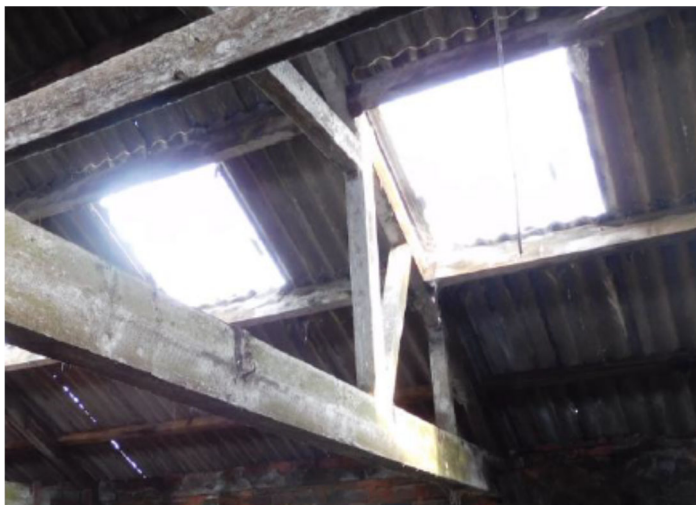
The roofing system has not been well maintained with roof drainage systems largely missing, and widespread evidence of water penetration into the building fabric.

Whilst a high-level inspection of roof timber was not possible, deterioration due to damp penetration is highly likely with potential structural deterioration of roof timbers.

The existing roof structure will not be suitable for the support of more substantial roofing materials to modern standards.

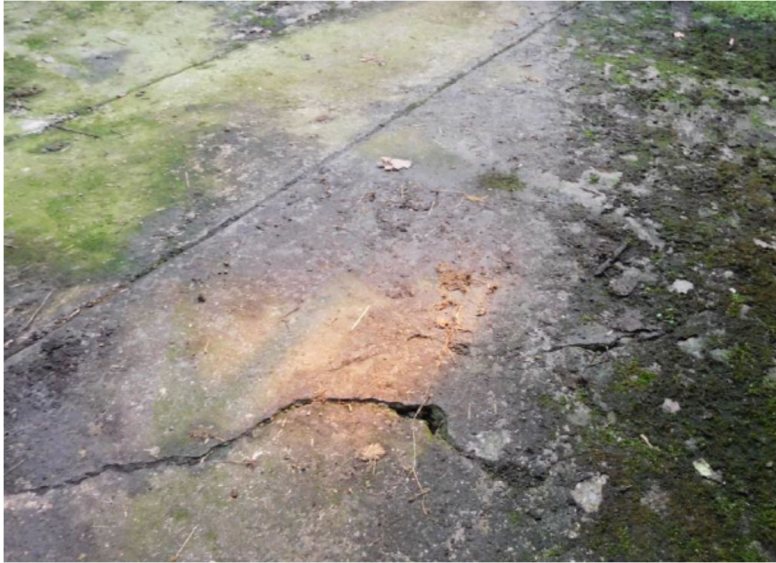
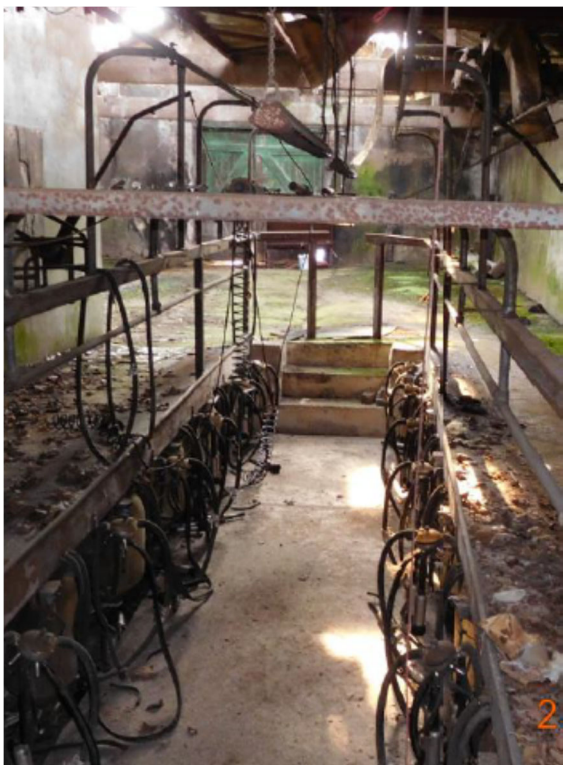
The existing ground floor construction is in poor condition with areas of cracking and evidence of ground heave. The potential for sulphates within the supporting ground cannot be discounted and will need to be addressed in the proposed works.

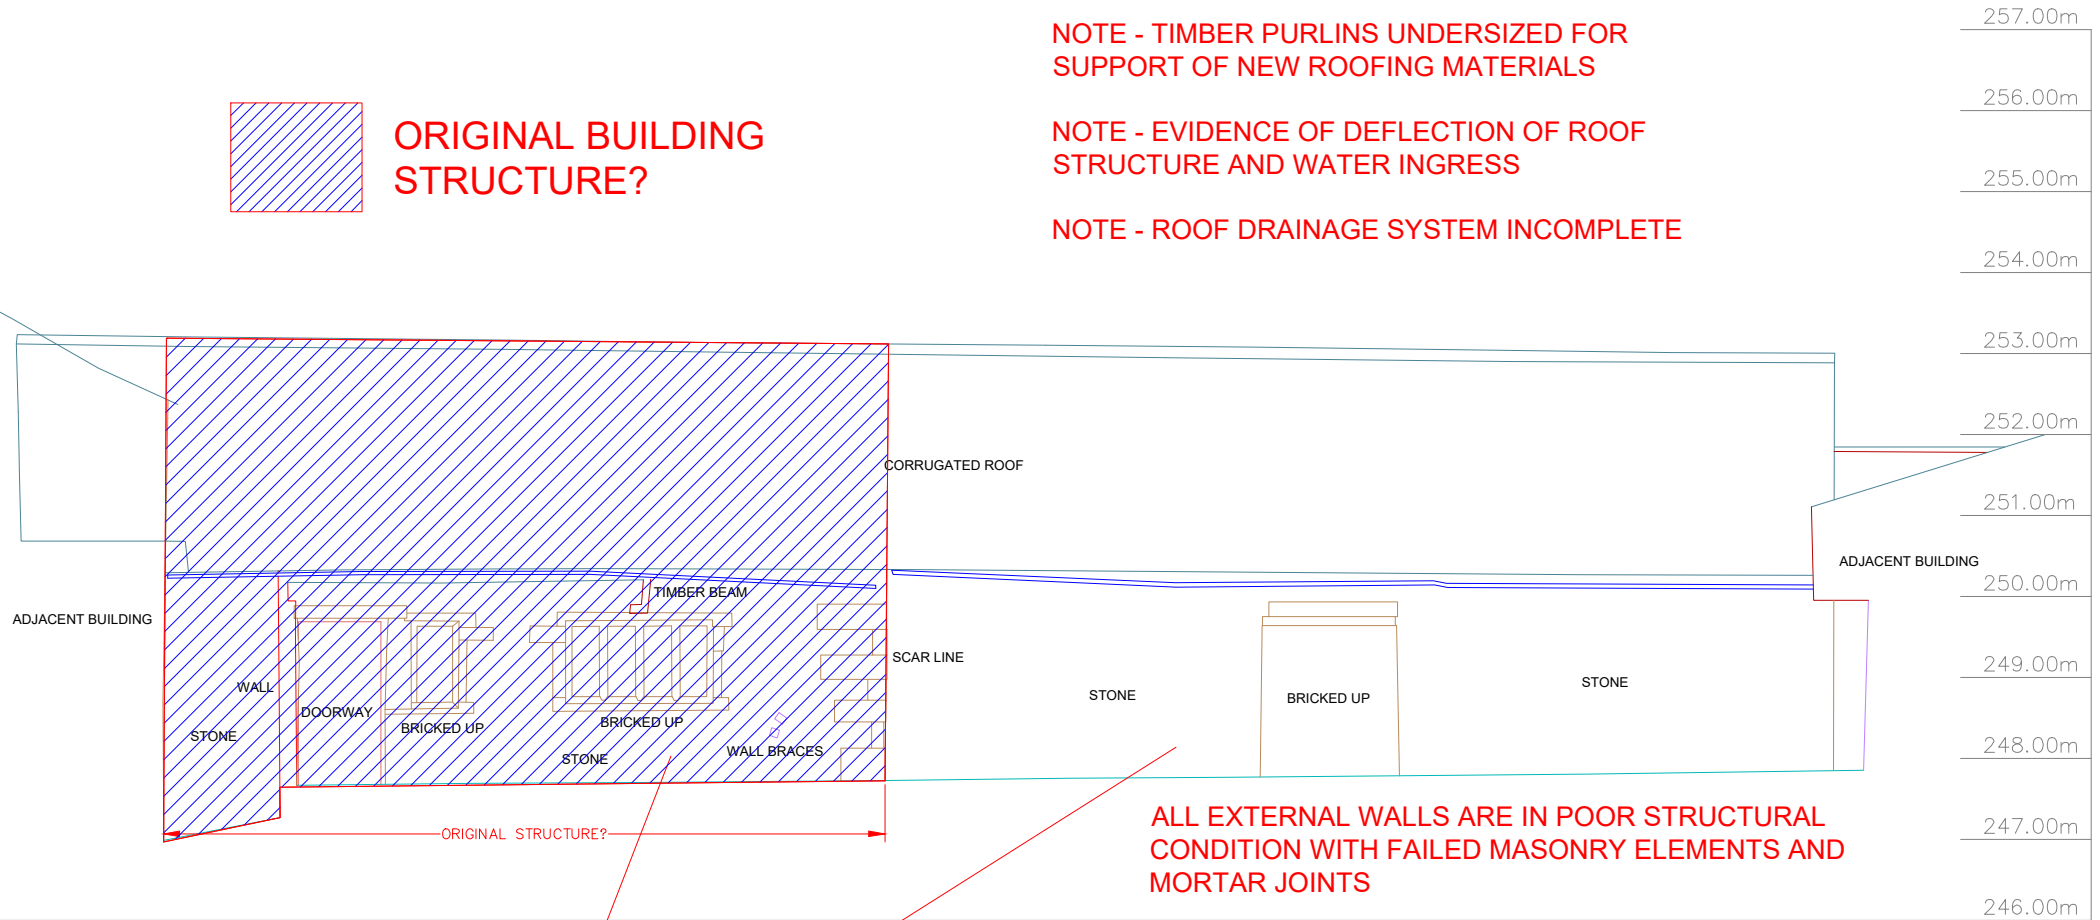
ELEVATION 1

ASBESTOS CEMENT SHEETED ROOF

NOTE - TIMBER PURLINS UNDERSIZED FOR  
SUPPORT OF NEW ROOFING MATERIALS

NOTE - EVIDENCE OF DEFLECTION OF ROOF  
STRUCTURE AND WATER INGRESS

NOTE - ROOF DRAINAGE SYSTEM INCOMPLETE

EXTERNAL WALL UNRESTRAINED OVER A LENGTH  
OF 22m

NOTE - WALL HAS DEFLECTED SIGNIFICANTLY

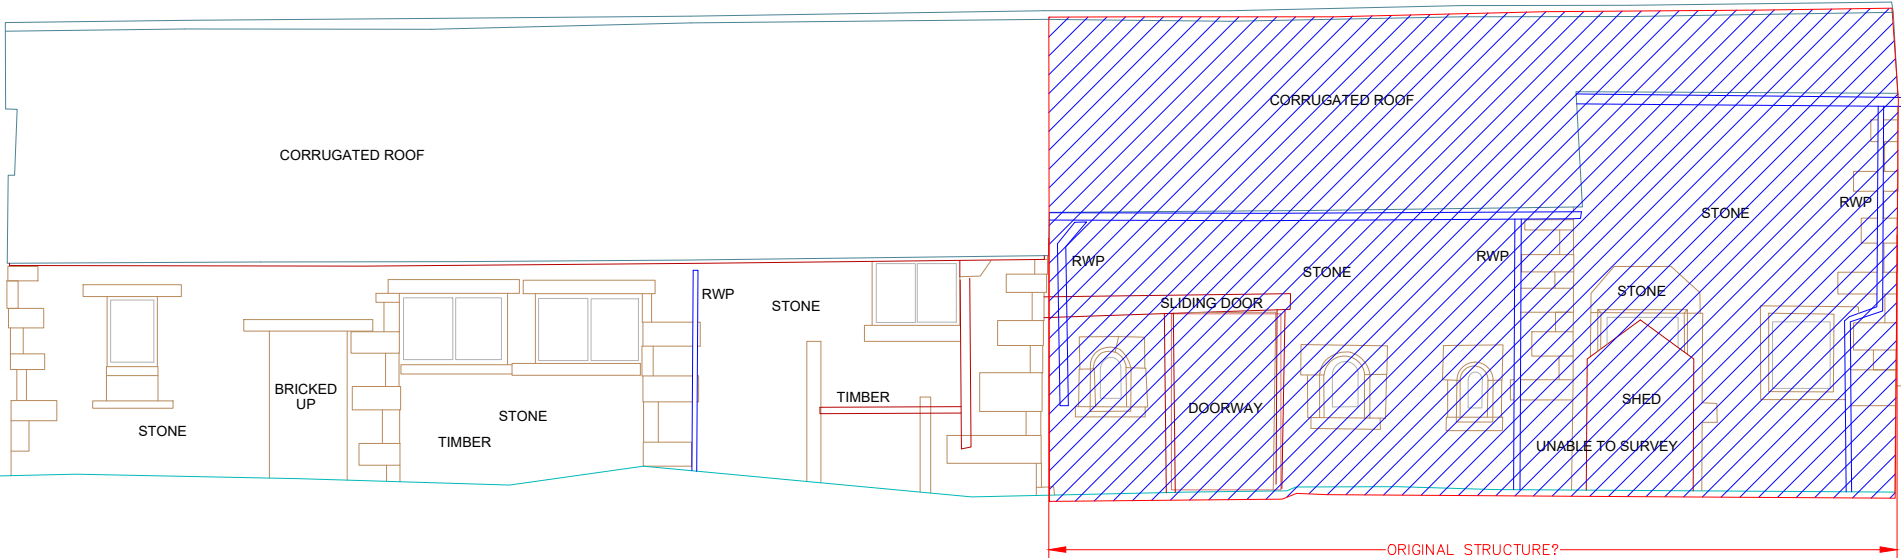
ELEVATION 3

ASBESTOS CEMENT SHEETED ROOF

NOTE - TIMBER PURLINS UNDERSIZED FOR  
SUPPORT OF NEW ROOFING MATERIALS

NOTE - EVIDENCE OF DEFLECTION OF ROOF  
STRUCTURE AND WATER INGRESS

NOTE - ROOF DRAINAGE SYSTEM INCOMPLETE

ALL EXTERNAL WALLS ARE IN POOR STRUCTURAL  
CONDITION WITH FAILED MASONRY ELEMENTS AND  
MORTAR JOINTS
