STRUCTURAL INSPECTION REPORT

Original Farmhouse, Yew Tree Farm,
Farnley Tyas
For John Radcliffe and Sons

Date 05/11/2021
Ref **4011/SIR002**

STRUCTURAL INSPECTION REPORT – ORIGINAL FARMHOUSE (BUILDING 6)

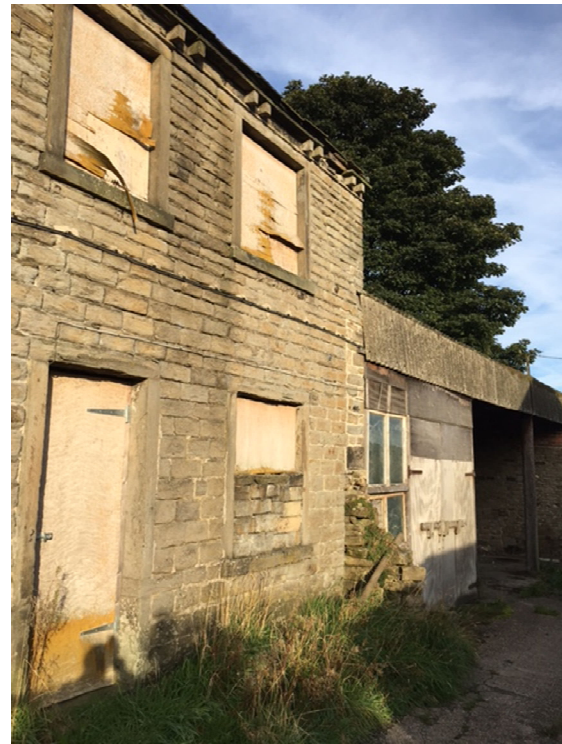
External walls exhibit widespread damp penetration with associated loss of mortar joints and deterioration of masonry facings (particularly at eaves level). Localised settlement cracking suggests foundation issues at the south-eastern corner of the building.

Along the full length of the rear elevation self-seeded tree have been allowed to establish and mature with potential consequences for the integrity of existing foundations which are likely to be shallow and susceptible to the shrinkage potential of underlying natural strata.

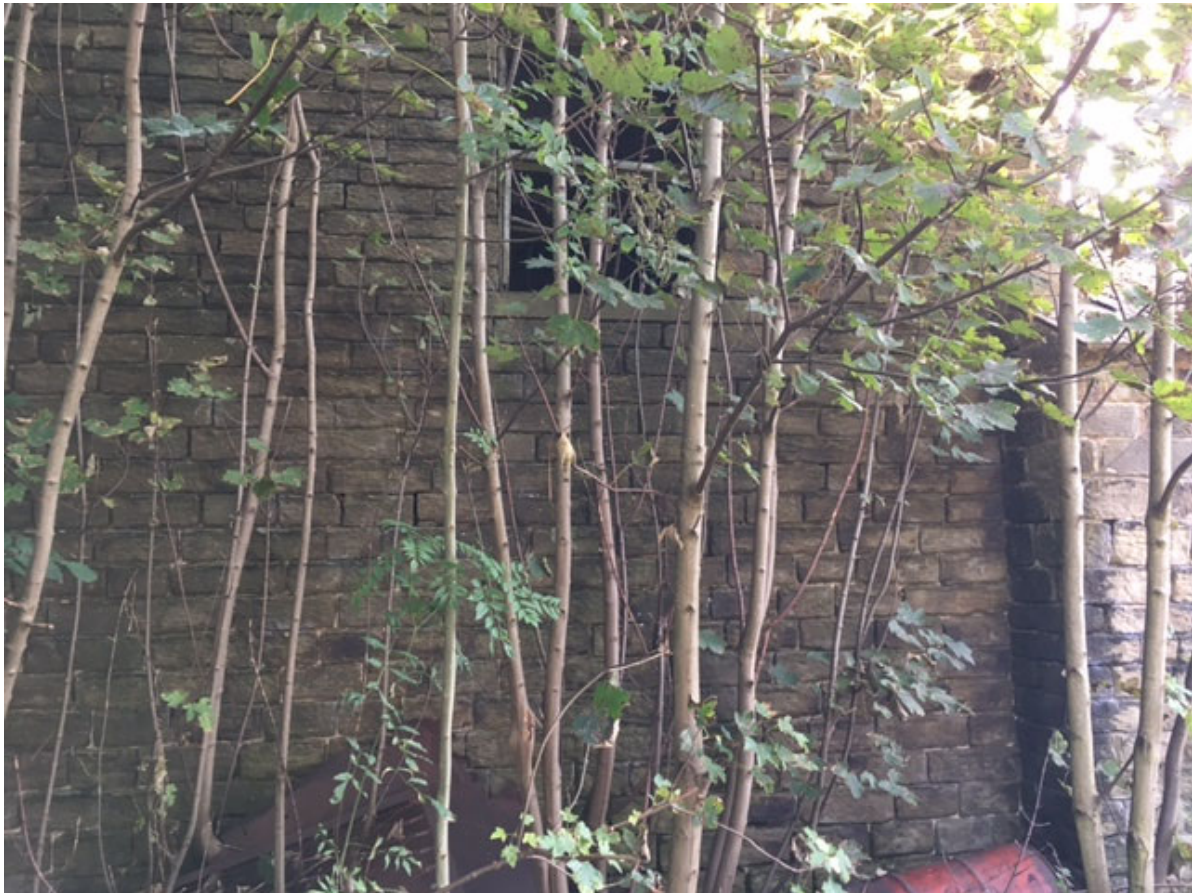
The roof covering has been compromised and the structure shows signs of structural distress. The roof drainage system is absent with no functioning gutters and downpipes. The chimney stack has been removed externally and widespread water penetration is evident with associated structural deterioration.

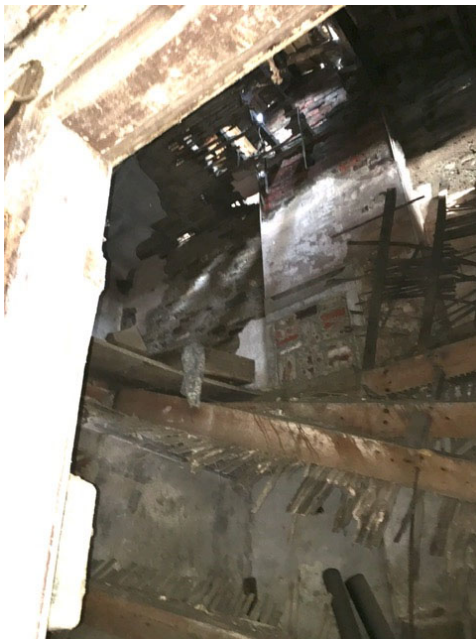
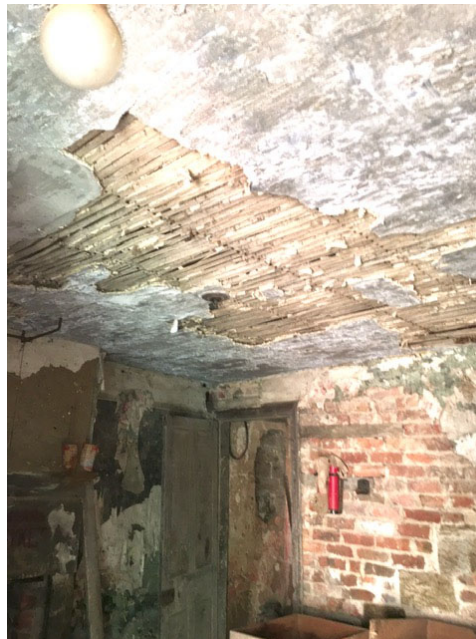
Safe internal inspection of the building is not possible. However, a partial inspection revealed a section of completely collapsed first floor construction and evidence of widespread structural deterioration due to water penetration.

The collapse of the first floor has removed essential lateral restraint to external wall constructions and has significantly impacted on the overall integrity of the building structure.

Collapsed first floor and ceiling structures

The collapse of the first floor and the associated loss of lateral restraint to the external walls render the building unsafe and consequently it should be secured against entry immediately.

The controlled demolition of the building is therefore recommended under a contract which should include all necessary CDM measures.
